### **NIST Response to the World Trade Center Disaster**

### Federal Building and Fire Safety Investigation of the World Trade Center Disaster

### August 26, 2008

Dr. S. Shyam Sunder Director and Lead Investigator Building and Fire Research Laboratory National Institute of Standards and Technology U.S. Department of Commerce

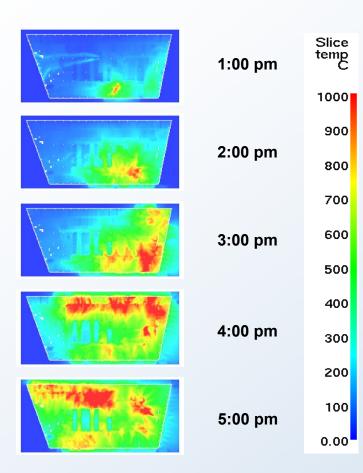
Progression of fires on Floor 12

- The major fires in WTC 7 were modeled using the Fire Dynamics Simulator (FDS) in a manner similar to those for the WTC towers.
- There were far fewer photographs and videos of WTC 7 than of the towers; thus, details of the WTC 7 fires were not as precise as for the towers.
- The fire simulations for WTC 7 were conducted for each floor individually; there were no obvious pathways for the flames and heat to pass from one floor to another, aside from the debrisdamaged area in the southwest corner of the building.
- Sustained and/or late fires were observed only on floors 7 through 9 and 11 through 13.
- The actual fires on these floors were most likely initiated at the time of the incidence of the debris from the collapsing towers.
- A typical single floor simulation took up to two days on a Linux cluster with 8 processors.

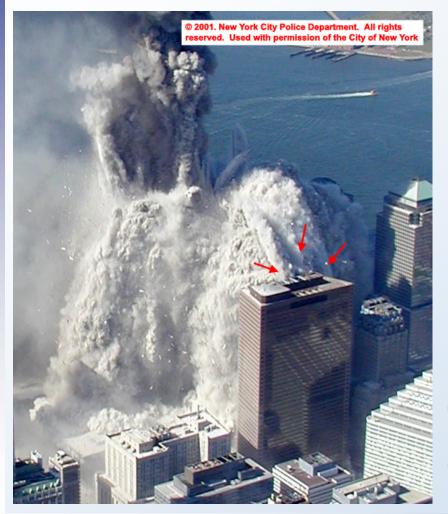
- Aerial photograph shot 14 s ± 0.5 s after WTC 1 began to collapse.
- Arrows mark arcs formed by debris that seemed to be ejected outwards from the debris cloud

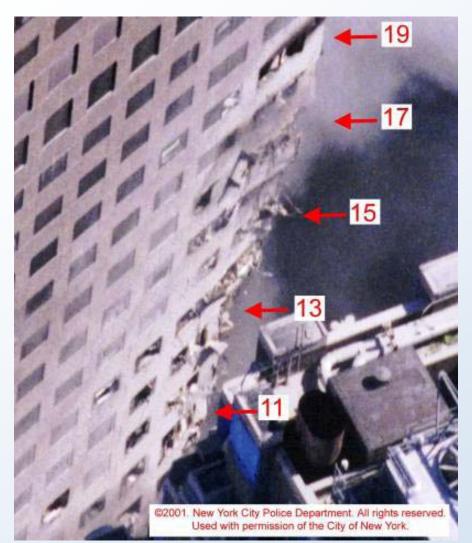
- Collapse of WTC 2 did not cause any structural damage or start any fires in WTC 7.
- Collapse of WTC 1 damaged seven exterior columns on the lower floors of the south and west faces and initiated fires on 10 floors between Floors 7 and 30.

- Enlargement of a photograph showing part of the west face of WTC 7.
- Arrows and floor numbers have been added for the corresponding rows of windows.

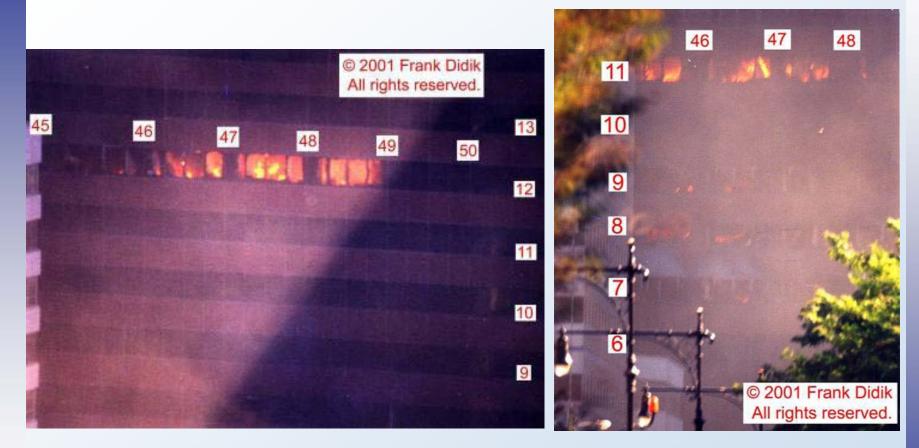
- Fires on the lower floors (Floors 7 to 9 and 11 to 13) grew and spread since they were not extinguished either by the automatic sprinkler system or by FDNY because water was not available.
- Fires were generally concentrated on the east and north sides of the northeast region beginning at about 3 p.m. to 4 p.m.
- The local fires on the upper floors (Floors 19, 22, 29, and 30) were not observed after approximately 1 p.m.
- Cropped photograph showing east edge of the north face and oblique view of east face of WTC 7.
- It was likely taken between 3:20 p.m. and 3:40 p.m.

- Cropped photograph of north face of WTC 7 taken between 3:11:15 p.m. and 3:16:51 p.m.
- Cropped photograph showing part of north face of WTC 7 at 4:39 p.m. ± 120 s.

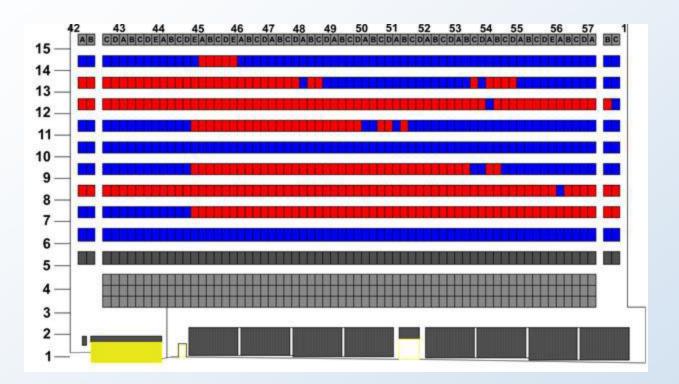
- Façade map showing where windows were broken and/or fire was observed during the period when fire first appeared shortly before 3:00 p.m. until the building collapsed at 5:20:52 p.m.
- Red represents windows where the glass was broken out and/or fire was observed through the window. The remaining windows are colored blue indicating that no direct evidence was observed for fires at these locations.

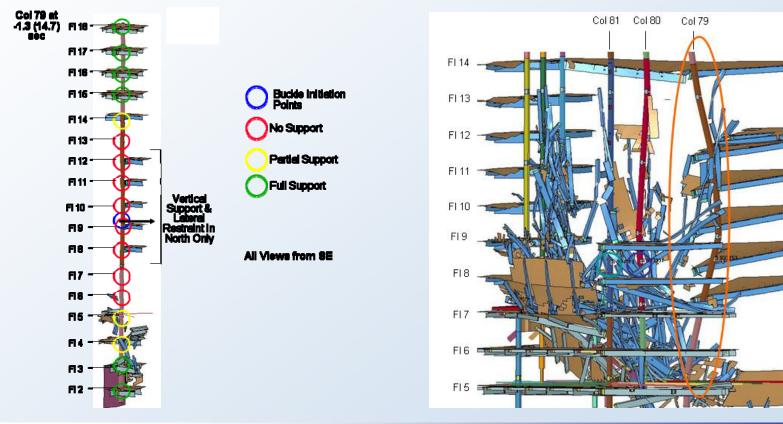
- Initial Local Failure for Collapse Initiation.
  - Fire-induced thermal expansion of the floor system surrounding Column 79 led to collapse of Floor 13 that triggered a cascade of floor failures.
  - This, in turn, led to loss of lateral support to Column 79 over nine stories, resulting in the buckling failure of Column 79.

- The probable collapse sequence that caused the global collapse of WTC 7 was initiated by the buckling of Column 79, which was unsupported over nine stories, after local fire-induced damage led to a cascade of floor failures.

- Despite extensive thermal weakening of connections and buckled floor beams, fireinduced damage in the floor framing surrounding Column 79 over multiple stories was the determining factor causing the buckling of Column 79 and, thereby, initiating progressive collapse.

**Relevance to WTC 7:** Had WTC 7 been expressly designed for prevention of fireinduced progressive collapse, it would have been sufficiently robust to withstand local failure due to the fires without suffering total collapse.

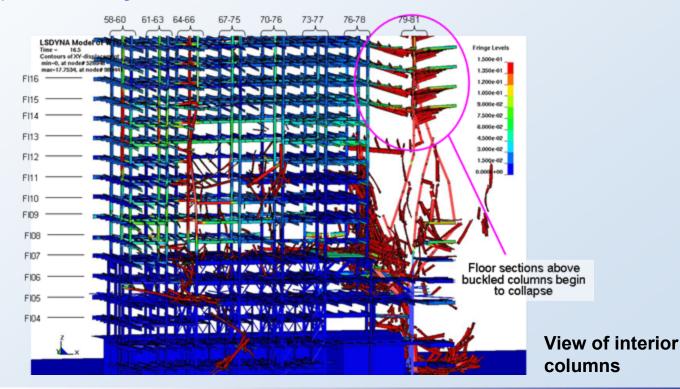
- Buckling of Column 79 (the collapse initiation event) triggered a vertical progression of floor system failures to the east penthouse and subsequent cascading failure of the adjacent interior columns on the east side of the building (i.e., Columns 80 and 81).
- Vertical progression of floor system failures spread to include the entire east region all the way to the top of the building.

- The buckling of Column 79 led to a vertical progression of floor failures up to the east penthouse and to the buckling of Columns 80 and 81.
  - An east-to-west horizontal progression of interior column buckling followed, due to loss of lateral support to adjacent columns, forces exerted by falling debris, and load redistribution from other buckled columns.

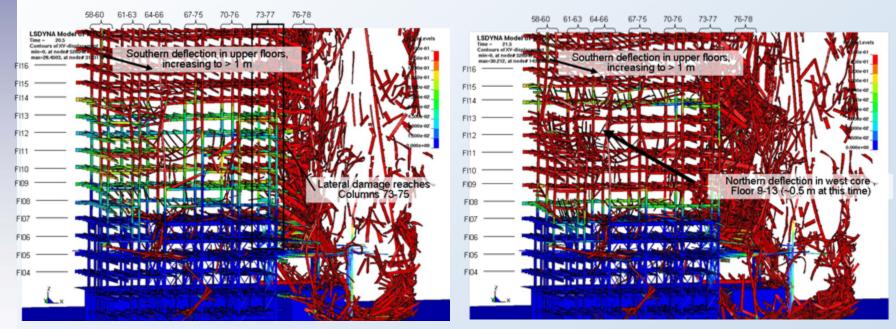
- The interior columns buckled in succession from east to west in the lower floors due to
  - loss of lateral support from floor system failures
  - forces exerted by falling debris
  - load redistributed from other buckled columns.

Failure progresses to the third line of interior columns from the east at 4.5 s following collapse initiation.

Buckling of all interior columns at 6.5 s following collapse initiation.

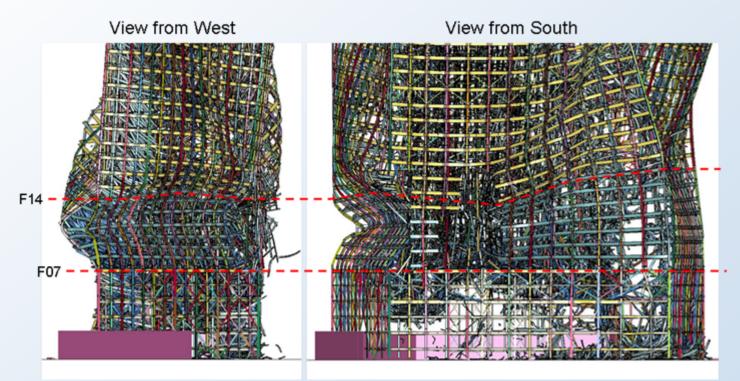
- The exterior columns buckled at the lower floors (between Floors 7 and 14) due to load redistribution to the exterior columns from the downward movement of the building core.
- The entire building above the buckled-column region then moved downward in a single unit, as observed, completing the global collapse sequence.

Buckling of lower exterior columns.

- The exterior columns then buckled as the failed building core moved downward, redistributing its loads to the exterior columns.
  - Global collapse occurred as the entire building above the buckled region moved downward as a single unit.

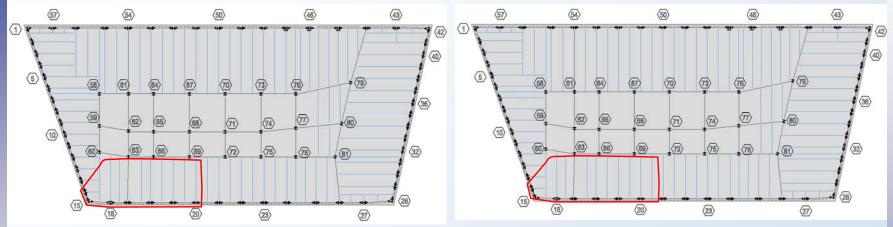
Floor 8

Floor 9

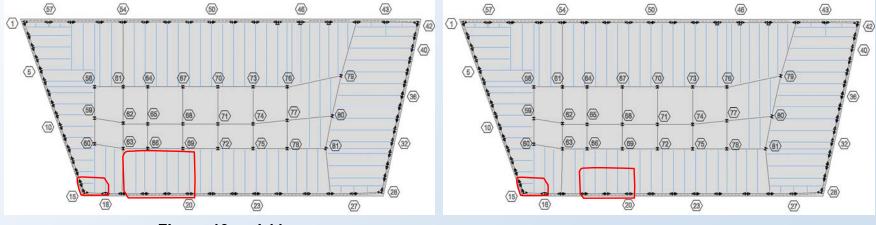
Floors 10 and 11

Floors 12 to 14
