Independent Investigation Report

The Baltimore City Fire Department
Live Fire Training Exercise
145 South Calverton Road
February 9, 2007

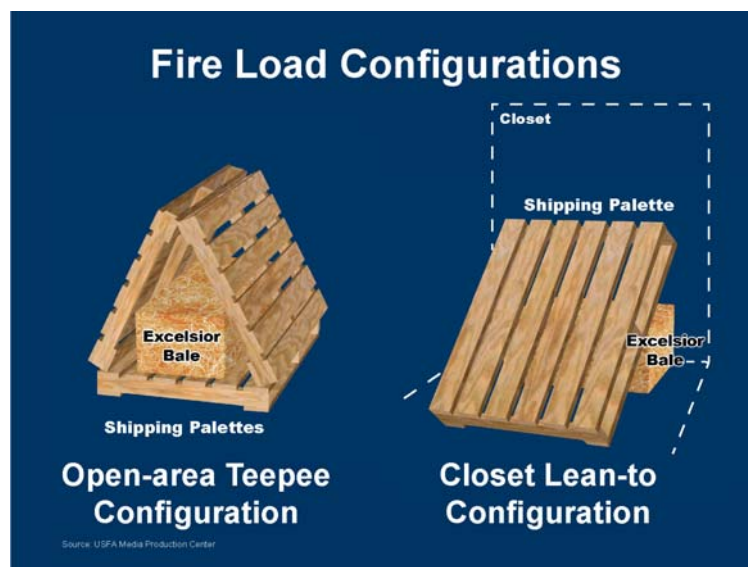
Division Chief Hyde noted in the documentation provided (Appendix B) that eleven bales of excelsior and ten pallets were used for the exercise. However, the presence of one of each fire load configuration in each of the larger rooms suggests at least twelve pallets were utilized in the set fires. These materials were distributed in various rooms throughout the structure by recruits and eventually were ignited. According to those involved with distributing the materials and setting the fires, two load configurations were used in each of the larger rooms. In one configuration, a pallet was laid flat on the floor as a base, with two others angled on the base, to form a “teepee” type construction. Excelsior was placed within the open area of the configuration. Another configuration used was the leaning of a single pallet against a wall, then placing excelsior between the pallet and the wall (Shown below).

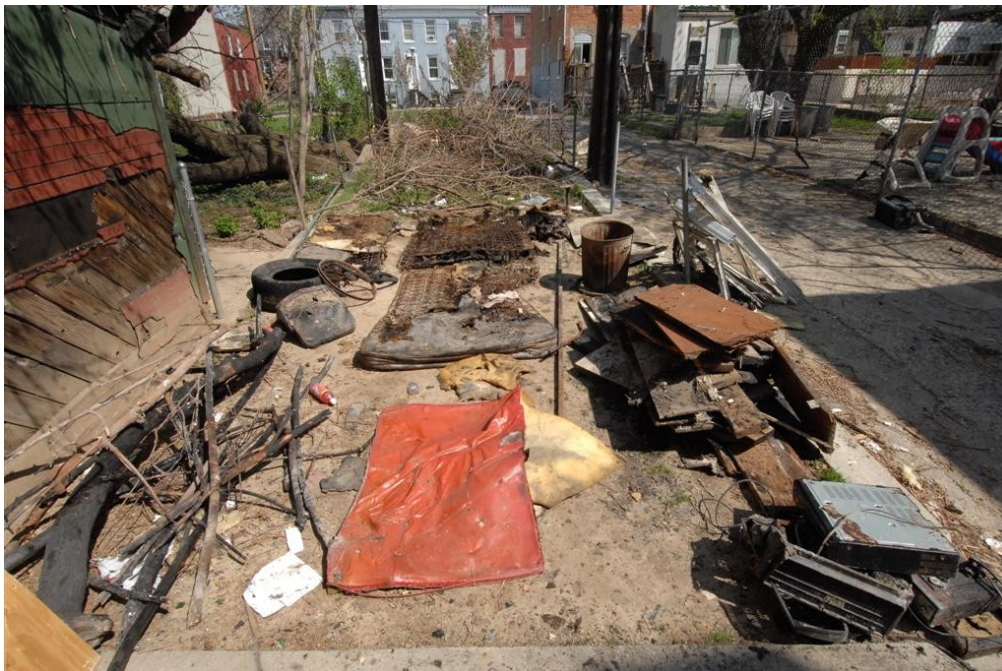
In addition to the materials noted above used for burning in the structure, a large amount of debris was present in the rear room on the first floor. A later visit to the structure revealed the following materials:

The picture below shows the debris that was removed from the first floor rear room

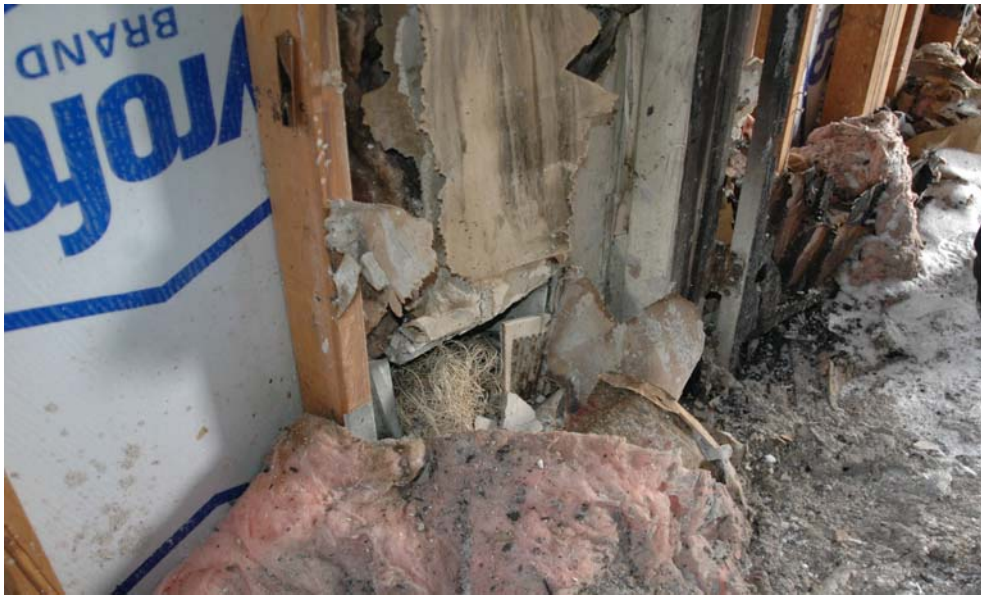
Discussion: It was reported that excelsior (additional fuel load) had been stuffed between the joists where the ceiling once was. In addition, Lieutenant Crest stated that they pulled wallboard and stuffed excelsior behind the walls. A walk through of the building by the investigative team revealed the excelsior in the exposed ceiling had ignited and was almost entirely consumed by fire, but that which was placed behind the walls did not fully ignite (See Photo). Contrary to the intent of the standard that the interior walls and ceilings be intact to avoid unsafe fire extension, Academy instructors participated in and directed students to load the void spaces created by the ventilation drill with combustible excelsior in an attempt to intensify the conditions to which recruits would be exposed.

Excelsior fire loading in vents between wall studs.

Recommendation: Patch all holes in the ceilings and walls as specified by the standard.

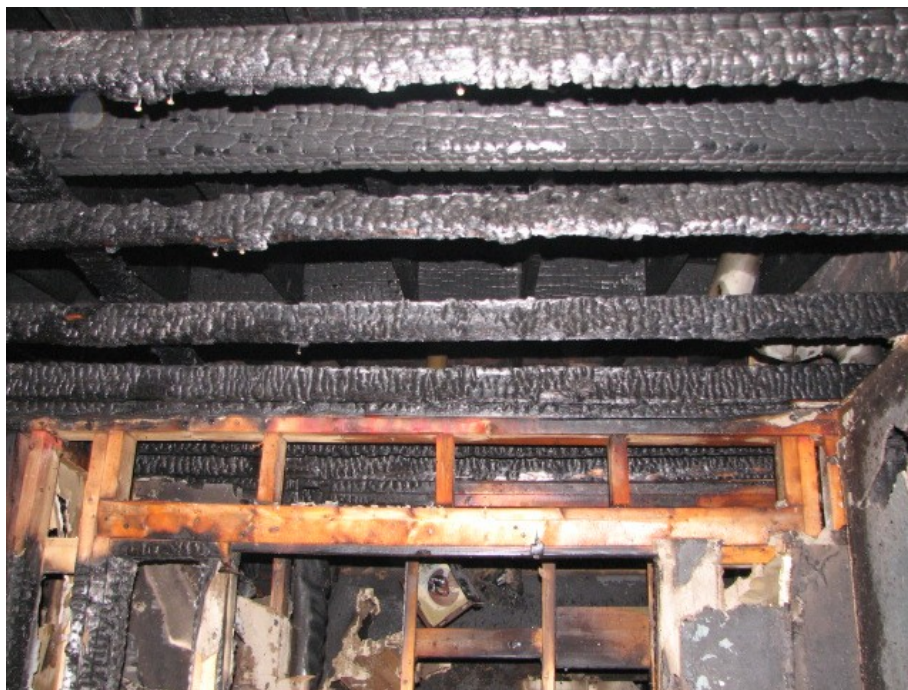
The exposed ceilings appear to have been a major contributing factor to the incident. This structural condition and other factors, such as the open ventilation of the structure combined with the placing of excelsior between the joists, likely contributed to the rapid fire spread and build up of heat that caused deteriorating conditions (See Photo). A fire set in the rear room of the second floor rapidly spread to a void space between the open ceiling joint and the roof and traversed under the roof toward the stairway and the area on the third floor where EVD Ryan Wenger, Paramedic Cisneros, and FPA Wilson were positioned, exposing them to intense heat and limited visibility. A ceiling that was intact would have slowed the rapid spread of fire and heat from at least four fuel load configurations set under the second floor roof.

Second floor rear room showing extensive char to ceiling joist under second floor roof.

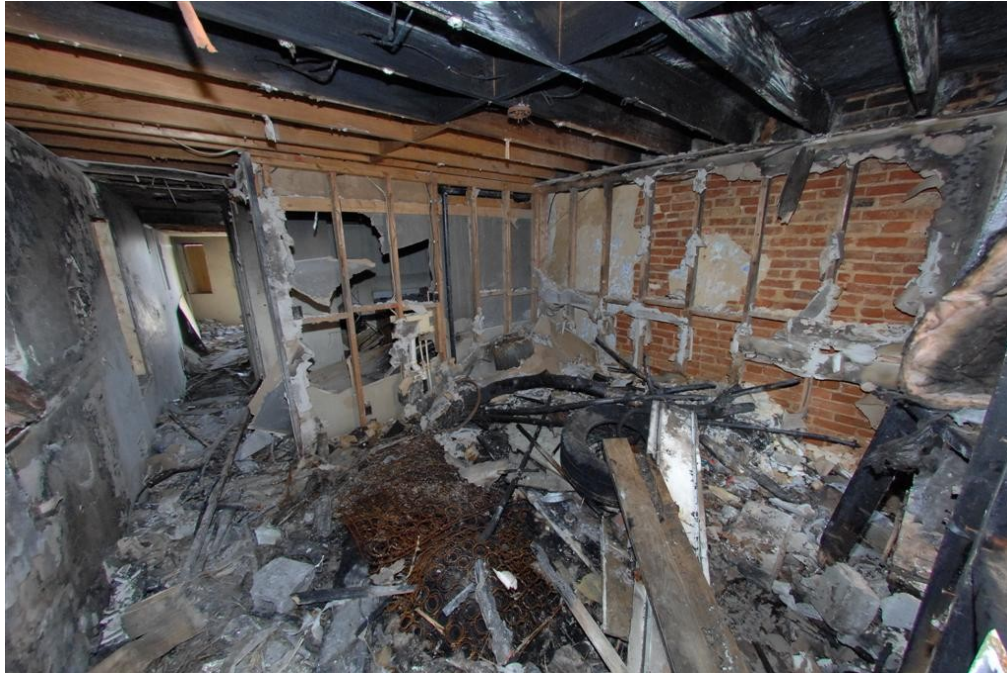
Debris in rear room prior to removal.

Both the obstructive and combustible debris created and contributed to an unsafe condition for personnel as they participated in the training exercise. As was mentioned previously, the crew of Engine 1 was instructed to proceed directly to the third floor. Wenger allegedly confirmed those instructions with Crest. The reason Crest supposedly told them to go directly to the third floor

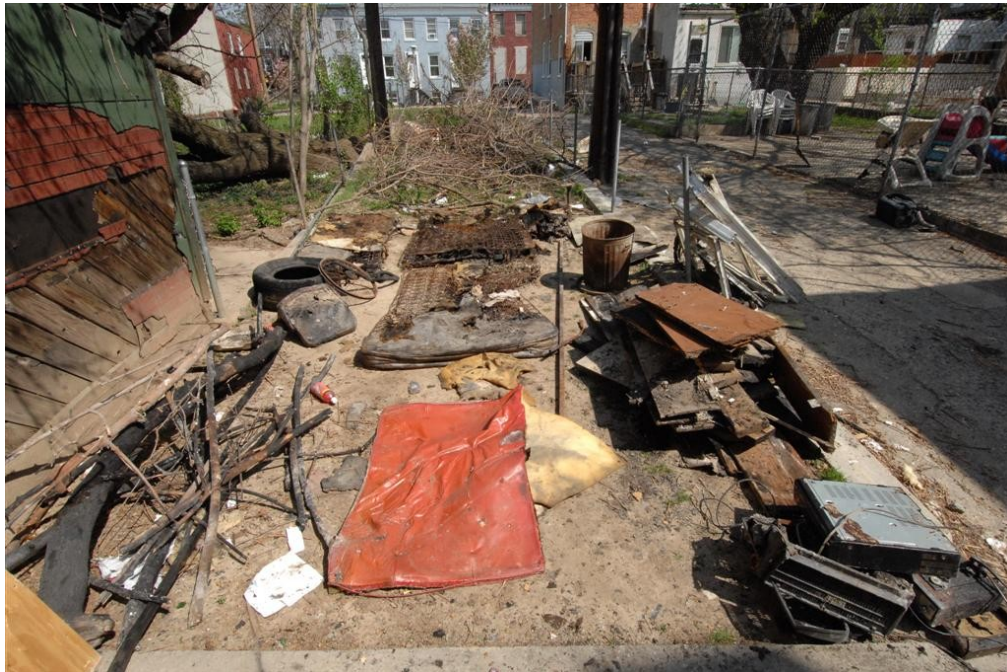
Debris on concrete pad after removal from rear room.

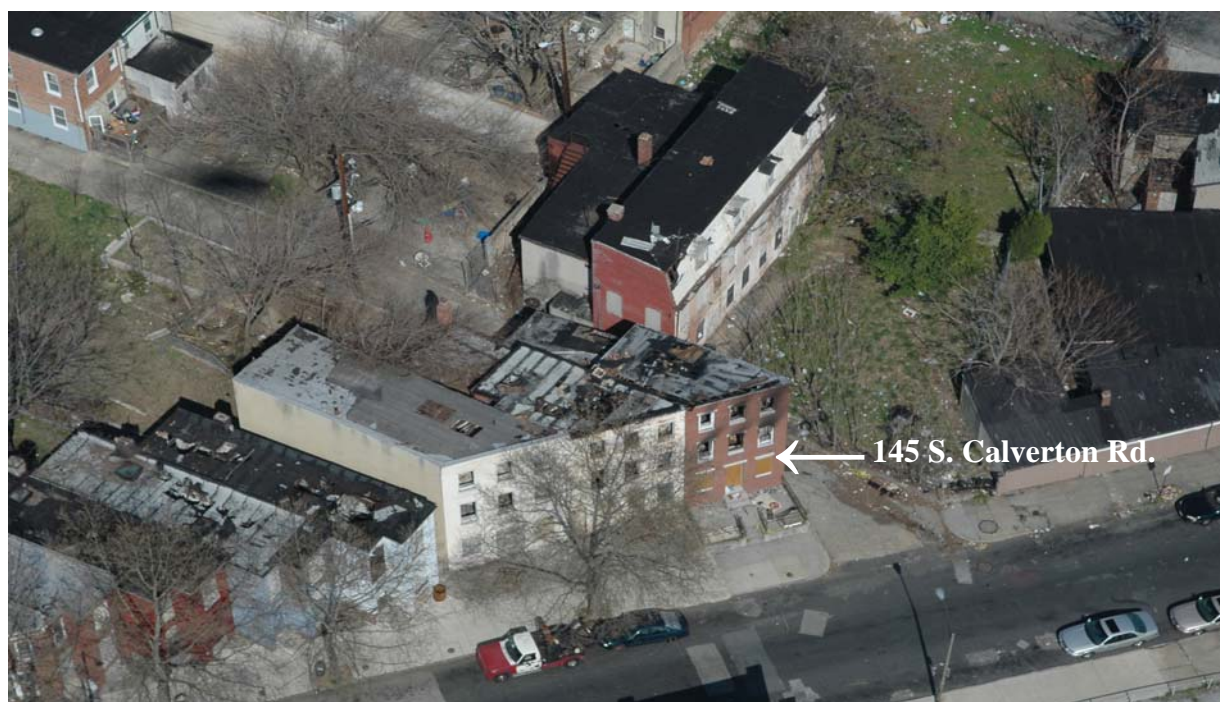
Discussion: The dwelling used was the end unit of a three unit block section that also included similar structures 143 and 141 South Calverton Road. The unit at 143 South Calverton was attached to 145 South Calverton and easily could have been involved as well. In addition, there is a structure across a ten foot alley that also could have been considered an exposure.

Picture shows exposures to B and D sides of structure.

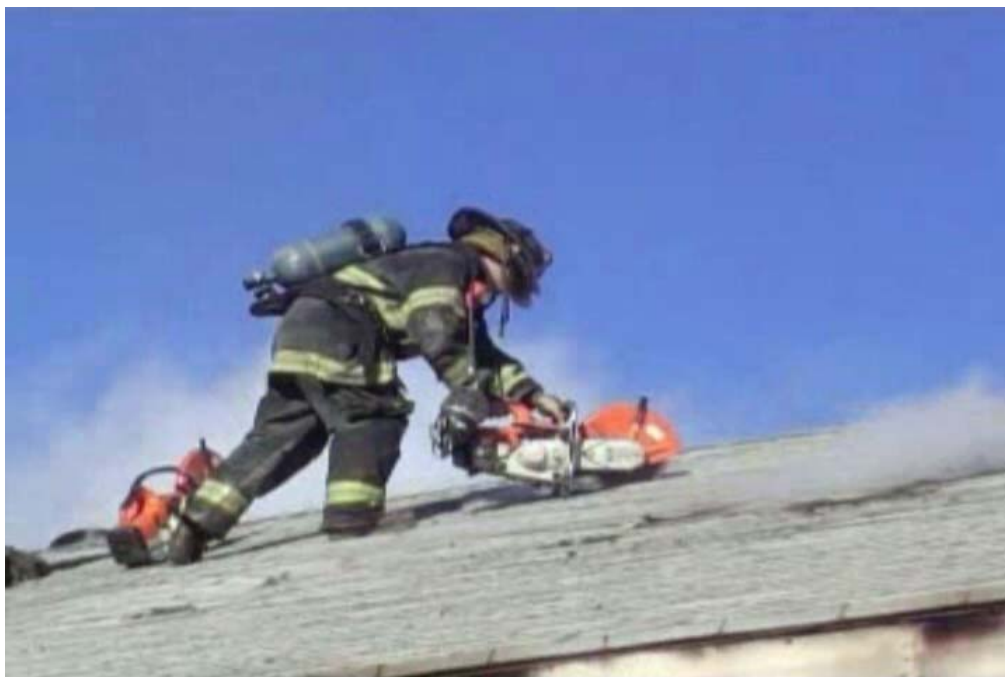
Unidentified adjunct instructor working on the roof without gloves or SCBA in-place.

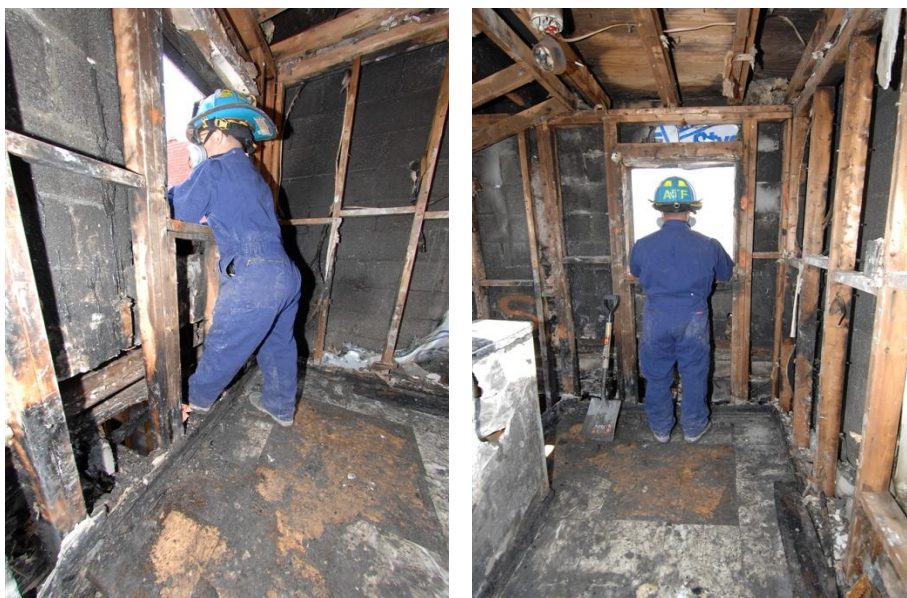
Although not currently a code violation, the level of the window sill through which Wenger, Cisneros, Wilson, and Tina Strawsburg exited was unusually high, measuring 41 inches from the floor. Given Wilson's height of 64 inches, this would have placed the level of the sill at approximately the middle of her torso. One of the members of the investigative team is five feet, six inches tall. He is shown in the photo below at the window where Wilson was rescued. The photo is an approximation as to the height of window sill in relation to Wilson. Wenger stated in his interview with BCFD investigators that he had to pull himself up a bit to get out of the window. One of the members of the investigative team who interviewed him during the NIOSH interviews stated that he appeared to be at least six feet tall.

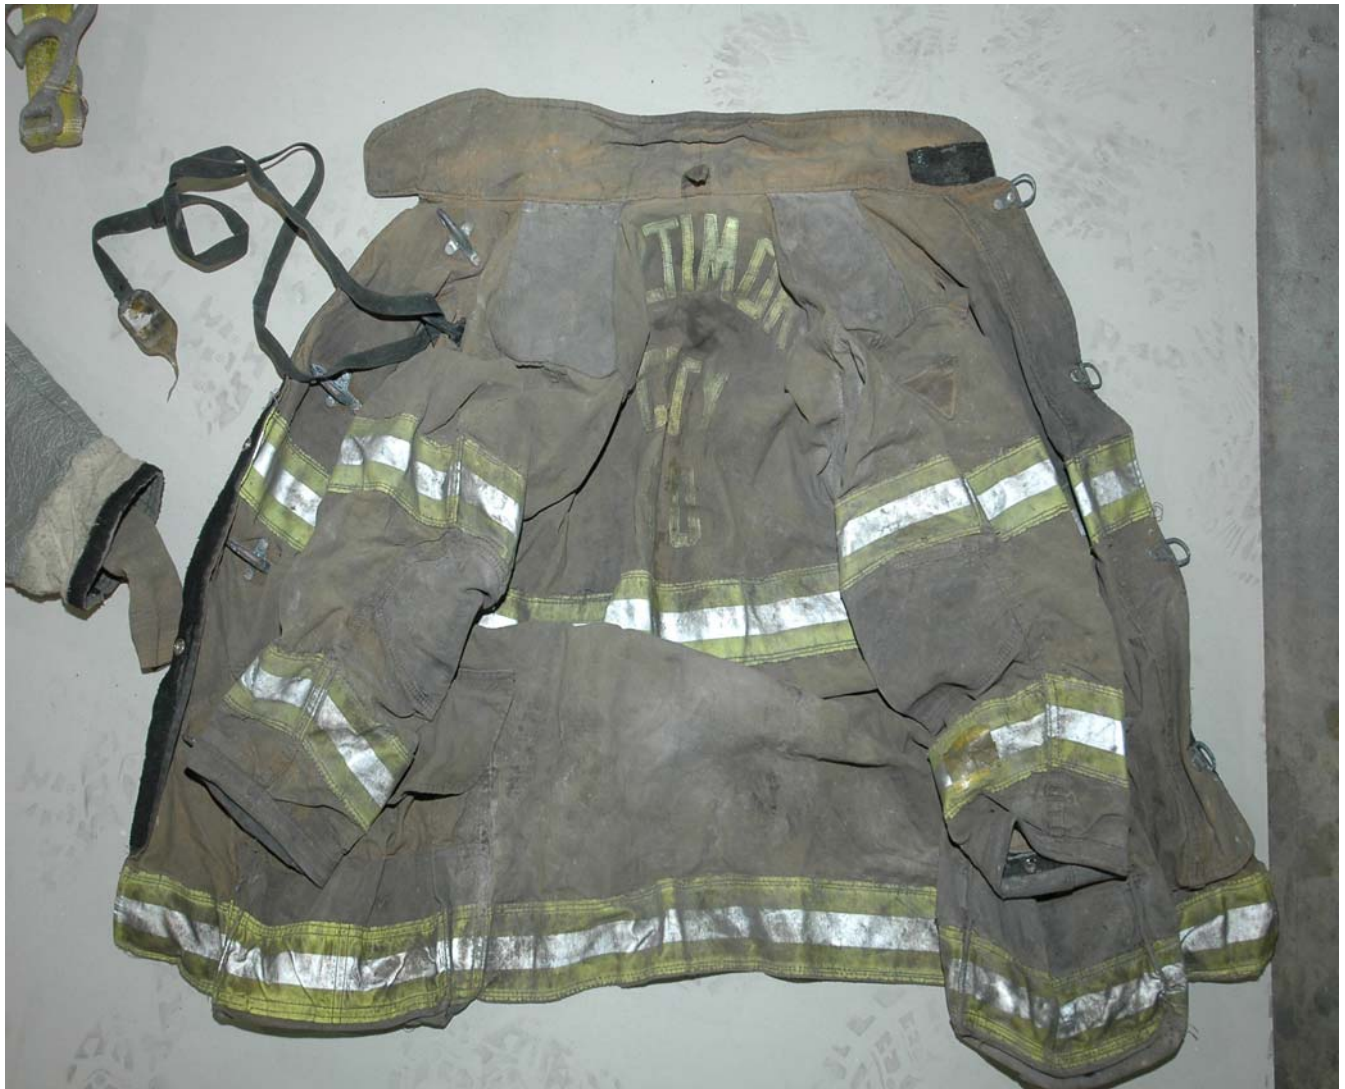
The coat was noted to be in serviceable condition, but nearing the end of its useful life. Interesting was the fact that the report stated the coat suffered little thermal exposure. Given the severity of Racheal Wilson's burns on her torso and arms, one would have thought that the coat would have shown signs of exposure to heat.

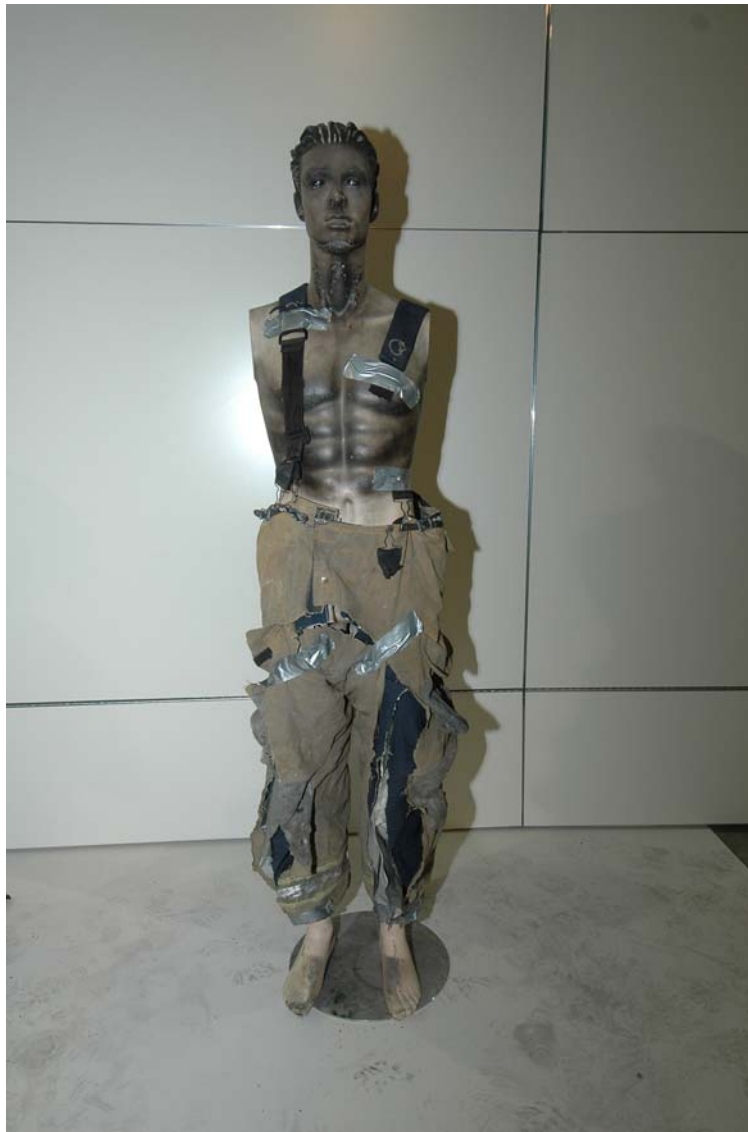
The pants, which were manufactured in 1997, had significant problems. Many areas were noted to have been patched or repaired. The leather on the right knee was worn through in some places and there was a “medium size hole” at the base of the fly. The report stated that the crotch seemed to have no integrity, and the thermal protection in the crotch and upper thigh was diminished, due to abrasion and wear. The pants were said to be beyond their useful life and the recommendation was that they be retired. This may have accounted for the serious burns Wilson suffered to her lower extremities.

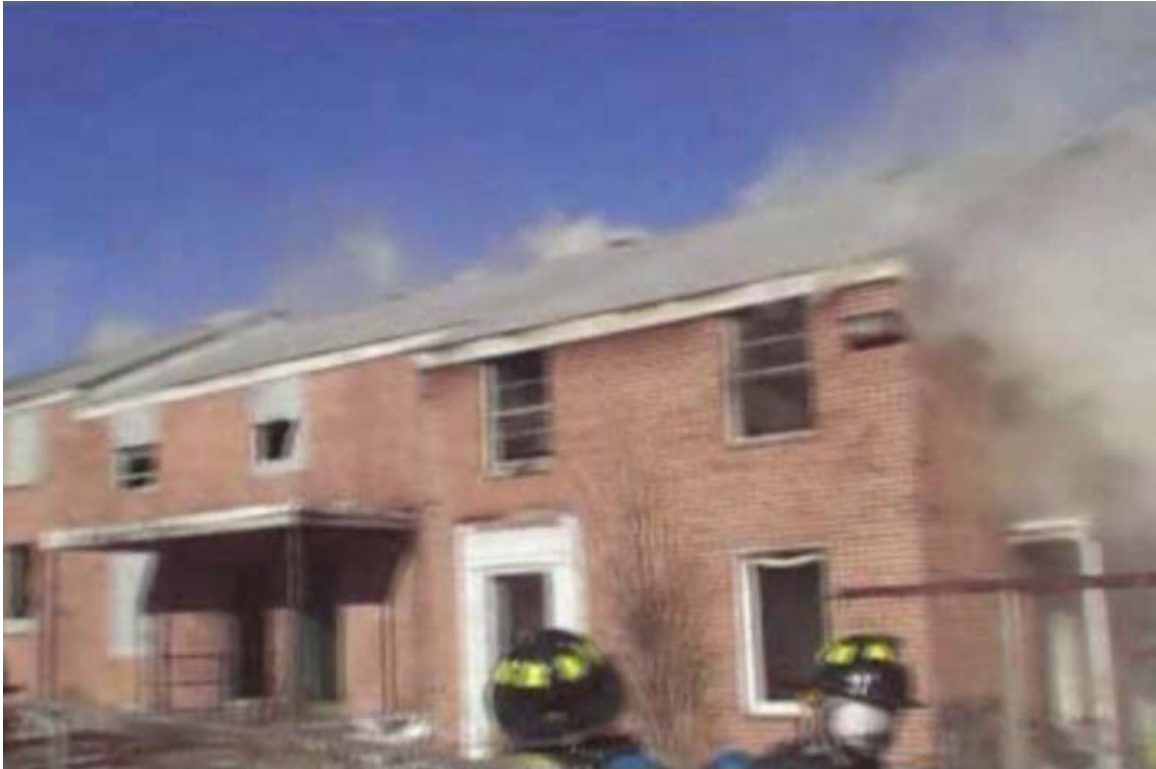
Photo (A) showing smoke spread to multiple occupancies.

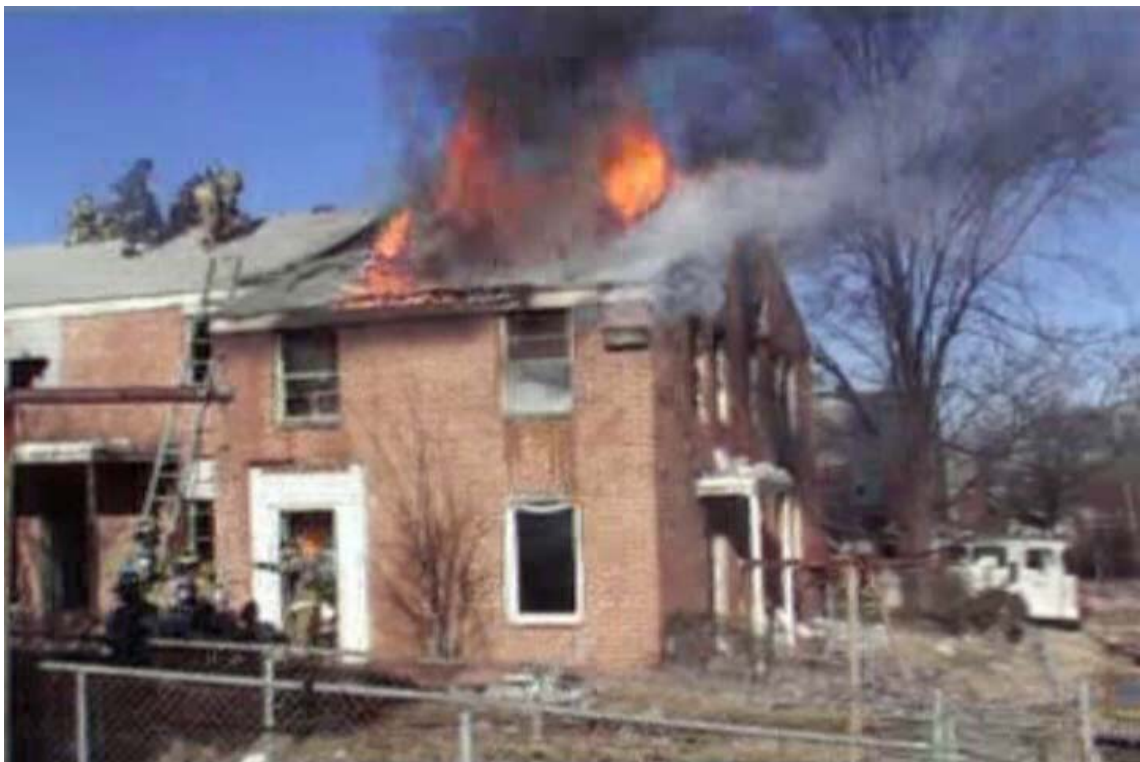
Photo (B) showing intensity of fire. Fire evident on the neck of recruit at doorway.

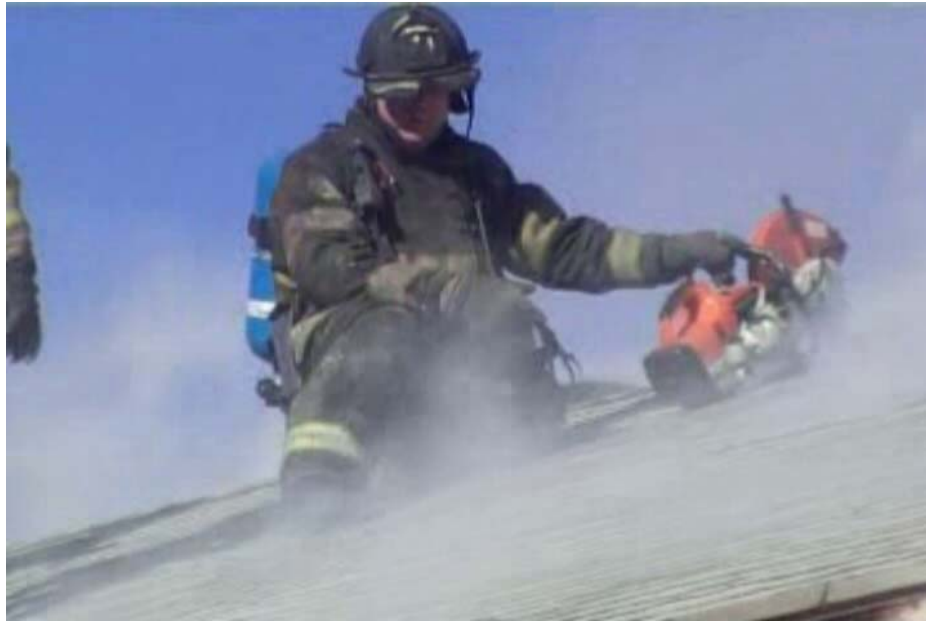
An instructor on roof without breathing apparatus.

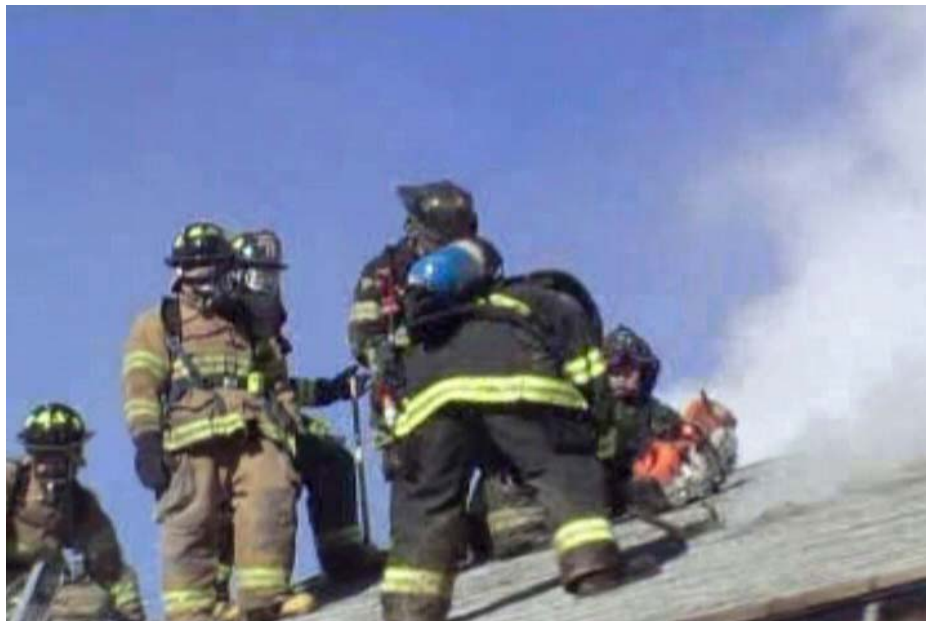
An instructor on roof without breathing apparatus; recruits on roof with breathing apparatus.

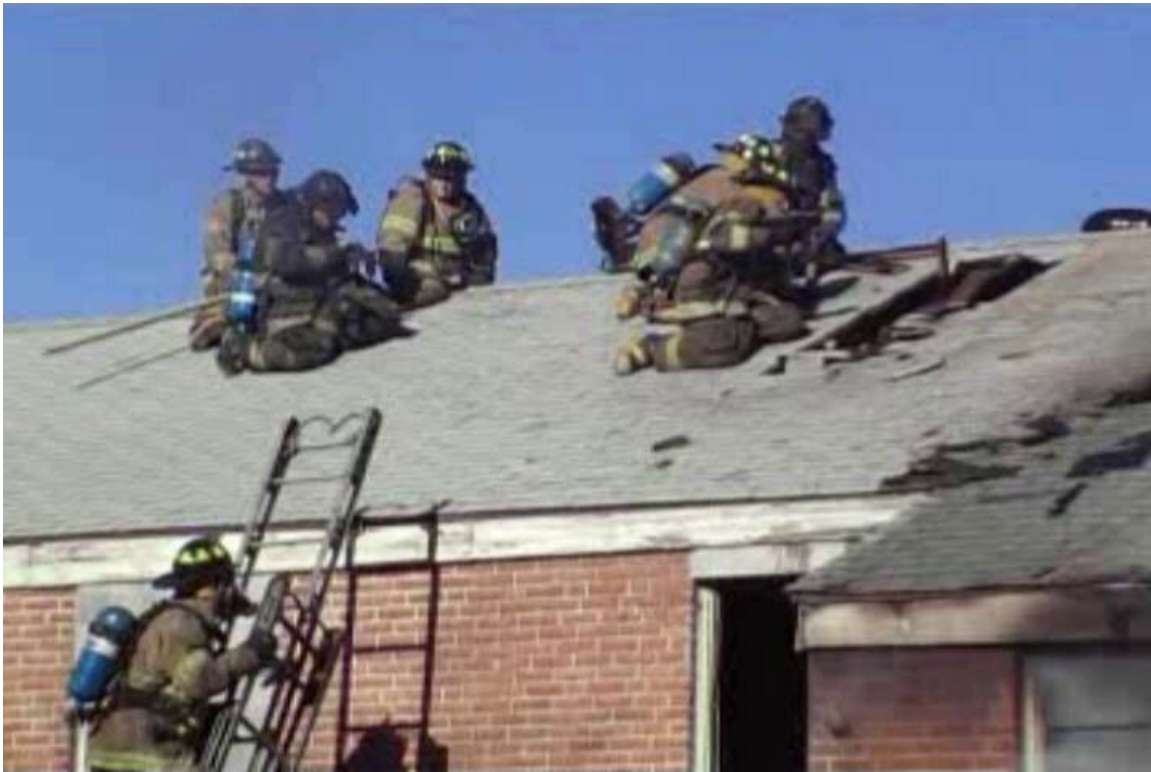
Recruits on roof without breathing apparatus.

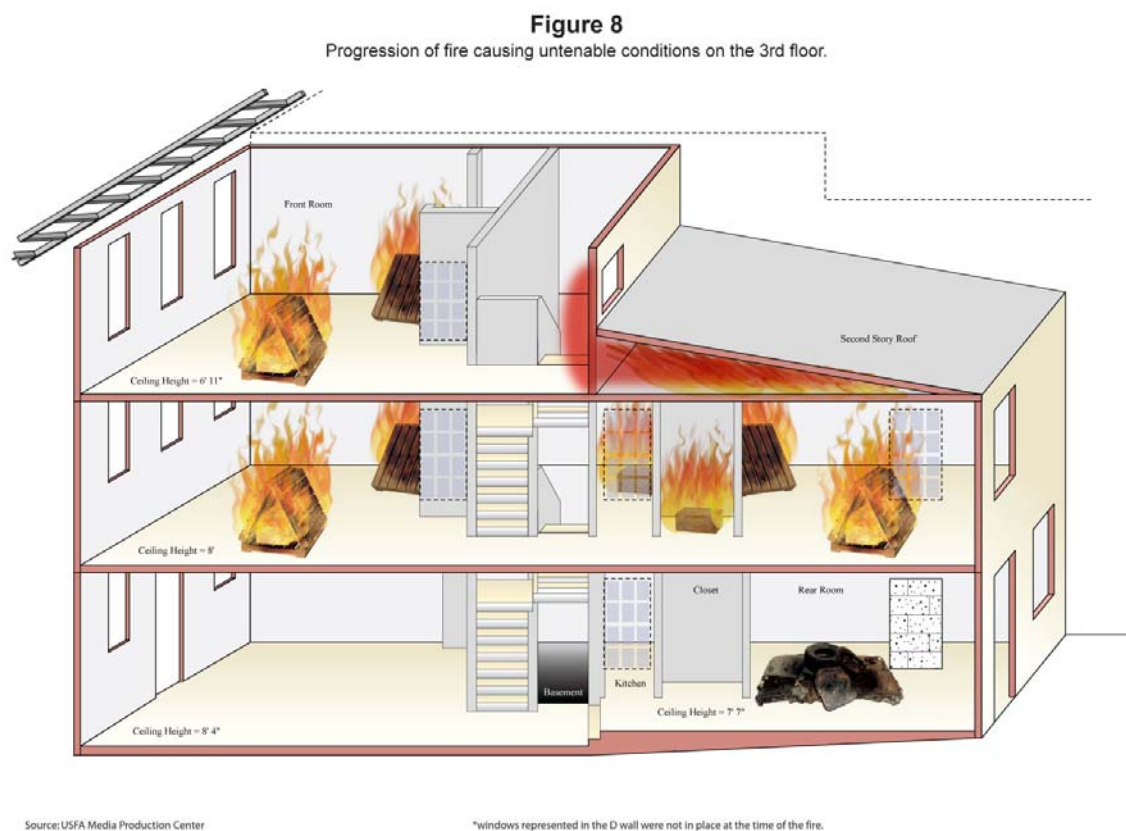
The room to the rear of the second floor was the one in which the ceiling had been pulled during previous training. This left an opening for the fire to travel with little resistance to the area under the roof that covered that portion of the second floor. The fire traversed throughout the area under the roof, causing high heat conditions in the area of the third floor where Wenger, Wilson, and Cisneros were located. In addition, heat and flame from other fires on the second floor proceeded up the stairs to the same area on the third floor. Finally, the fire on the third floor added to the untenable conditions the crew of Engine 1 encountered on the third floor.
