**Colerain Township Department of
Fire and Emergency Medical Services**

**Line of Duty Death
Fact Finding Committee
*Preliminary Report***

July 11, 2008

SQUIRRELSNEST LANE LINE OF DUTY DEATH FACT FINDING COMMITTEE
PRELIMINARY REPORT

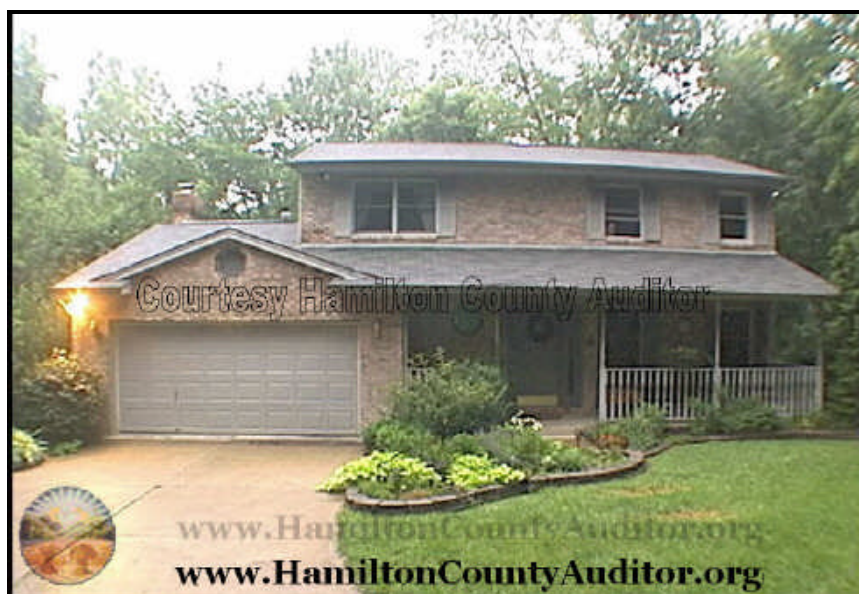
The structure at 5708 Squirrelsnest LN (Figure 1) was an approximate 2,046-square-foot² (main two floors), two-story, single-family home located in the Squirrelsnest Subdivision in the Dunlap area of the township. The structure was constructed in 1991, in a conventional style; it was of traditional wood frame and brick veneer construction, a gable roof with composition shingles, and a poured foundation with a finished walkout basement. The main level (first-floor) flooring system was comprised of 2-inch by 10-inch wood joist constructed 16-inches on center with $\frac{3}{4}$ -inch oriented strand board as the sub-floor. The structure was heated and cooled by means of natural gas and electricity.

Figure 1: Front (alpha side) photo of 5708 Squirrelsnest LN.

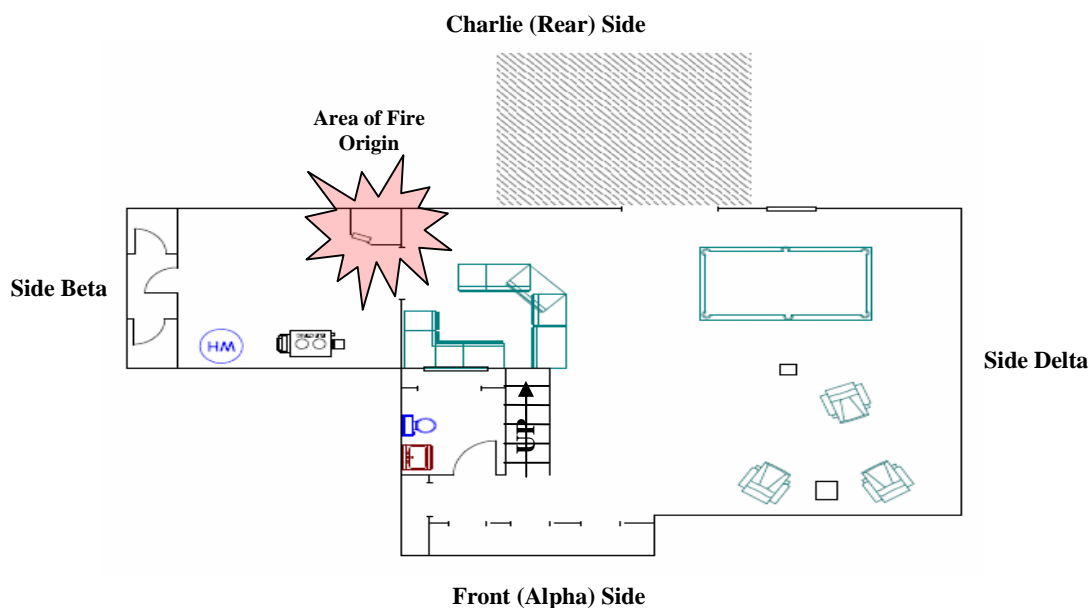
According to the Ohio State Fire Marshal's Office, the origin and cause of the incident was classified as accidental, with the official cause listed as an electrical short in a fan that

originated in the basement near a converted cedar wood lined closet used to cultivate orchids (Figure 2).

Figure 2: Structure's basement layout indicating fire area of origin. (Ohio State Fire Marshal's Office)

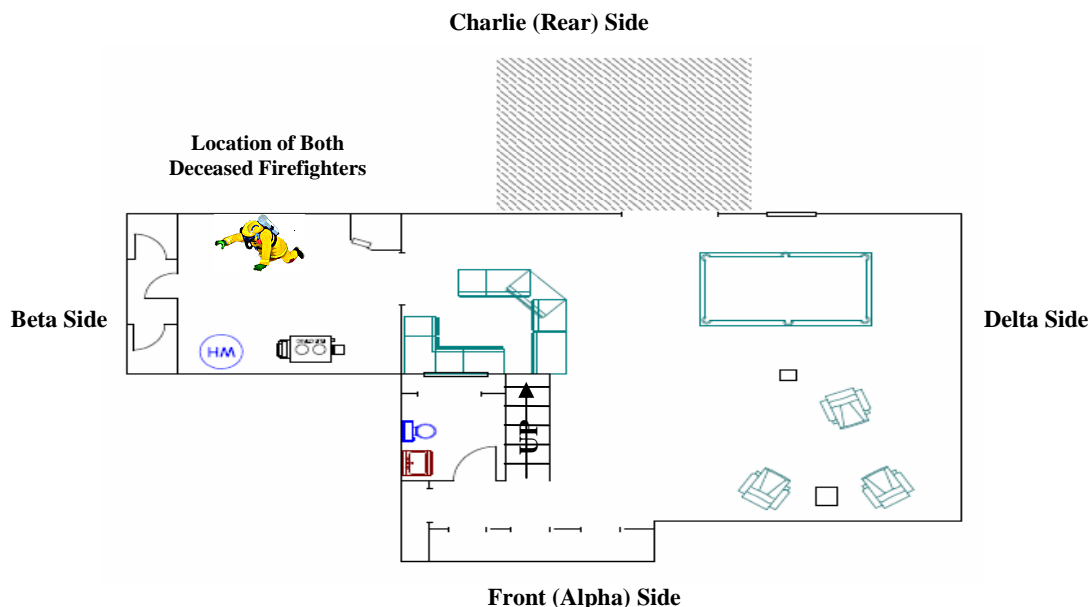
- **07:08:05 [FG 11]** – Capt. Broxterman’s body is located (Figure 3).

- **07:29:28 [FG 11]** – Ffr. Schira’s body is located (Figure 3).

*Figure 3: Structure’s basement layout indicating location where both deceased firefighters were found.
(Ohio State Fire Marshal’s Office)*

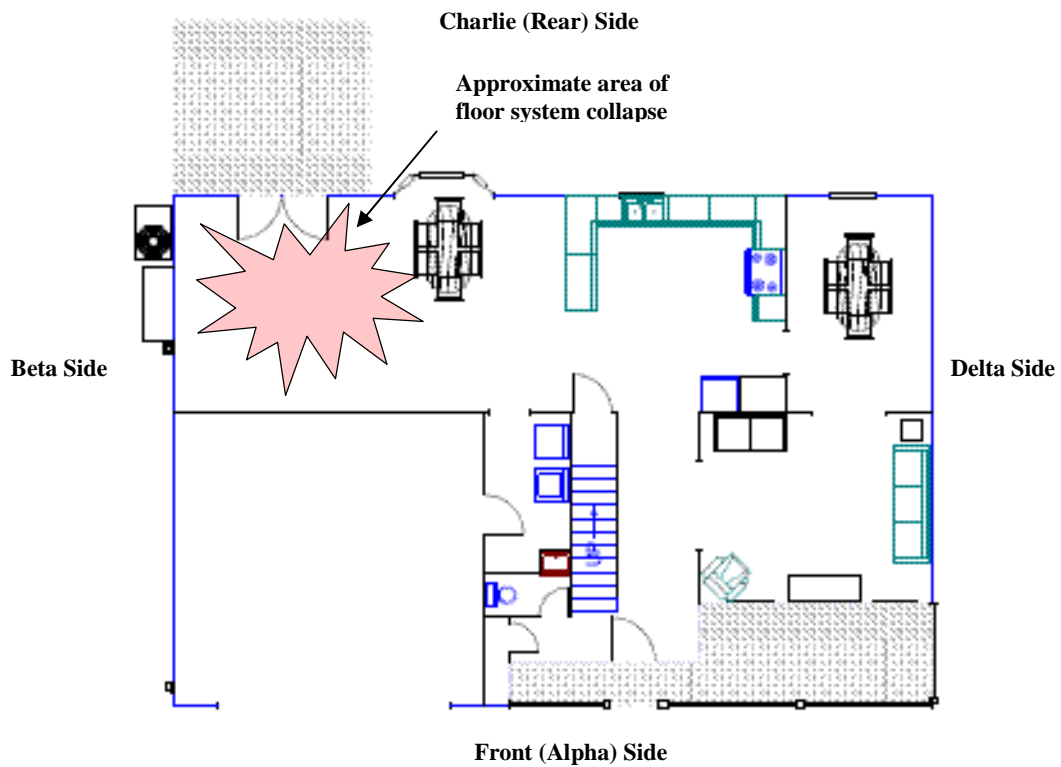
During the time period between 06:30:20 and 06:34:20, it is the belief of the committee that one or more catastrophic events occurred within the structure including failure of the flooring system near the *Beta/Charlie* corner of the structure’s main floor (Figures 4-6). The photo in Figure 6 was taken from the main level kitchen area near the top of the stairway from the basement looking towards the *Beta/Charlie* corner.

Figure 4: Structure's main floor layout indicating approximate area of flooring system collapse. (Ohio State Fire Marshal's Office)

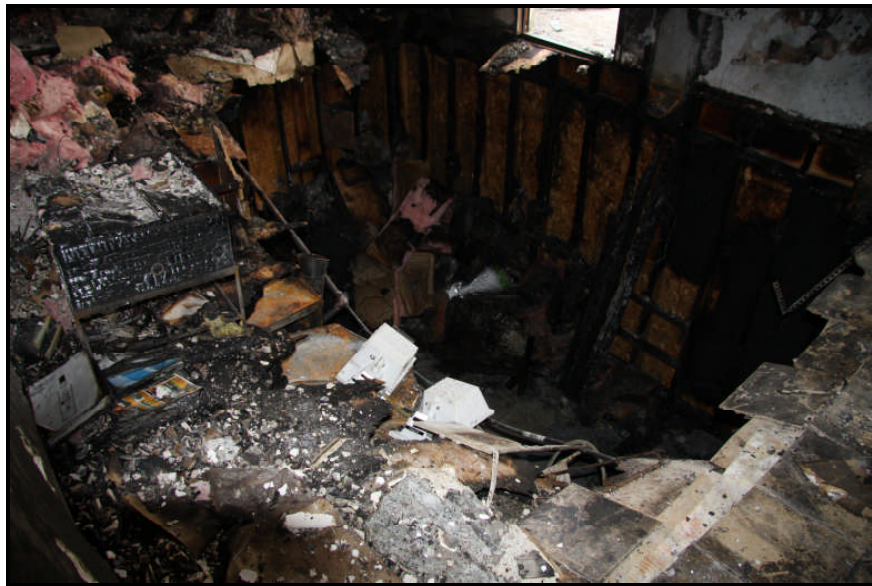
Figure 5: Interior photo of the collapsed area and flooring system. (Colerain Fire & EMS)

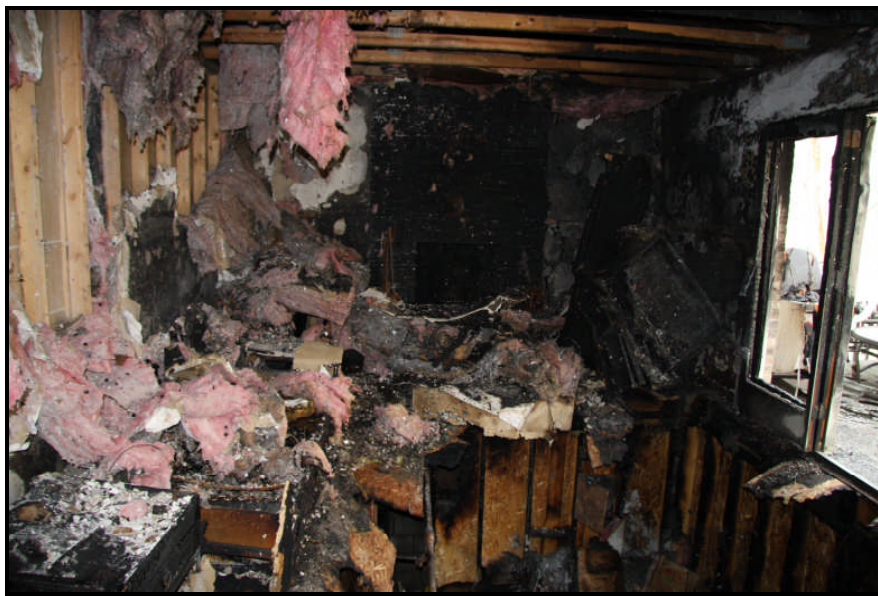
Figure6: Expanded interior photo of the collapsed area and flooring system. (Colerain Fire & EMS)

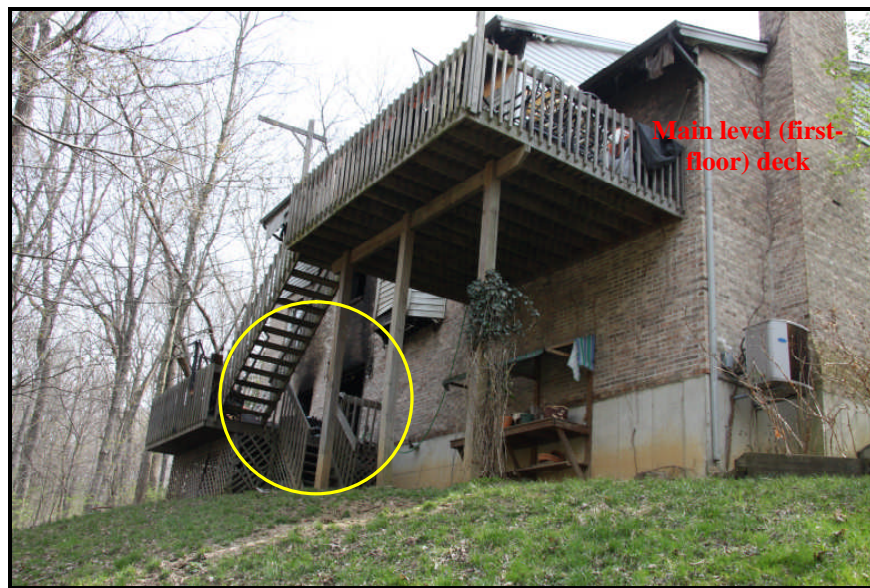
*Figure 7: Rear elevations from the Beta /Charlie corner showing the basement exterior door and window.
(Colerain Fire & EMS)*

E109's crew advanced to the rear of the structure and noticed that the fire coming out of the basement exterior door and window was extending upward on the exterior running along the soffit line. E109's OIC sent E109's Ffr.1 to E102's FAO to request that the second 1¾-inch pre-connected hose line be charged. E109's crew knocked-down the exterior fire in the rear and held position under the supervision of the rear sector officer. While doing so, E109's personnel were instructed not to direct their fire stream into the structure through the open doors or windows.
