Final Report

**Southwest Supermarket Fire
35th Avenue and
McDowell Road**

**March 14, 2001
Incident #01-045301**

**Phoenix Fire Department
150 South 12 Street
Phoenix, Arizona 85034**

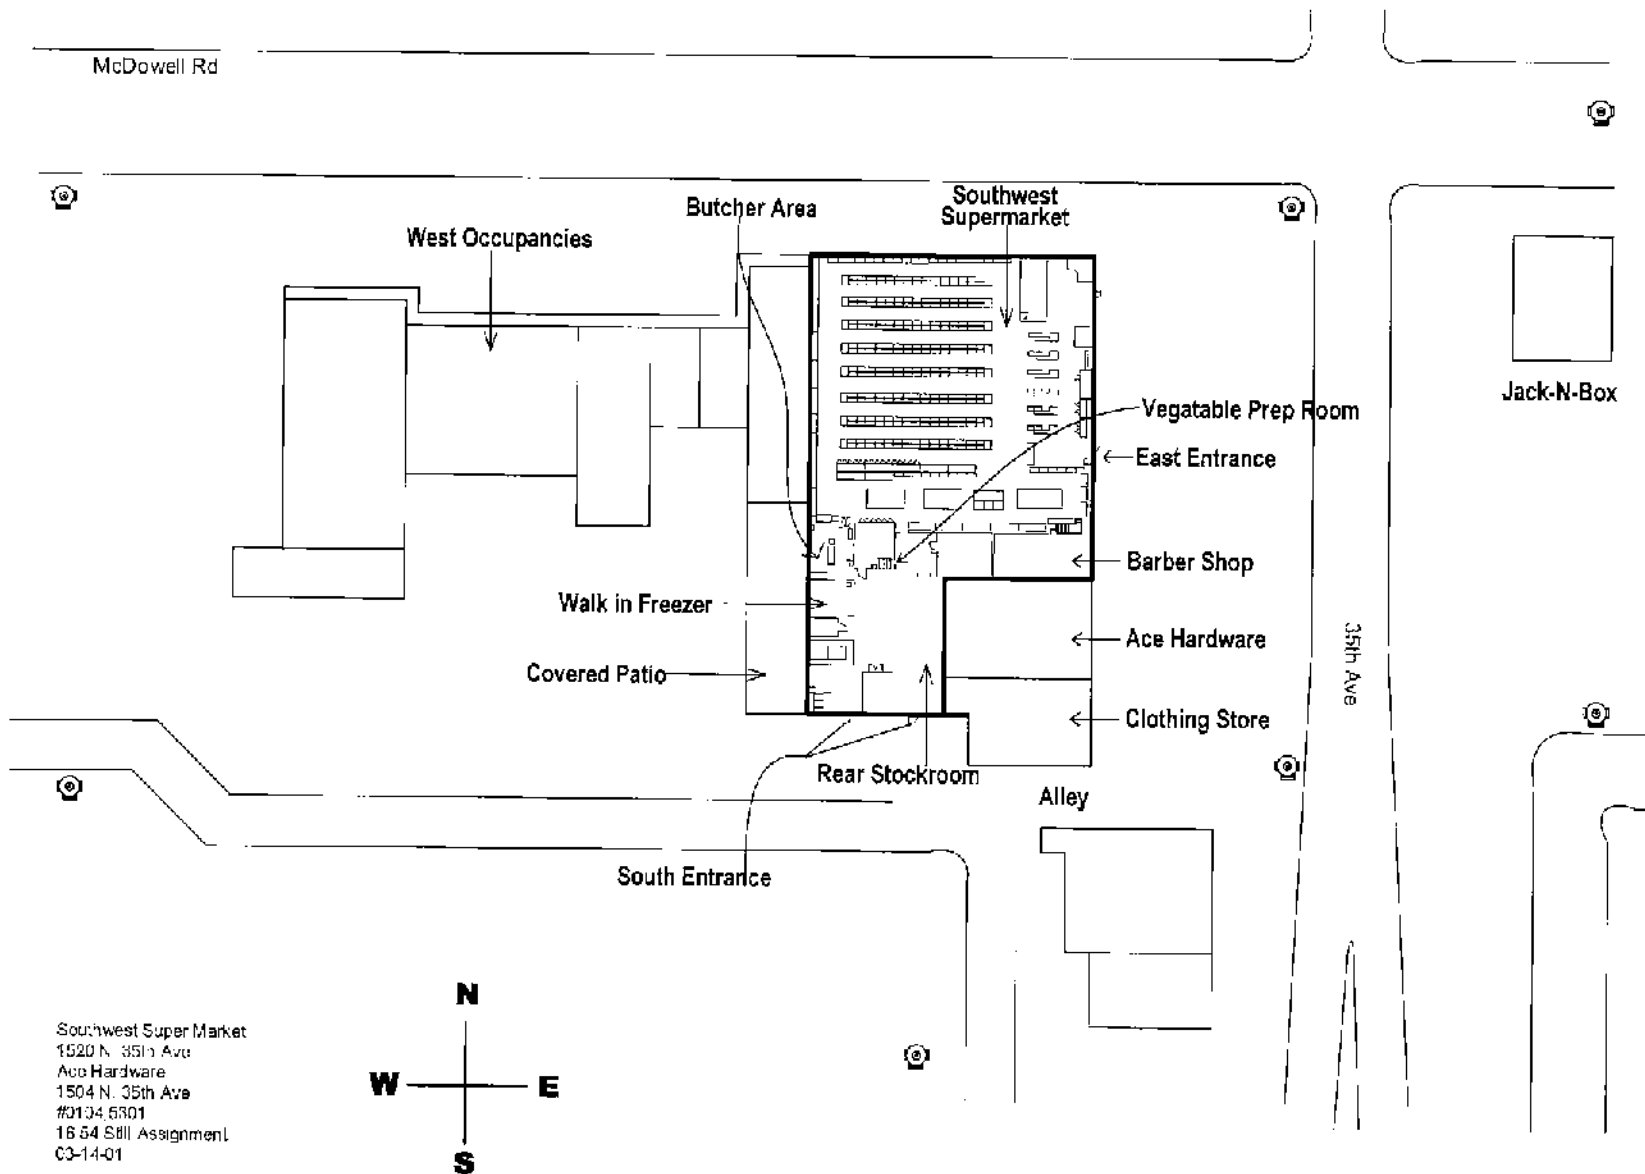
On the south side of the building there was a rear loading dock that was approximately 2 feet high and 3 feet deep covering the entire length of the rear area. Next to the loading dock between the two doors was a trash compactor, a dumpster, and numerous bales of cardboard. There was another dumpster and more bales of cardboard to the east of the rear door.

On the south side, in the alleyway, was a power pole approximately 20 feet away from the rear entrance. There was a bank of three transformers with an electrical drop that fed the entire complex. The electrical wires entered above the rear loading dock and were directly above the initial fire location.
