Contra Costa County Fire Protection District

Investigation Report: Michele Drive Line of Duty Deaths

July 21, 2007

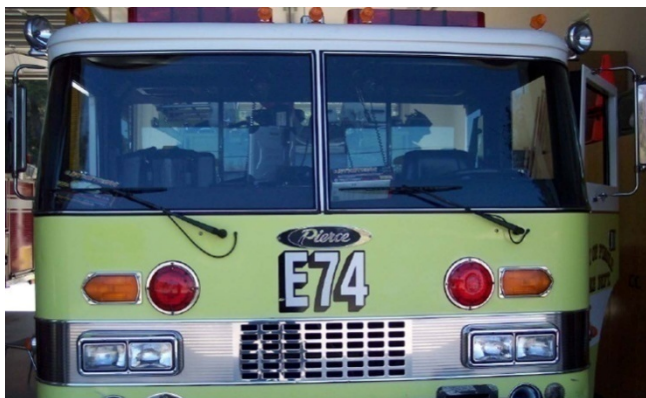
Photo 1 – Engine 74 in use as Engine 73

Station 74. This engine was marked with "E74", and was visible to Captain 70 when he gave the following radio transmission, *"Engine 74, Engine 70, Michele IC, I'm passing command"*.) The transfer of command from Captain 70 was not heard by Captain 73. It may have been missed because the radio transmission was directed to "E74". Engineer 73 both observed and heard Captain 70 pass command to Engine 74. The transfer of command was also heard by personnel on Engine 69 and Quint 76 while responding to the incident. Firefighter 73 arrived at the front porch as the hoseline was being charged and

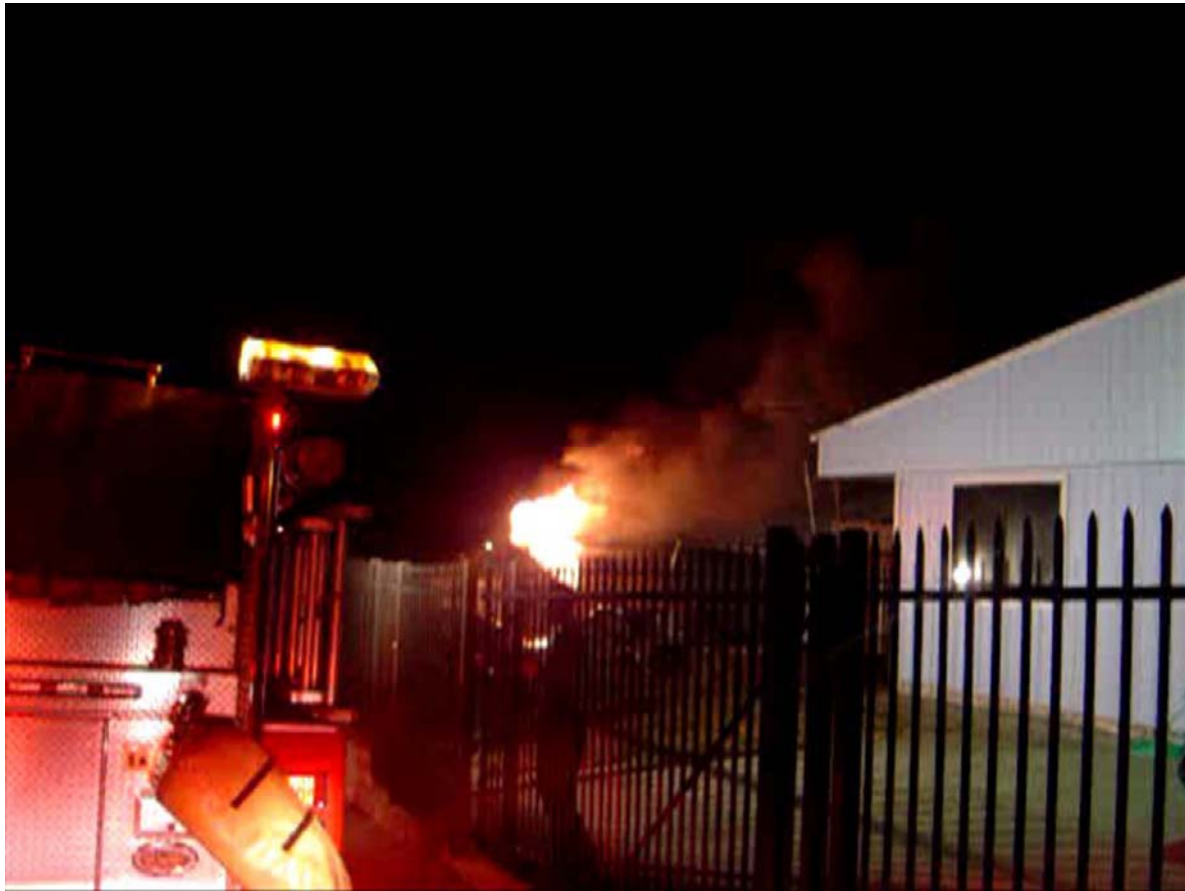
increase in fire activity (Photo 2). This activity occurred from both the “Alpha” side window (bedroom #1) and the “Bravo” side of the structure.

Photo 2 - Increased fire activity from Bedroom #1 window (Alpha side)

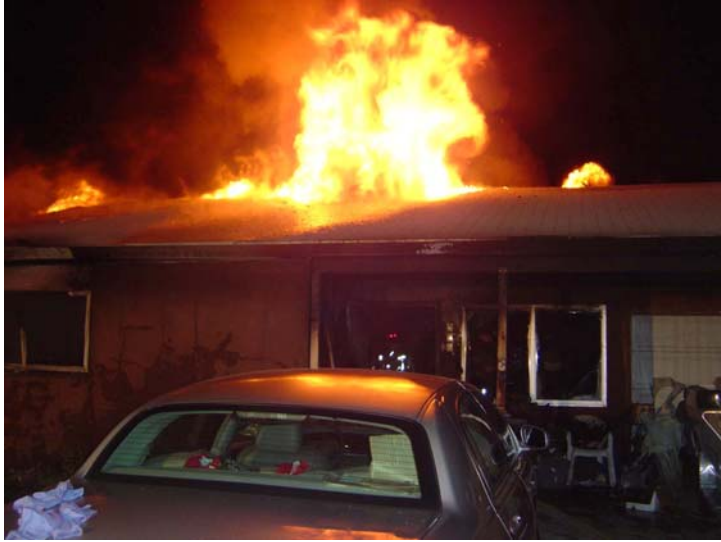
As Captain 69 and Engineer 69 exited the roof, they heard a loud pop and saw flames venting 8' to 10' from the ventilation hole (Photo 3). After exiting the roof, Captain

Photo 3 – Fire venting from ventilation hole

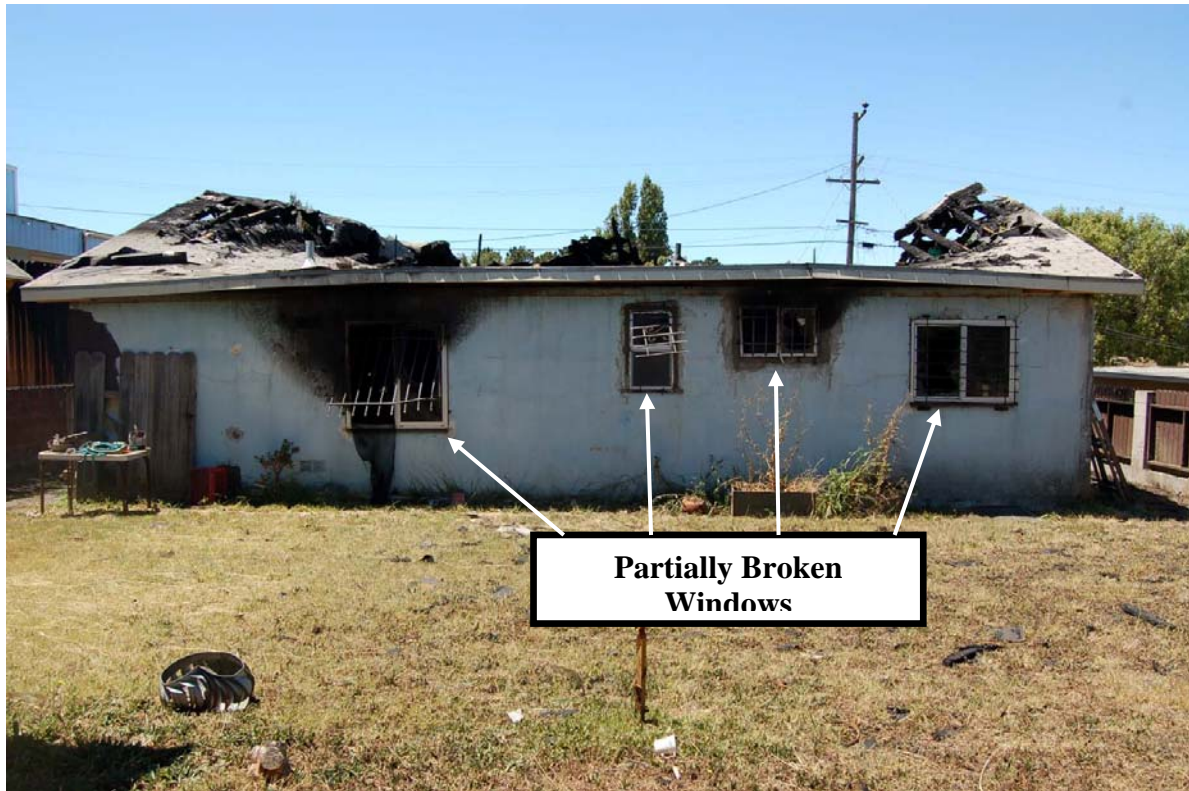
screens and broke a couple of windowpanes but did not get any significant release of smoke (Photo 4). They continued to the “Bravo” / “Charlie” corner and observed fire on the “Bravo” side from bedroom #2 window and the attic space above. Captain 69 and Engineer 69 returned to the “Alpha” side and met with Michele IC (Battalion 7) who directed them to continue the primary search for the second resident. Firefighter 69 completed resuscitation efforts on the first victim and rejoined his crew. Captain 69 directed Engineer 69 and Firefighter 69 to start the search while he replaced his SCBA air cylinder.

Photo 4 - Partially broken windows on Charlie side – rear of structure

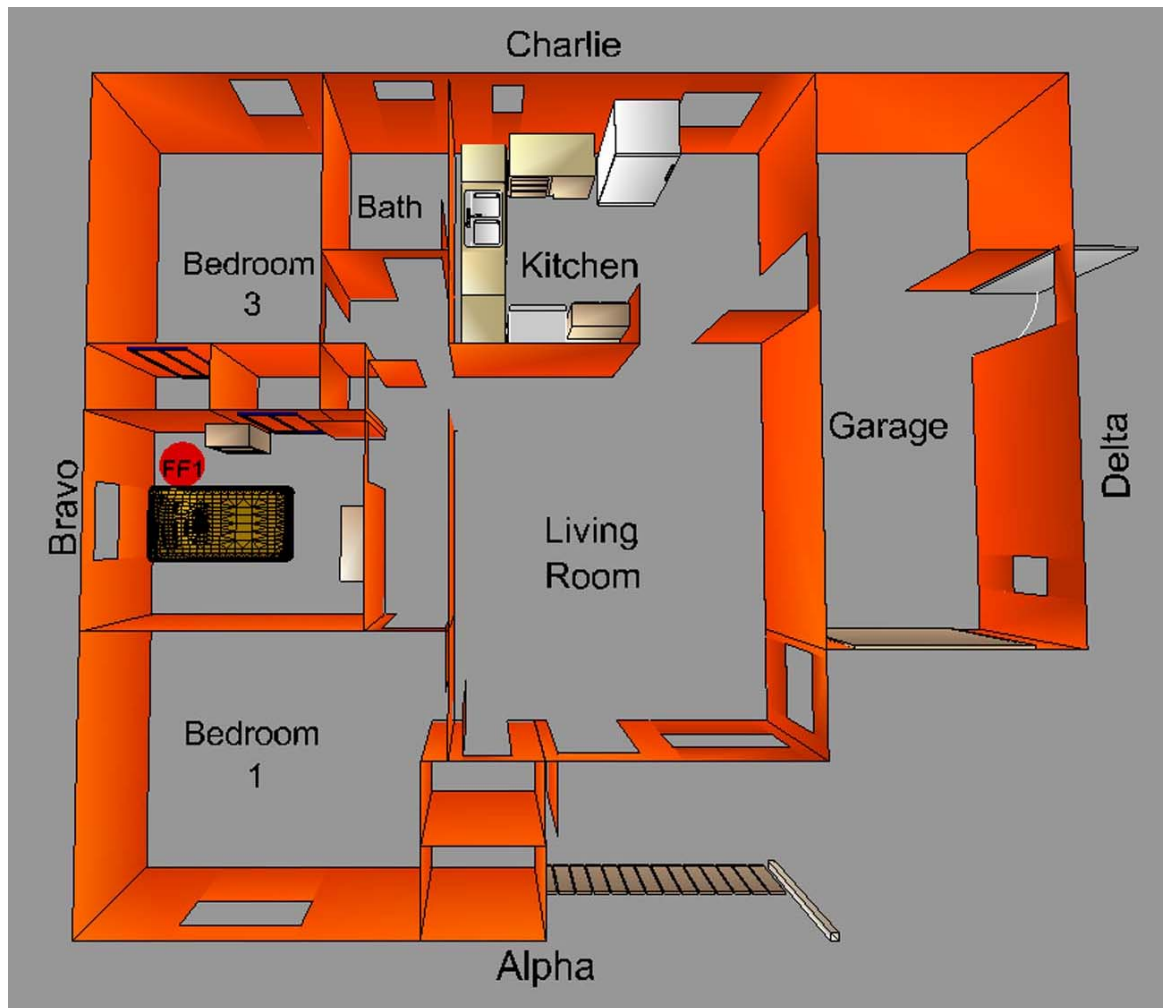
evacuate the structure, but based on the urgency of his assignment and the tenable conditions, he decided not to evacuate immediately. At approximately 02:22 hours, while searching bedroom #2, Engineer 69 spotted a leather turnout boot along the right side of the bed. After moving some light debris, he realized it was a downed firefighter (FF1, Figure 11). Engineer 69 rolled the firefighter on his side and determined that he was still wearing an SCBA facepiece and the low air alarm (secondary bell) was slowly ringing. He immediately began to extricate him, but struggled because parts of the SCBA straps and turnouts were damaged to the point of failure. He yelled to Firefighter 69 for assistance. Together they struggled to remove the firefighter, and were able to move him to just inside the bedroom doorway. Visibility in the room decreased as the smoke conditions worsened. Near the point of exhaustion and with his SCBA low air alarm activated, Engineer 69 was briefly disoriented. Firefighter 69 assisted Engineer 69 toward the front door.

Figure 11 - Location of Firefighter 1 (FF1)

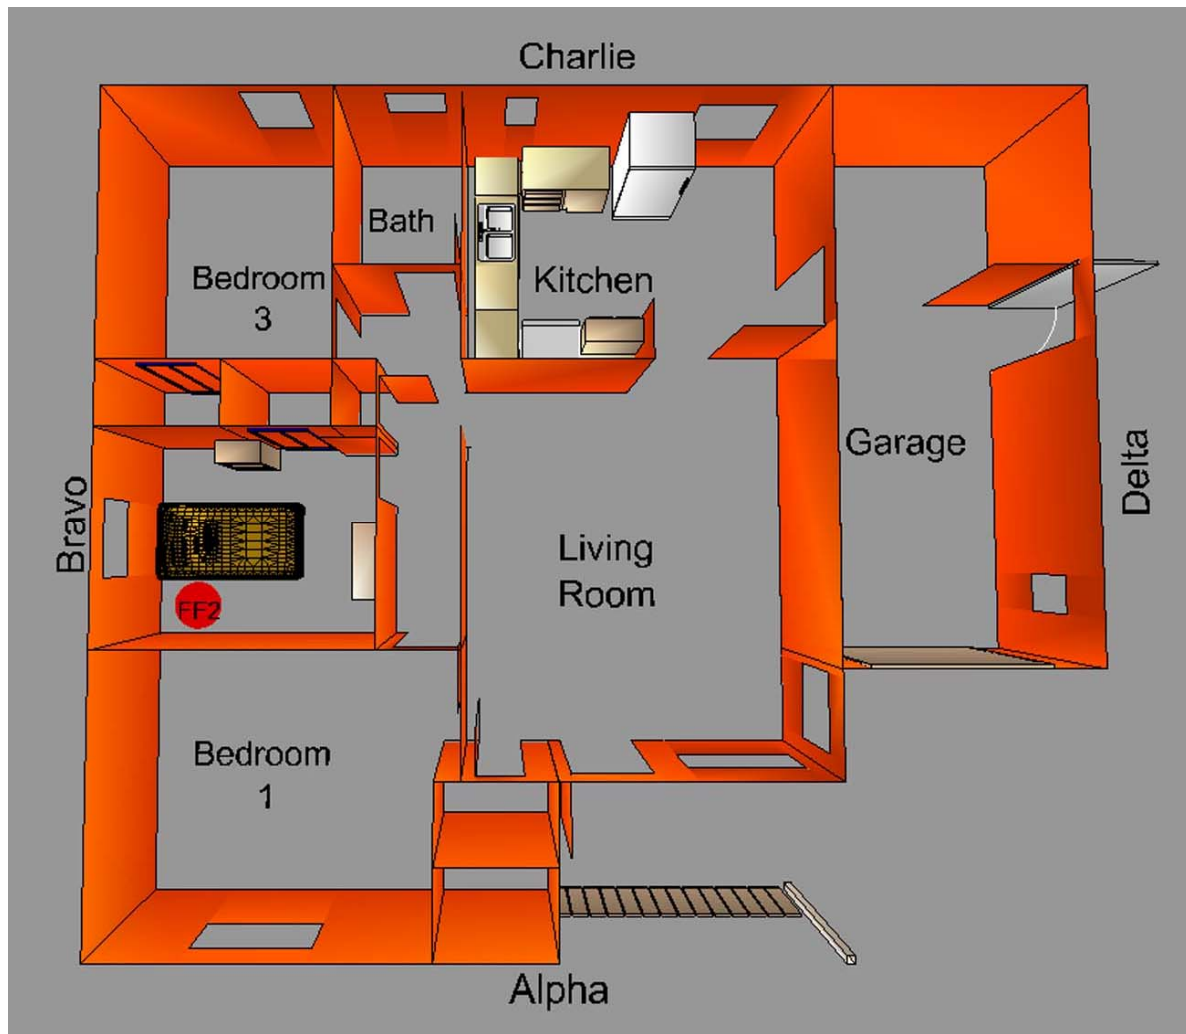
personnel. Battalion 64 returned with a 1 ¾" hoseline followed by the crew from Engine 72. Captain 76 moved out of the way to make room. Battalion 64 and the crew of Engine 72 knocked down the remaining fire and utilized a backboard to remove the second firefighter (FF2, Figure 13). (Note: The estimated time of removal was 02:34 hours.)

Figure 13 - Location of Firefighter 2 (FF2)

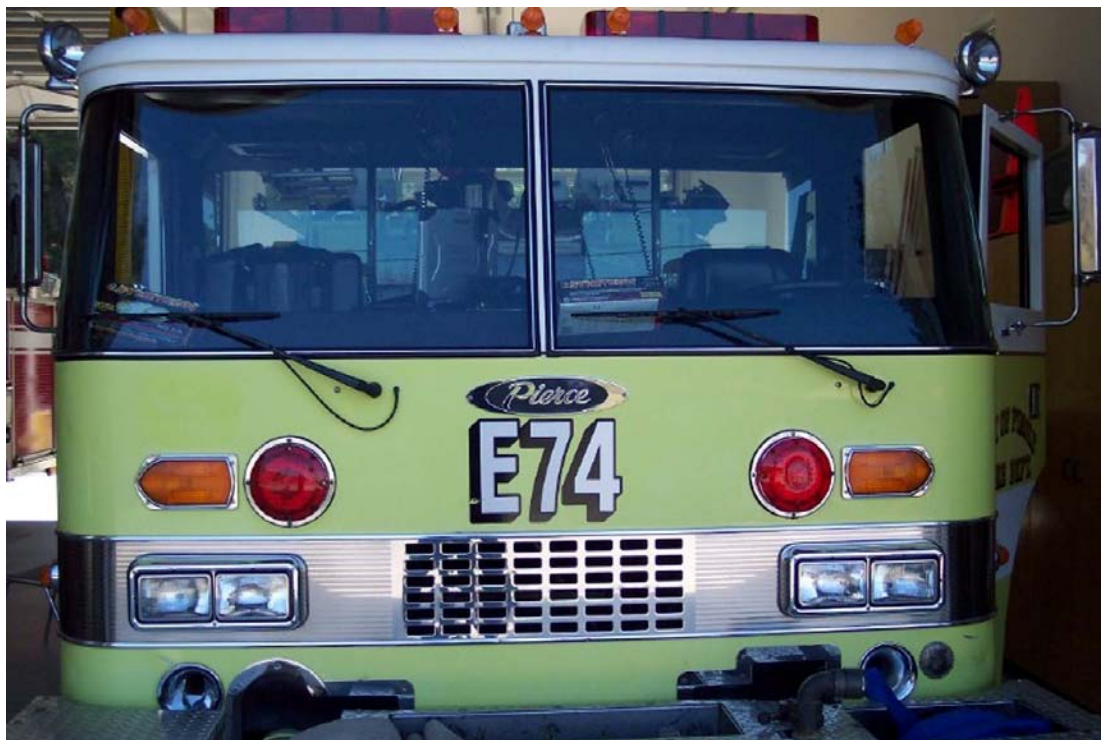
- 4.1. Engine 73 did not have the correct apparatus identifier.

Although personnel from Station 73 were using the radio identifier "Engine 73", they were operating on a spare apparatus marked with the identifier "E74" (Engine 74). This

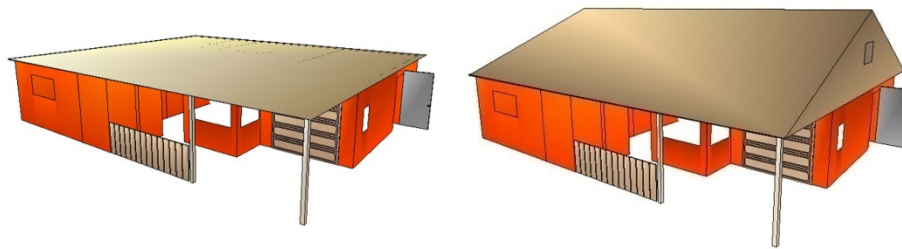
The roof modification prevented effective vertical ventilation of the living space. The hole cut in the roof only provided ventilation of the attic space. The ventilation crew was unsuccessful in the effort to breach the flat roof. The ventilation crew failed to identify the addition of the rain roof. The ventilation tactics employed for this type of roof construction were ineffective.

Original Flat Roof

Rain Roof (Built 1991)

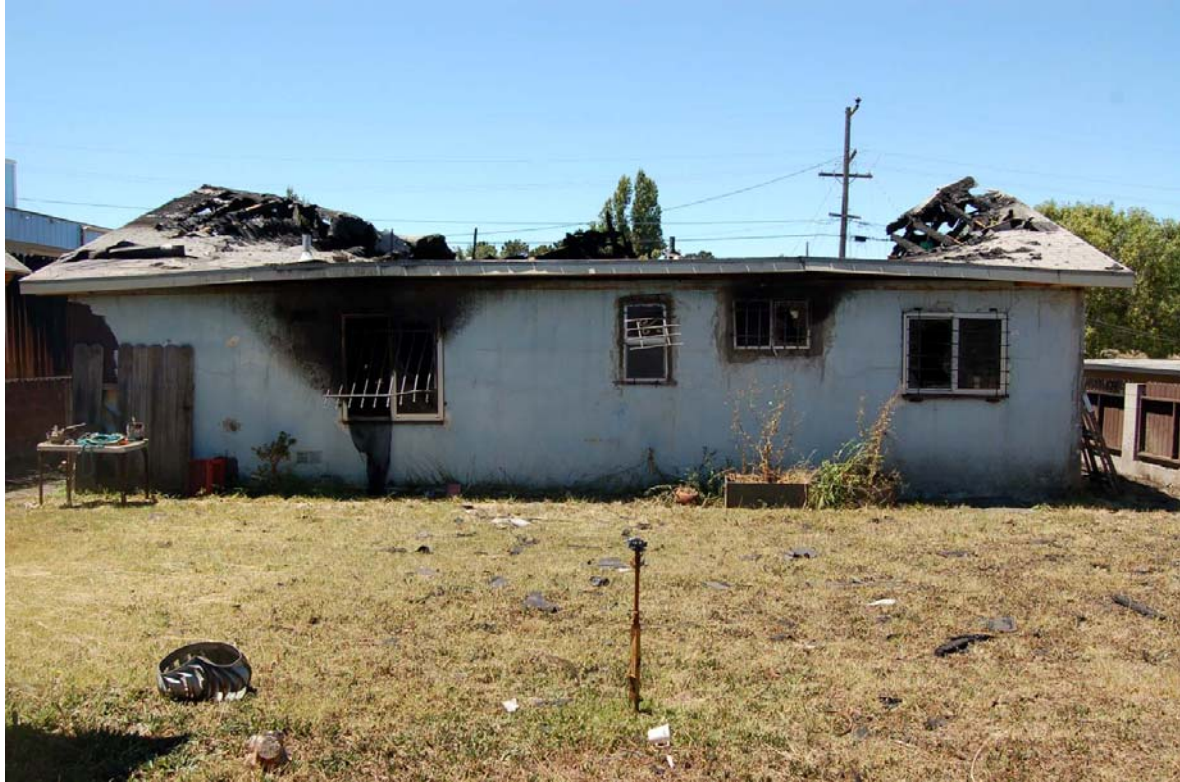
Picture 3 - Charlie side with partially broken windows and security bars

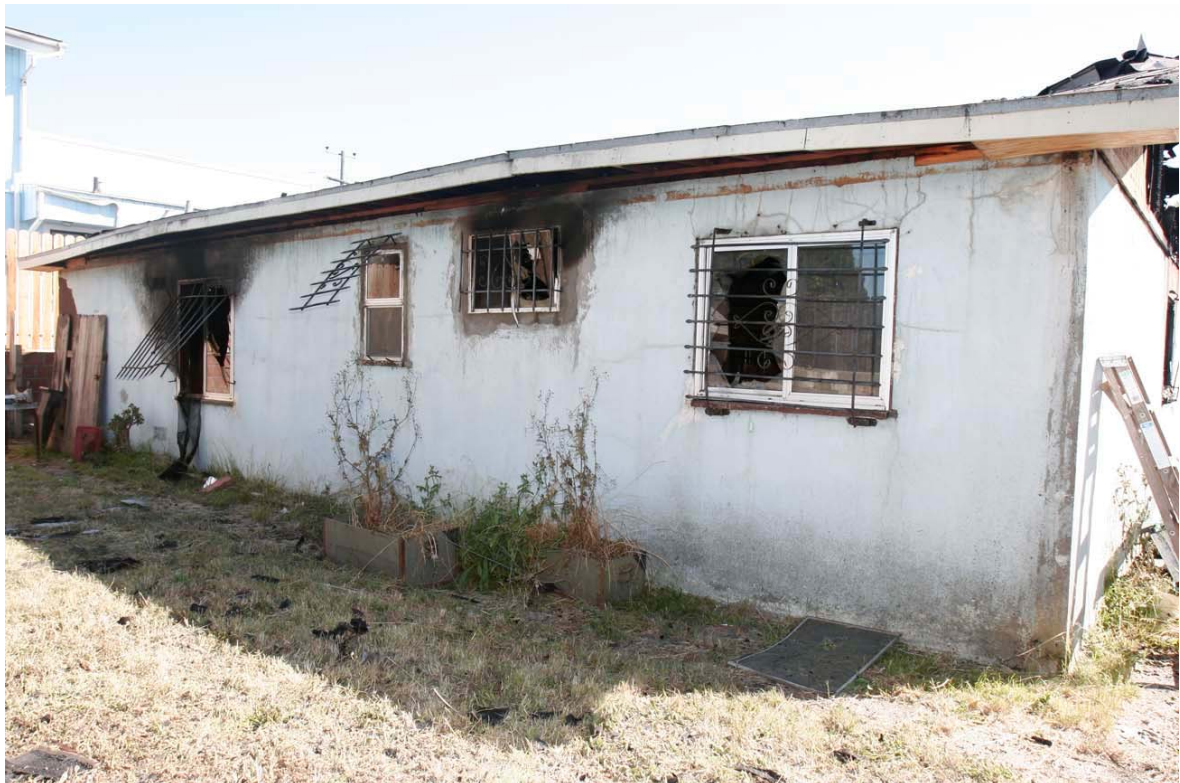
Picture 4 - Charlie side with partially broken windows and security bars

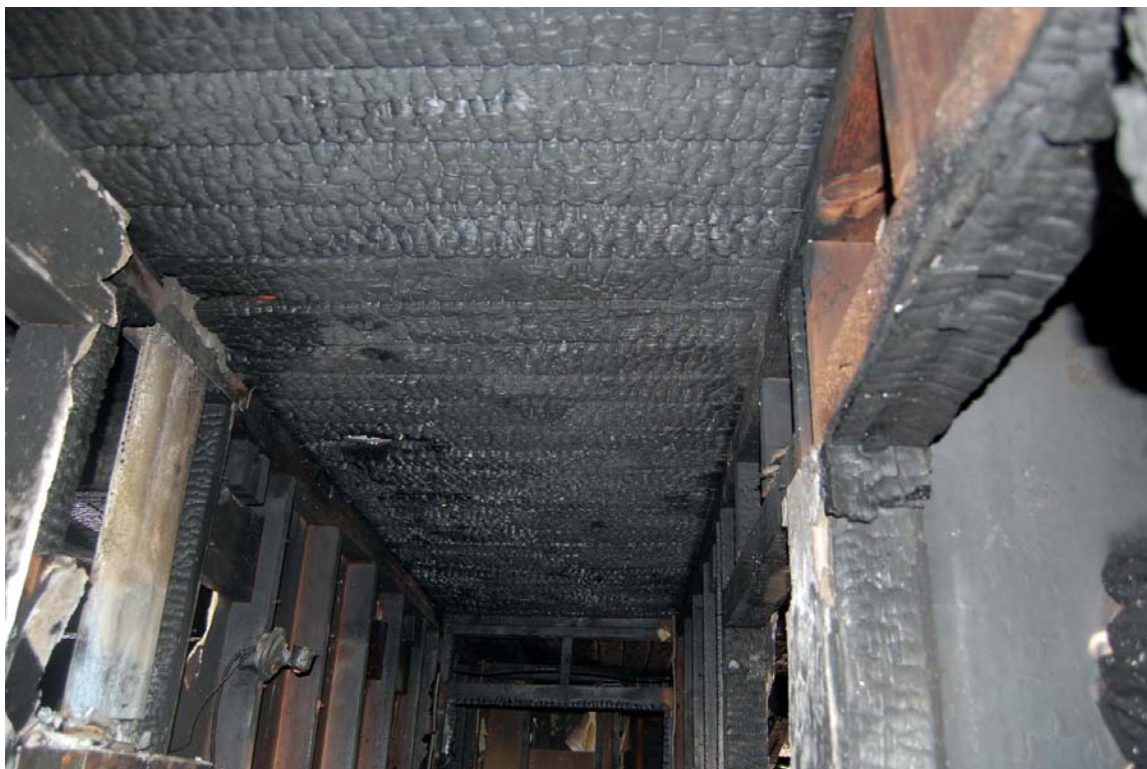
Picture 10 - Hallway ceiling looking towards Bedroom #1

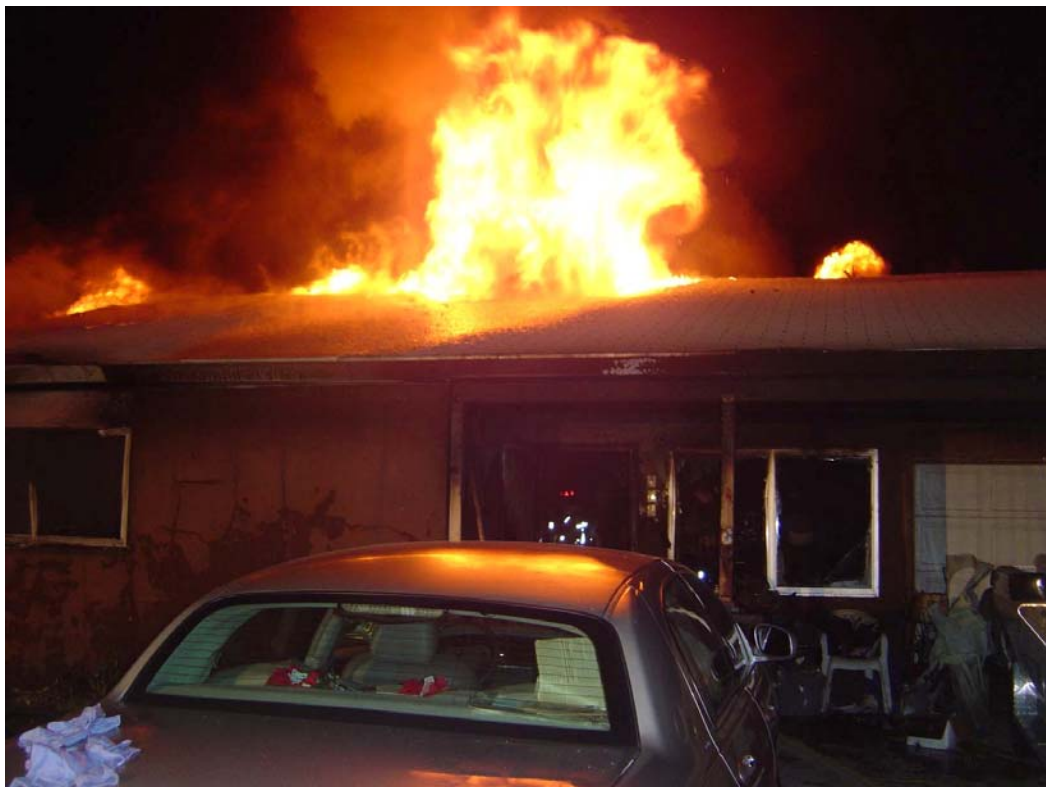
Picture 12 - Fire from ventilation hole
