HAI Project No.: 1JJB05264.006

**Report Concerning the Exterior Wall Claddings
Involved in the Monte Carlo Hotel Fire**

**Building Division
Department of Development Services
Clark County, Nevada
4701 Russell Road
Las Vegas, Nevada 89118**

August 13, 2008

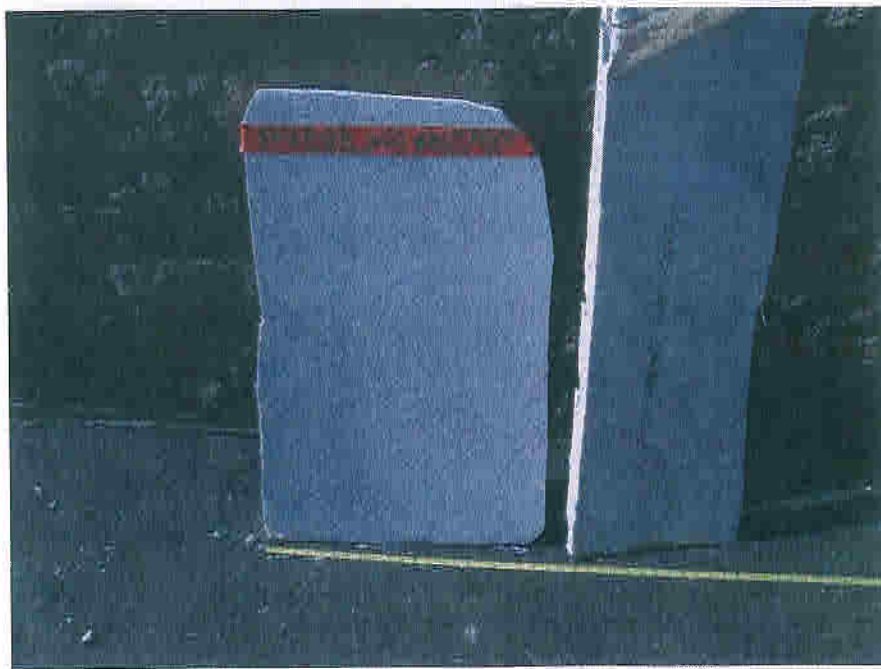
Figure 4—Samples 7 and 8 – front view

In general, on the flat sections of the wall (Samples 7 and 8) it appears that EIFS was installed and the EIFS used a 1 inch thickness of EPS. It should be noted however, that the lamina thickness measured on the samples was significantly less (28 – 69% less) than that specified in Sto's evaluation report.

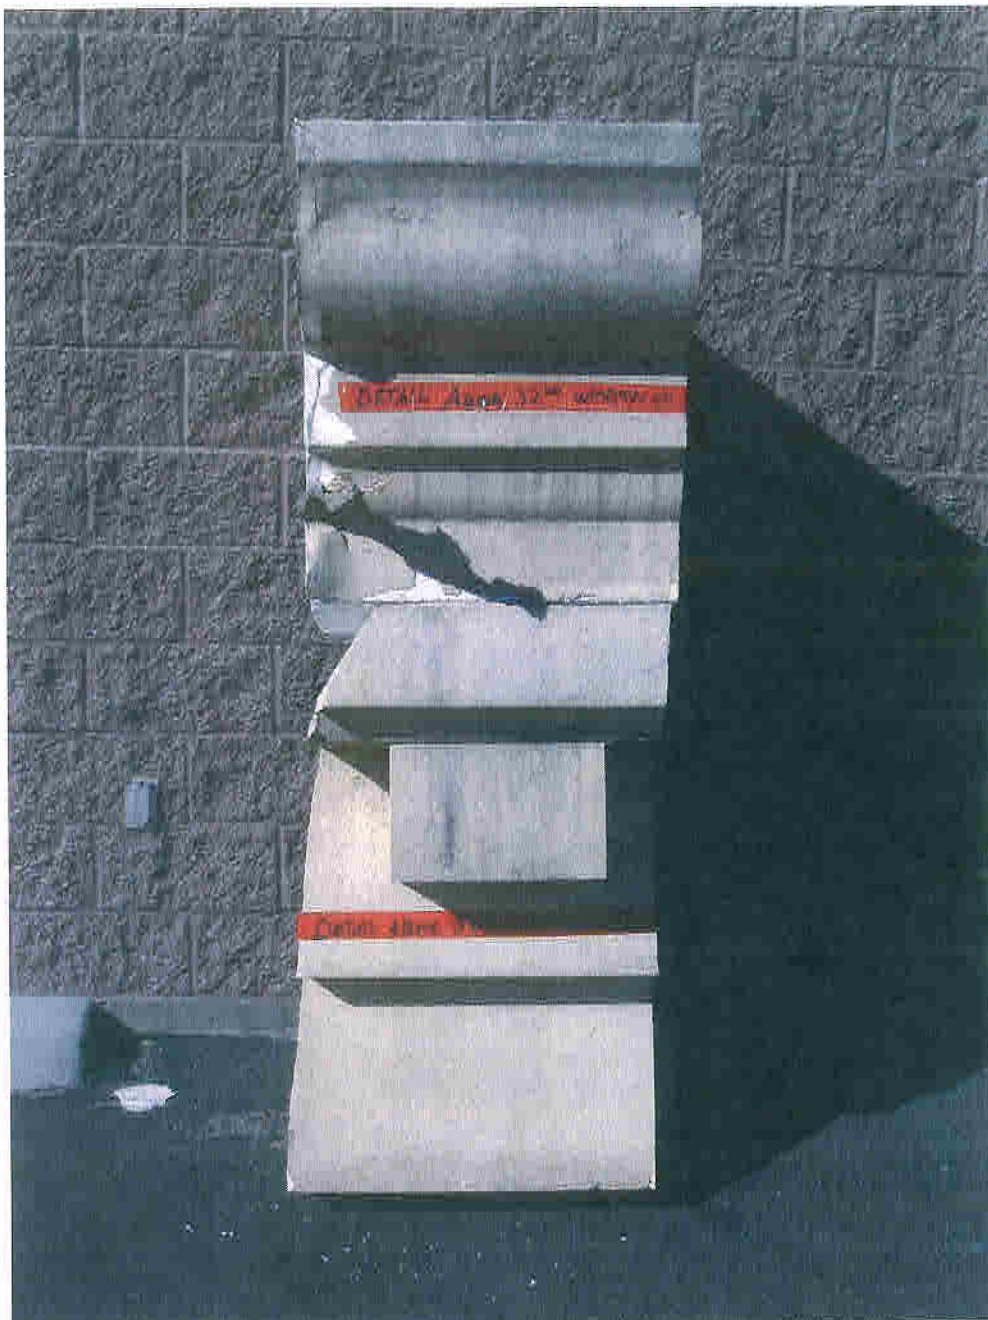
Figure 7—Sample 2 – front view

Sample 2 was a sample from the horizontal cornice at the top of the 32nd floor, just below the parapet area. Two small samples from Sample 2 were sent for characterization. The first small sample identified as MVA sample A was from the top of the cornice. In this sample the EPS was covered with an approximately 2-mm (0.08-in.) thick coating that appears to be a combination of a polyurethane coating covered by a thin EIFS lamina. It should be noted that this small MVA sample A was removed from an area of the larger sample that included mesh/fiberglass fabric. The majority of the Sample 2 from which the small MVA sample B was removed did not have the mesh/fiberglass. In the second small sample identified as MVA sample B, the EPS appears to be covered by a 1-mm ((0.04-in.) thick painted polyurethane type resin. No mesh/fiberglass fabric was present in this sample.

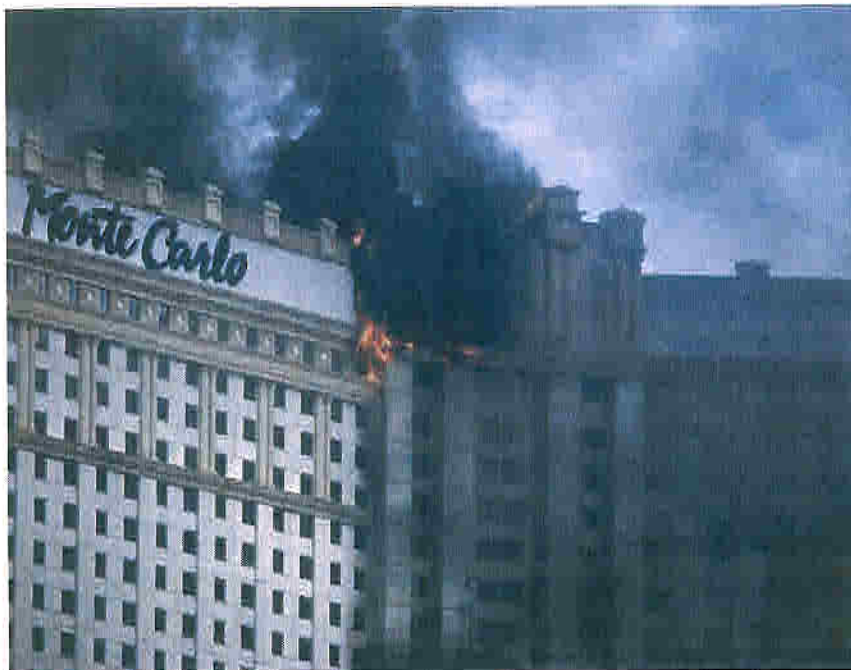
Figure 15—Early stage of the fire (*photo credit to FOX News*)

The fire on the left side of the central core then progressed laterally. The adjacent materials on the right side of central core façade began to burn and the fire continued to propagate laterally over these decorative materials. The fire also moved to the left along the upper portion of the west tower and began to involve the cladding materials. Figure 15 provides a photograph of this progression.

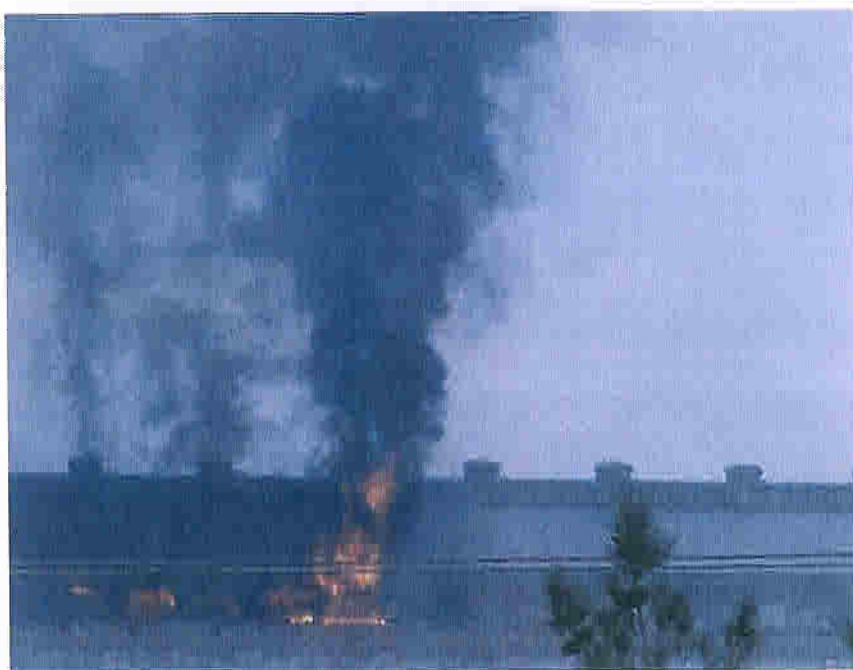
Figure 16—Latter stage of fire (*photo credit to FOX News*)

Observations indicate that the EIFS on the upper wall area while involved in the immediate area of fire exposure from the fire below, did not exhibit significant lateral flame-spread. The burning on the flat wall did not significantly advance the flames per se but rather tended to lag behind the flame front caused by the burning of the decorative band at the top of the wall, the decorative band at the top of the 32nd floor and window medallions. The video observations show for much of the time, that the fire is limited to burning by the the decorative band at the top of the 32nd floor, the window medallions and the upper decorative band on top of the wall. See Figure 16 for a photograph showing this performance.
