A Summary of a NIOSH fire fighter fatality investigation

Career Probationary Fire Fighter Dies While Participating in a Live-Fire Training Evolution at an Acquired Structure - Maryland

Fatality Assessment and Control Evaluation Investigation Report # F2007-09

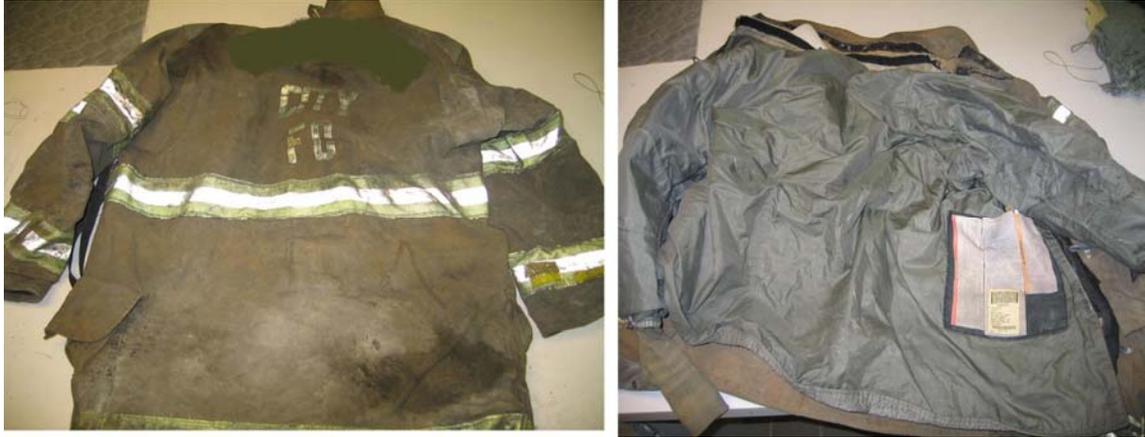
The turnout gear that was worn by the victim was sent by the department to the manufacturer for inspection. The NIOSH investigative team noted that there were little to no signs of heat exposure on either the coat or the pants (Photos 1 and 2).

Photo 1. Turnout jacket shell and liner worn by victim.

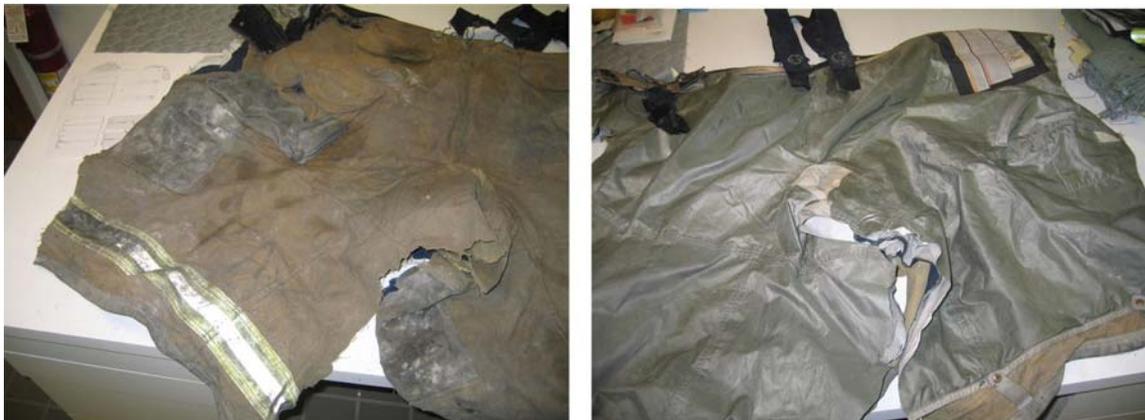
Photo 2. Turnout pant shell and liner worn by victim.

The coat was manufactured in 2002 and was reported by the manufacturer to still be in serviceable condition, but requiring extensive cleaning. The pants were manufactured in 1997. The manufacturer reported that the pants shell and liner were beyond their useful life and that they should have been retired. The manufacturer reported that thermal protection and moisture integrity was diminished due to abrasion and wear, especially in the crotch area of the pants (Photo 3).

Recommendation #7: Fire departments should develop an inspection criteria to ensure that all protective ensembles meet the requirements of NFPA 1851, Standard on Selection, Care, and Maintenance of Structural Fire Fighting Protective Ensembles.

The latest edition of NFPA 1851, August 2007, recommends mandatory retirement for all structural fire fighting protective gear at 10 years from the date of manufacture regardless of the level of use. The fire department sent their old turnout gear that was removed from service to the training academy for use by recruits.

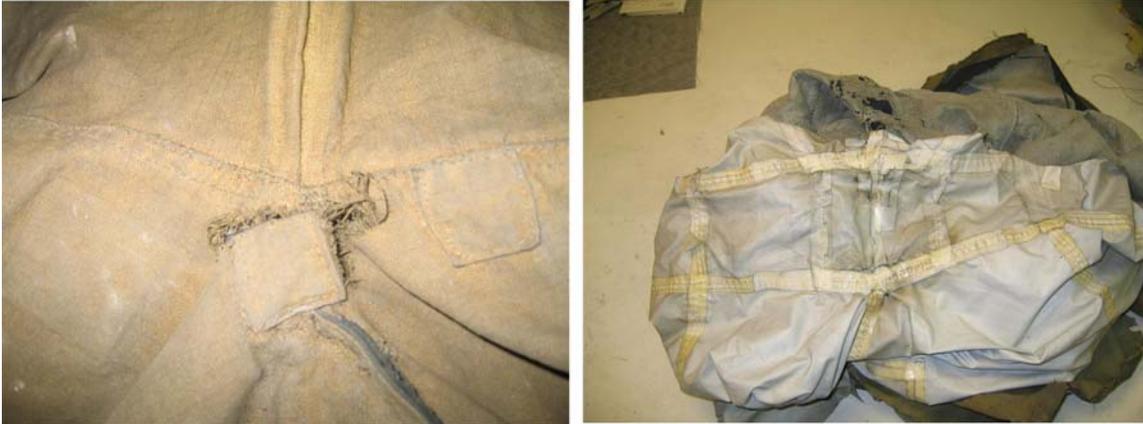
Photo 3. The repaired crotch area of the turnout pants shell, and inverted liner with diminished thermal integrity due to age and use.

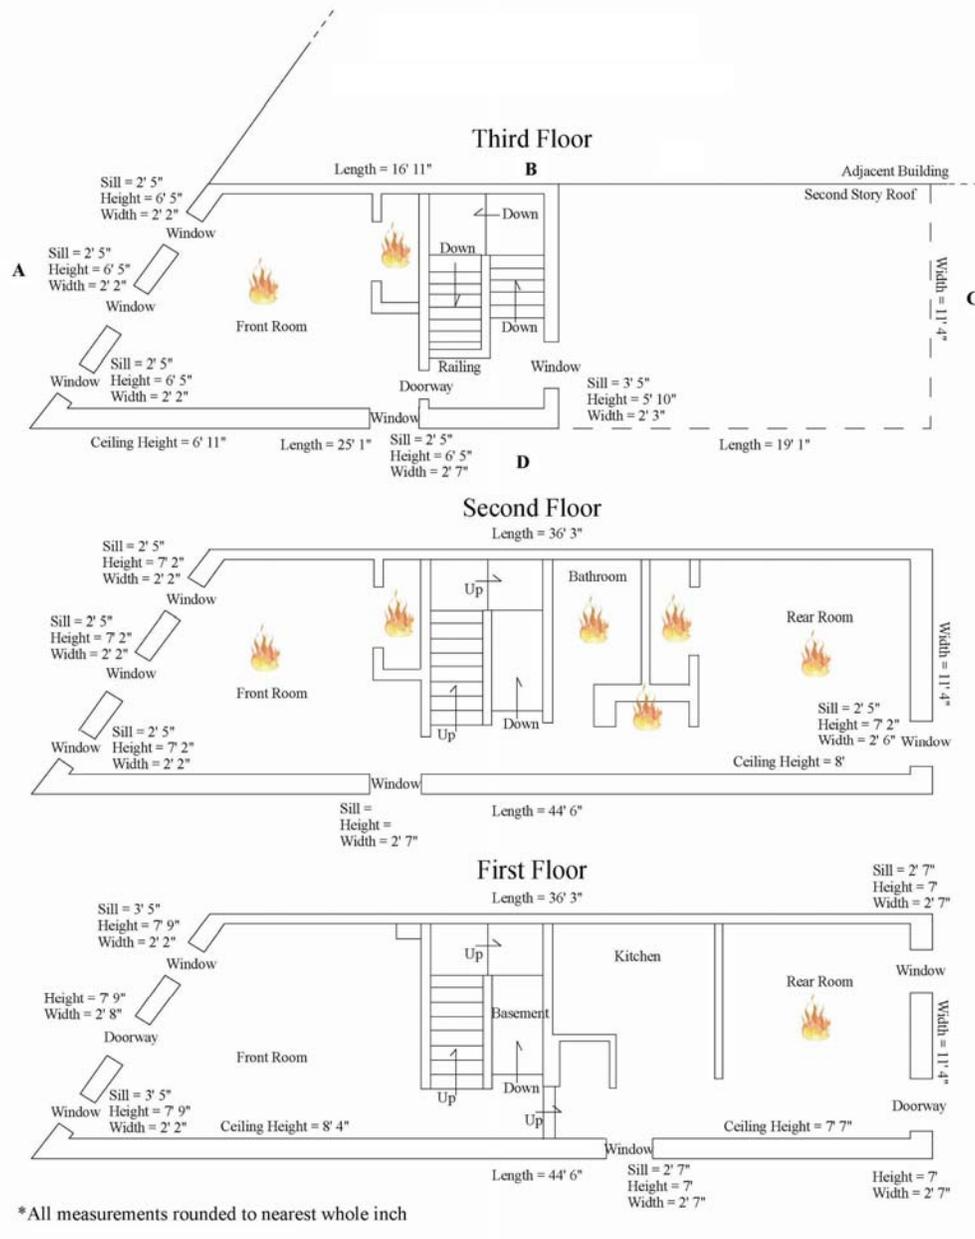
The first and second floors were approximately 44 feet long by 11 feet wide. The first floor consisted of a kitchen and a central stair case separating a front and a rear room. On the second floor, a bathroom and the staircase separated a rear and front bedroom. The third floor was above only the front portion of the townhouse. It had a front bedroom and a hallway that led to the stairway. The landing at the top of the stairs to the third floor contained a window on the C-side wall (Figure 1). The window sill was approximately 3-foot 5-inches above the floor and approximately 2-foot 3-inches wide (Photo 4).

Figure 1. Layout of the fire structure. Fire symbols designate the location of the individual training fires set for the training evolution (Courtesy of USFA Media Production Center).

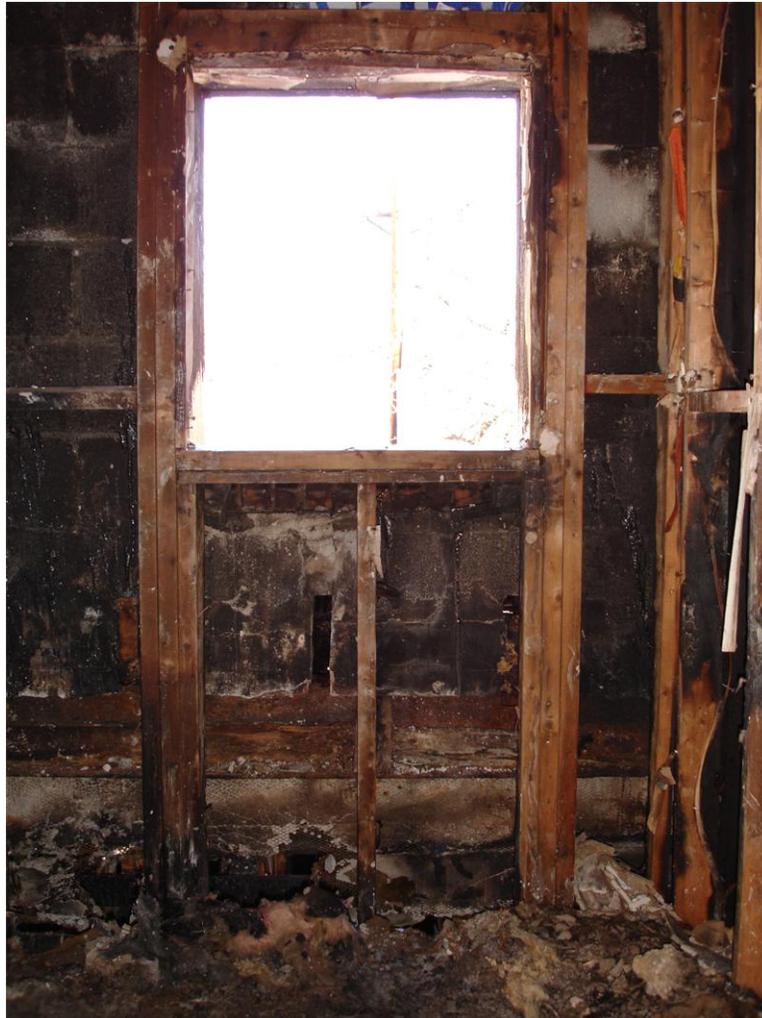
Photo 4. Window sill on third floor landing looking towards the rear or C-side of the structure. Sill is 41-inches above floor level

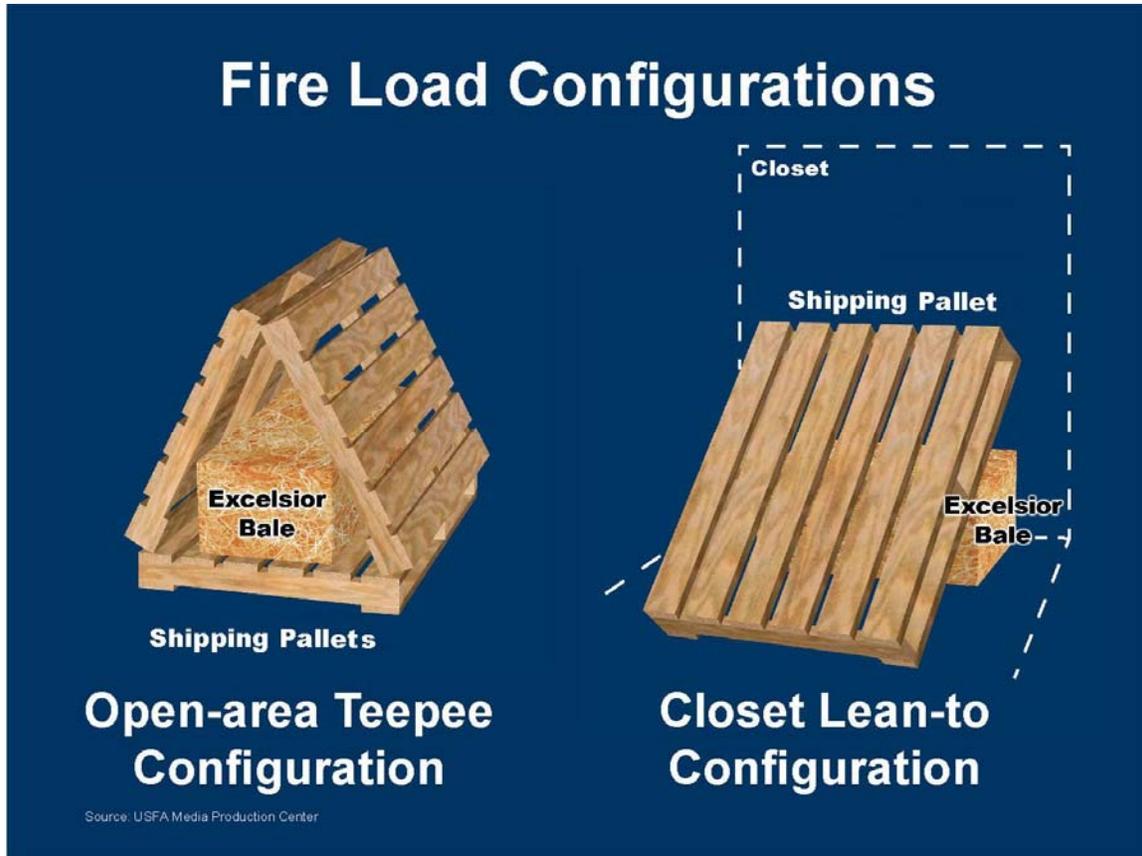
Through interviews it was determined that at least 12 wooden pallets, 11 bales of excelsior, and miscellaneous trash from the structure were used to light the fires in either a teepee or a lean-to configuration. The teepee arrangement consisted of a pallet flat on the floor with two others on top leaning into the center supporting one another. A bale of excelsior was placed in the void area. The lean-to consisted of a pallet leaning against a wall with a bale of excelsior underneath (Figure 2).

Figure 2. Example of fire load configurations (Courtesy of USFA Media Production Center).

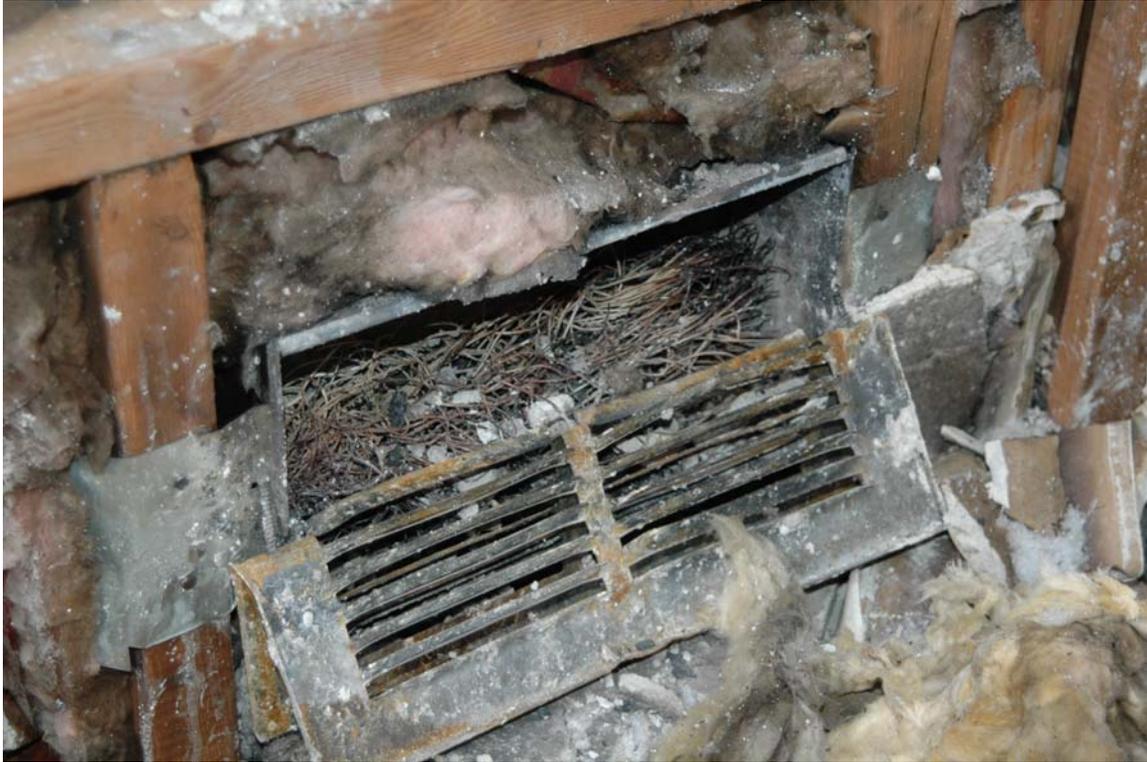
Through the interviews and during the walkthrough it was noted that excelsior was also stuffed into wall and ceiling openings, duct work vents, and behind drywall where it existed and/or was accessible (Photo 5).

Photo 5. Excelsior that was stuffed into duct work vents.

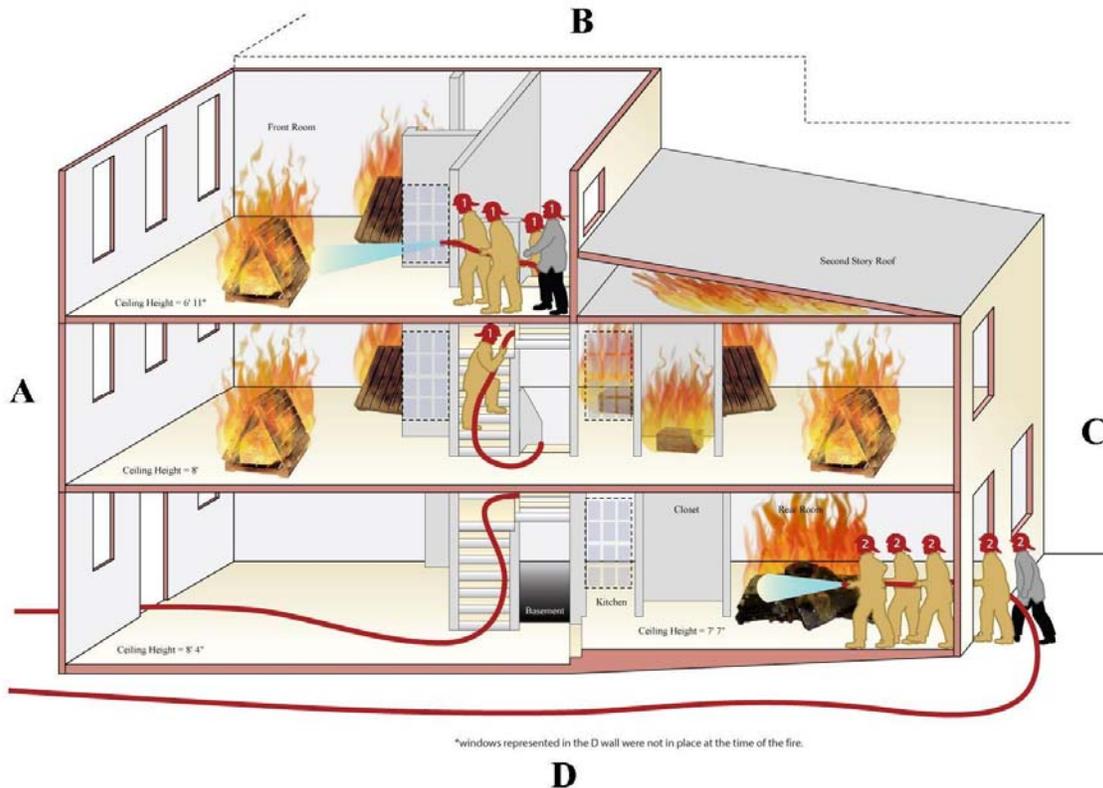
Figure 3. Engine 1 crew on third floor. Engine 2 suppressing fire in rear room on first floor (Courtesy of USFA Media Production Center).

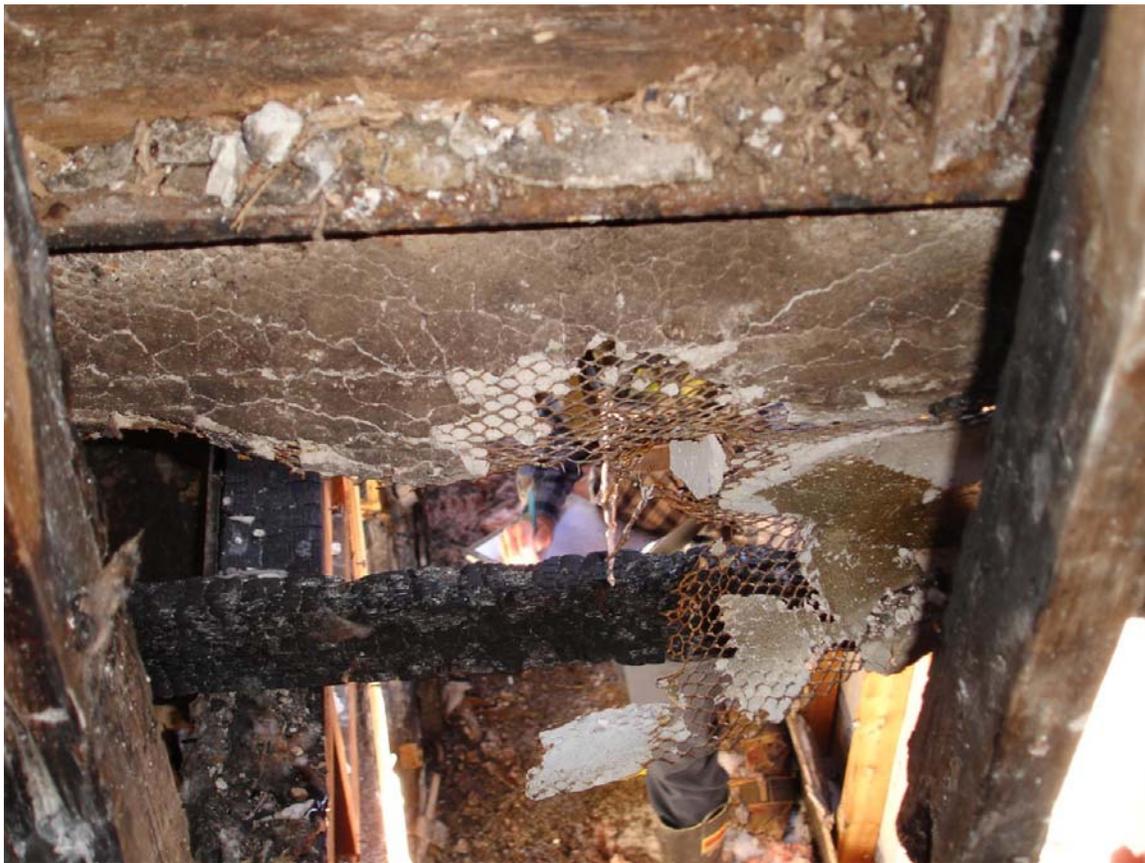
the first and second floors. Heat and flames from the rear area of the second floor were also extending directly into the stairwell area. This was likely due to the ceiling having been pulled down in the bedroom during previous training exercises, and the fire entering the attic area under the second floor roof (Figure 3). The heat and flames exited this area through the voids in the wall on the stairwell and just below the window on the third floor landing (Photo 6).

Photo 6. Void in wall just below window on third floor landing.

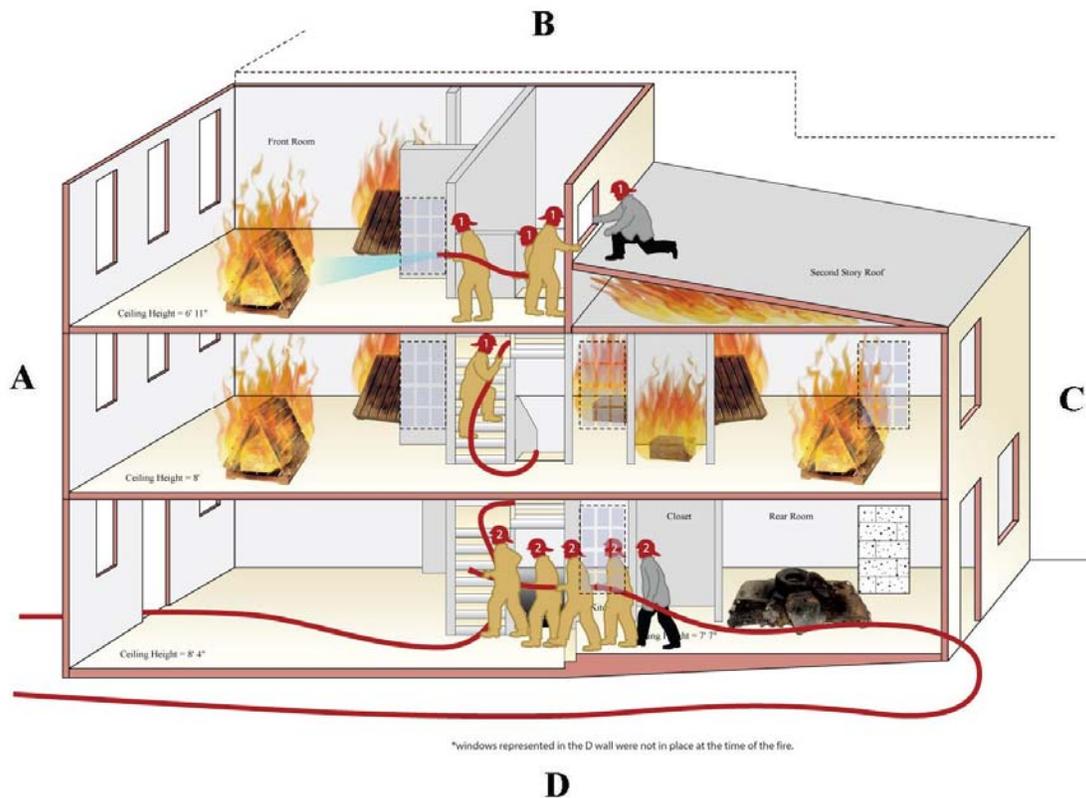
The Engine 1 adjunct instructor felt a rush of intense heat and knew something was wrong. He did not have a radio to make contact with the officer in charge, nor did he know of any alternative means of exit because they had not completed a walk-through or any pre-burn briefing prior to the training evolution. He leaned out of the window on the third floor landing to assess his situation and possibly make contact with someone. The back-up fire fighter came up the stairs and stated that she needed to exit because the conditions on the stairs were too intense. The adjunct instructor exited through the window onto the second floor roof and assisted the back-up fire fighter out of the window (Figure 4).

Figure 4. Engine 1 personnel operating on third floor and stairwell. Engine 2 advancing to the second floor. Engine 1 Adjunct Instructor on roof, remainder of crew inside (Courtesy of USFA Media Production Center).

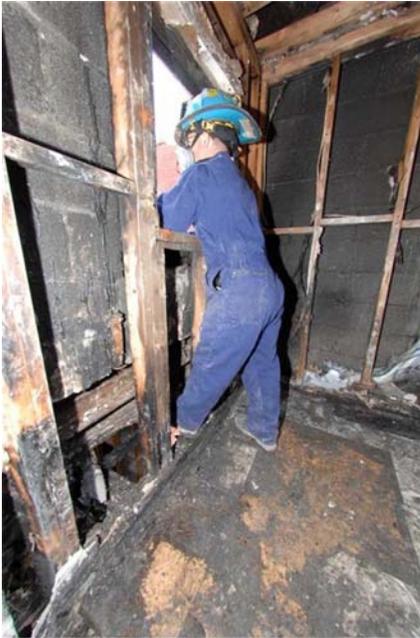
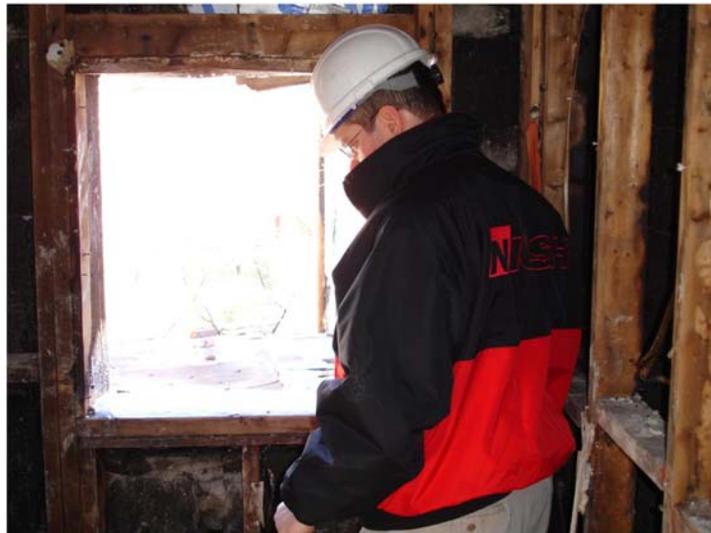
The victim also attempted to exit through the window, but was severely impeded due to the height of the window sill and possible obstructions (Photo 7).

Photo 7. ATF investigator on the left is approximately the same height as the victim. NIOSH investigator on the right is approximately the same height as the Engine 1 adjunct instructor.

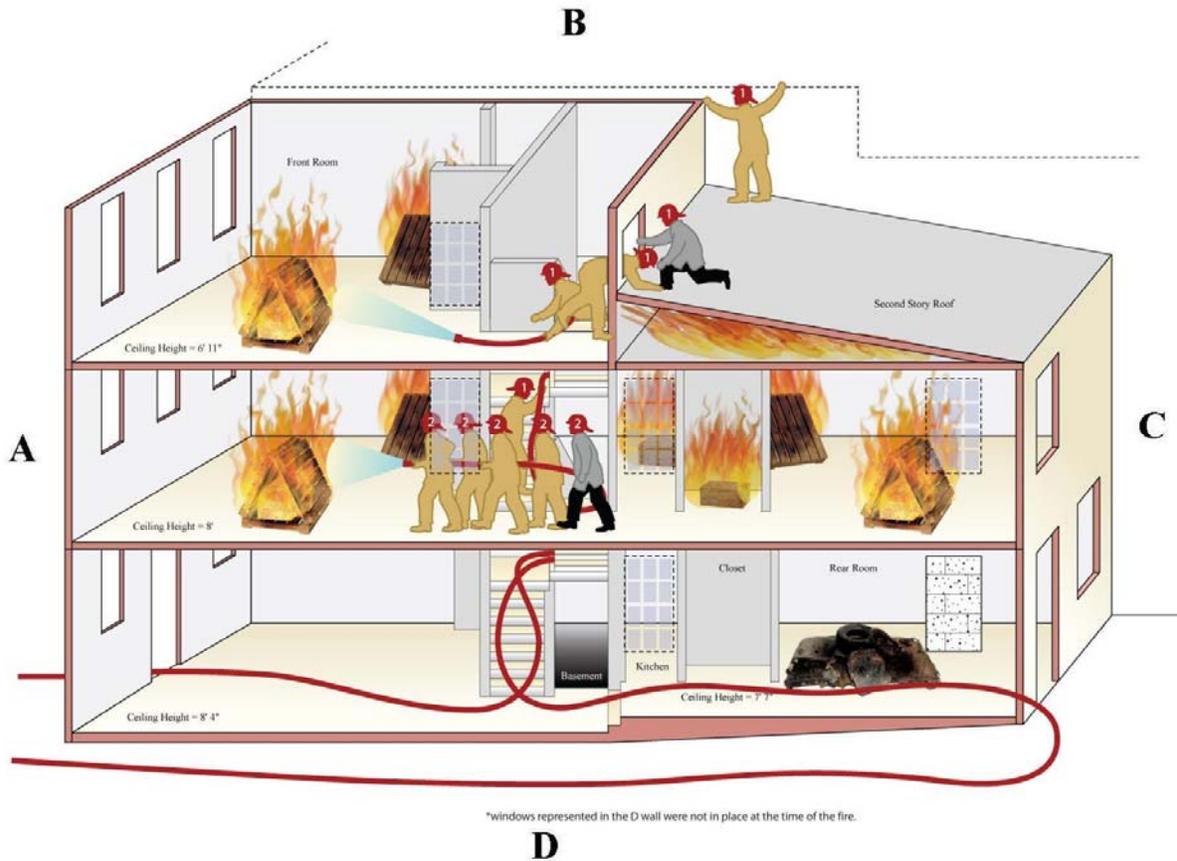
The two other recruits on Engine 1 were now on the landing between the second and third floors. The hose line was not advancing and they felt a rush of air go over them followed by heavy fire. They made their way to the bend of the stairs and saw the victim, who was alone, attempting to exit through the window. The victim was attempting to climb out of the window and screamed for them to retreat as the intense flames were venting out of the same window around her. The two recruits went back down the stairs and were faced with extensive fire. *Note: The recruits stated that they didn't know what to think about the victim being stuck in the window. They didn't know if it was part of the training, and they didn't have anyway nor anyone to ask. They decided it would be best to fight fire instead of just leaving the building.* They pulled the nozzle down from the third floor and started to fight the fire on the second floor where they met Engine 2 (Figure 5).

Figure 5. *Engine 1 crew attempting to exit on to roof. Engine 2 crew suppressing fire in front room on second floor (Courtesy of USFA Media Production Center).*

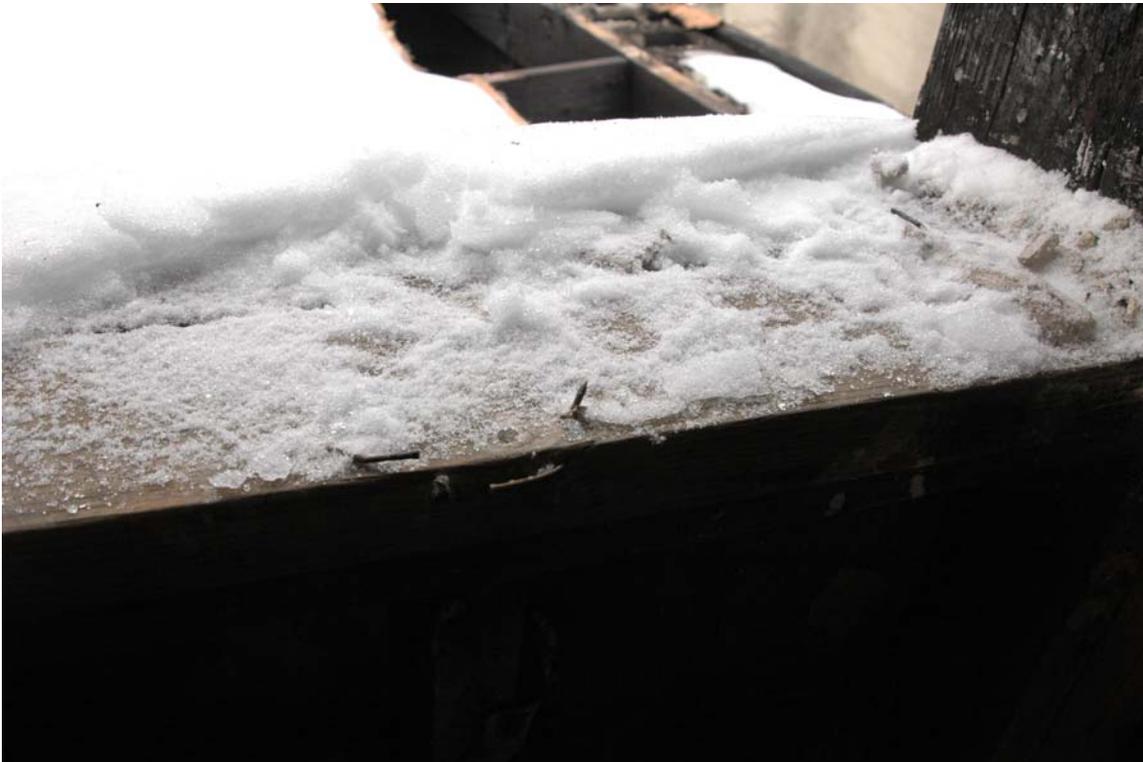
removed it in an attempt to articulate to the other recruits to retreat. Or, it could have also become dislodged from being caught on the window sill or a nail protruding from the window sill (Photo 8).

Photo 8. Nails that were exposed at the window sill on the third floor landing.

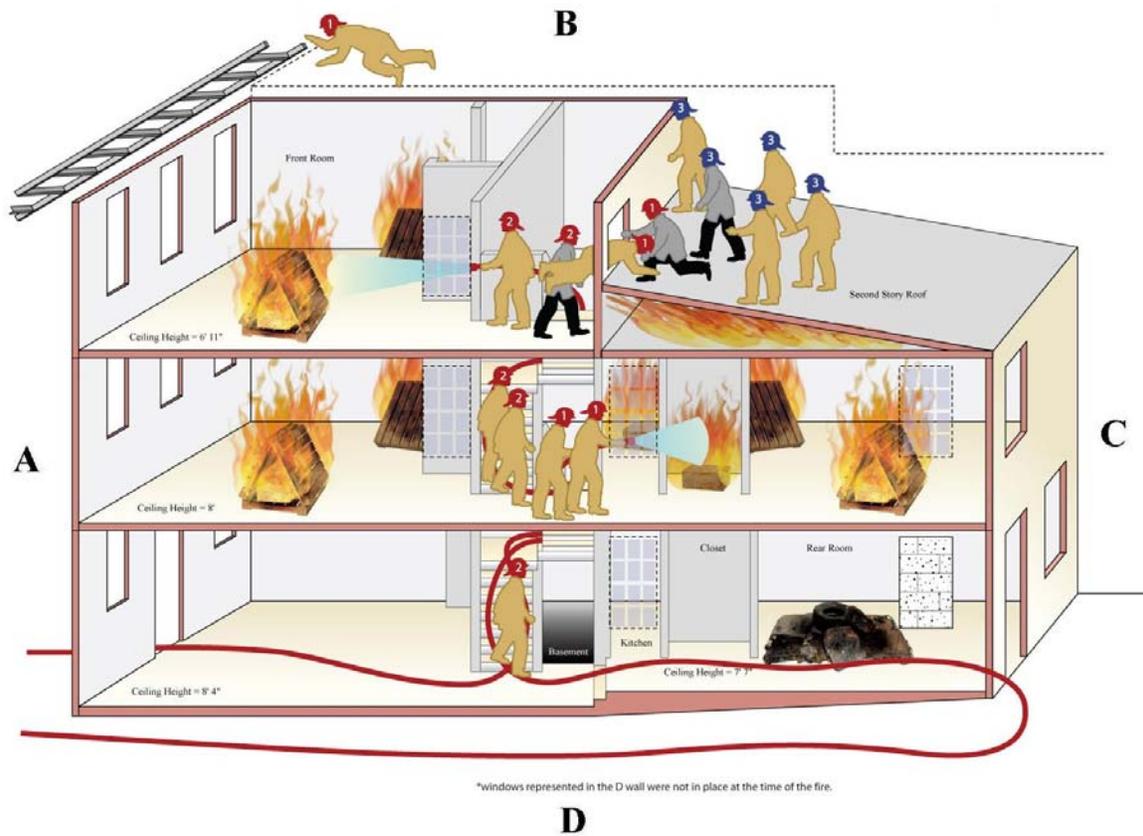
on the third floor (Figure 6). Members from Truck 3 on the second floor roof initiated life saving support. She was quickly removed from the roof and transported to a shock trauma center where she was pronounced dead.

Figure 6. Engine 1 crew exiting to roof and down ladder. Engine 2 crew suppressing fire in front room of third floor. Truck 3 members assisting Engine 1 crew exiting window (Courtesy of USFA Media Production Center).

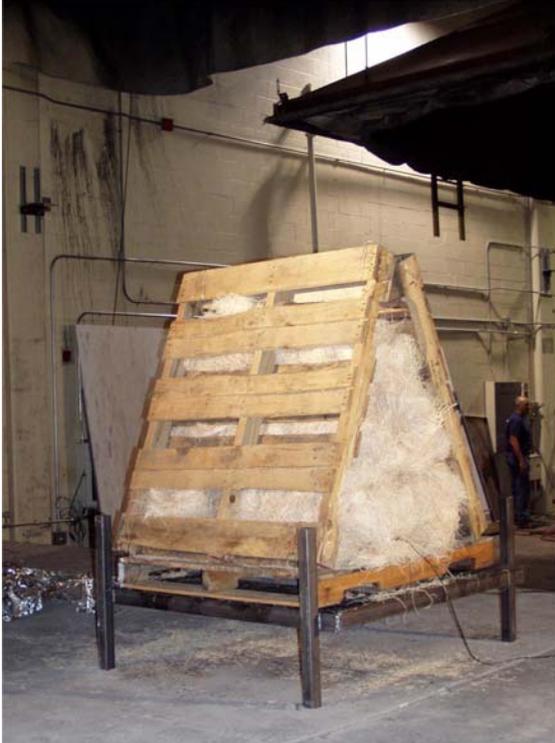
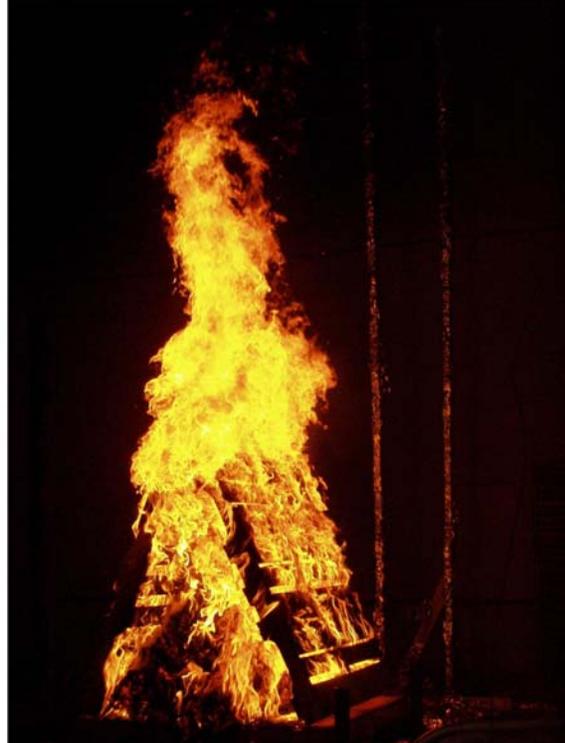
Photo 9. NIST heat release experiment.

In this incident, the three lean-to fires could be considered as equaling one “A-frame” fire in the NIST experiment. Taking into account all of the staged training fires in this incident, the training fires equaled approximately four “A-frame” fires, suggesting a heat release rate of approximately 8,000kW. With the addition of the fire load in the rear room on the first floor, the exposed wood framing members, the insulation, and added bales of excelsior, it can be estimated that the total heat release rate for the structure was in excess of 10,000 kW. It is unknown whether a flashover occurred at this training exercise. Based on the ventilation limits of a residential room with a single open doorway, the minimum amount of energy needed to flashover a room is approximately 2,000 kW.^c
