NISTIR 7094

Structural Collapse Fire Tests: Single Story, Wood Frame Structures

Structural Collapse Fire Tests: Single Story Wood Frame Structures

A series of fire tests was conducted in Phoenix, Arizona to collect data for a project examining the feasibility of predicting structural collapse. The fire test scenario was selected as part of a training video being prepared by the Phoenix, Arizona Fire Department. Multiple fires were started in each structure to facilitate collapse; the fires were not intended to test the fire endurance of the structures. Four structures with different roof constructions were used for the fire tests. Temperatures were measured as a function of time in four locations within each structure. Furniture items were placed in the front and back of each structure to simulate living room and bedroom areas. The living room and bedroom areas of each structure were ignited simultaneously using electric matches. Peak temperatures obtained during the tests ranged from approximately 800 °C (1500 °F) to 1000 °C (1800 °F). The roof of each structure collapsed approximately 17 minutes after ignition. In addition to the full scale tests, the plywood and oriented stra

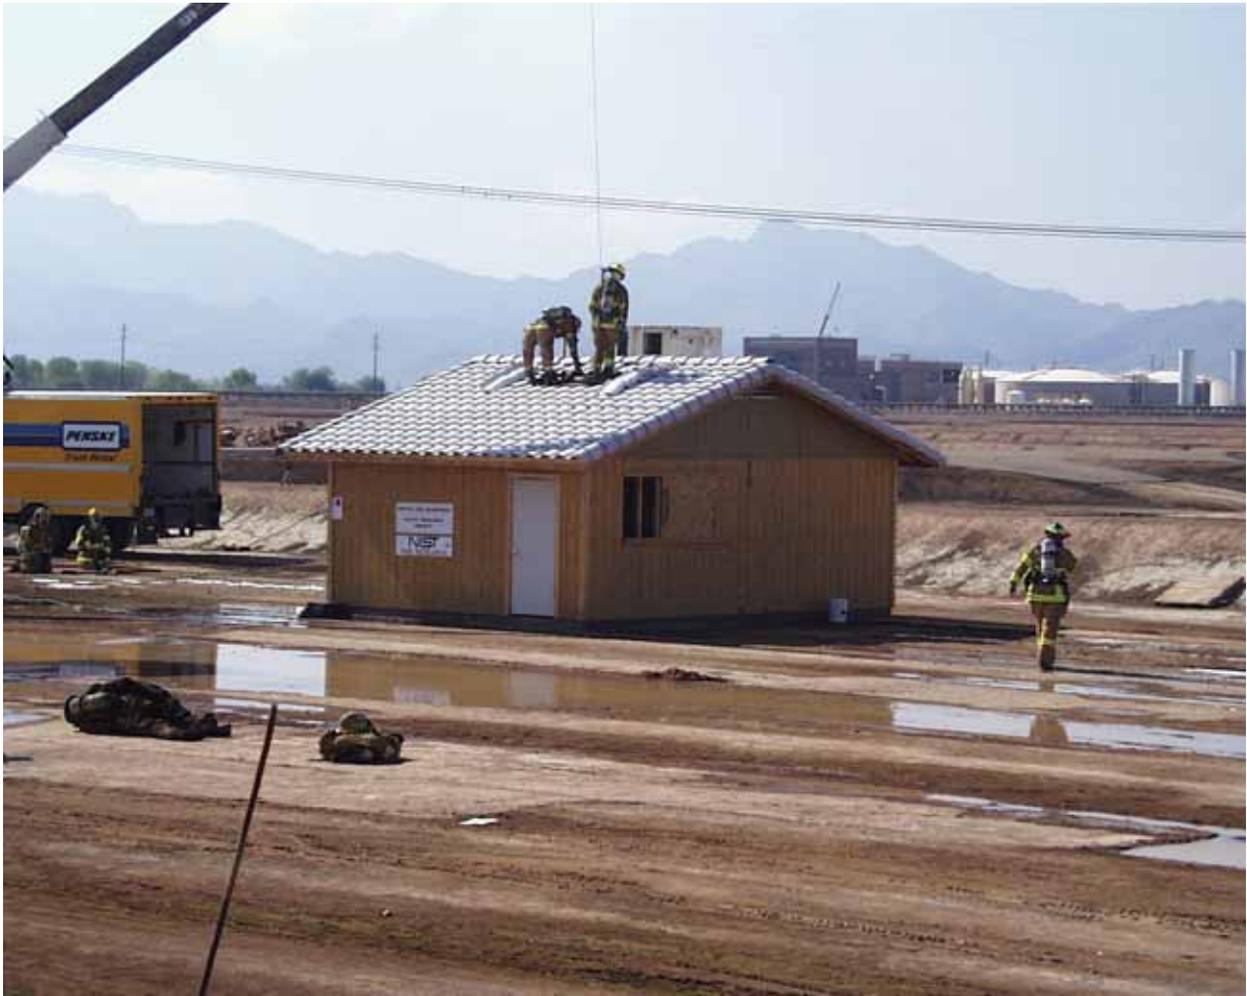
Figure 1. Photograph showing the front and one side of test structure with tile roof prior to start of test.

The Phoenix Fire Department built four single story wood frame residential type structures for this series of tests. These structures were identical except for the roof construction. One structure had a roof consisting of asphalt shingles on 12.7 mm (½ in) five-ply plywood while a second structure had asphalt shingles on 12.7 mm (½ in) oriented strand board (OSB). Both structures had a layer of 6.8 kg (15 lb) felt paper between the asphalt shingles and the plywood or OSB. The other two structures used tile over either plywood or OSB as the roof construction. The cementitious tile roofs had two layers of 13.6 kg (30 lb) felt over the plywood or OSB and nominally 25.4 mm (1 in) by 50.8 mm (2 in) boards to hold the tile in place. The measurements for the materials used to construct the test structures described in this report are approximate nominal dimensions.

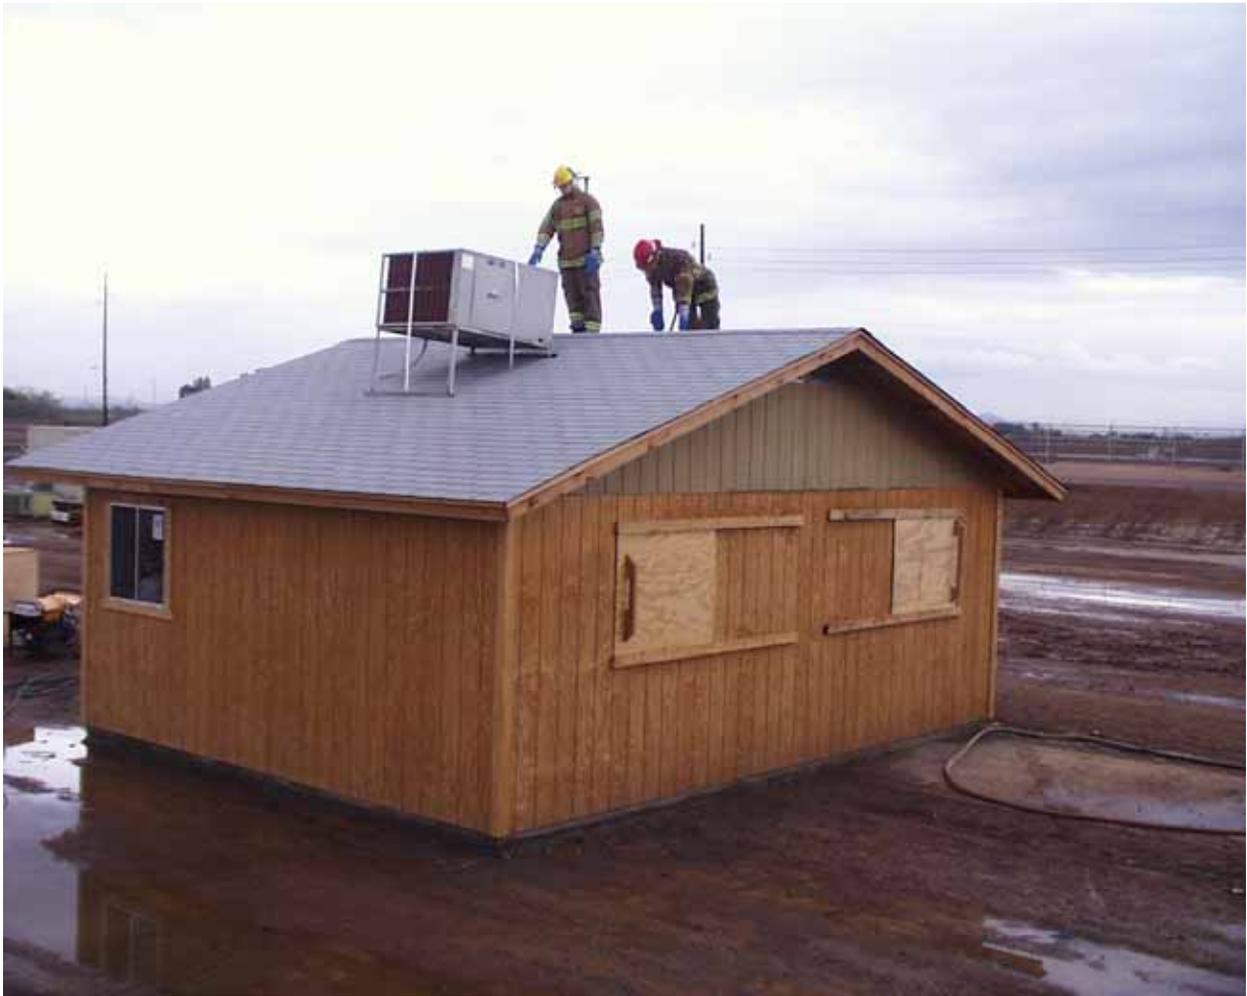
Figure 2. Photograph showing rear and one side of test structure with asphalt single roof prior to start of test.

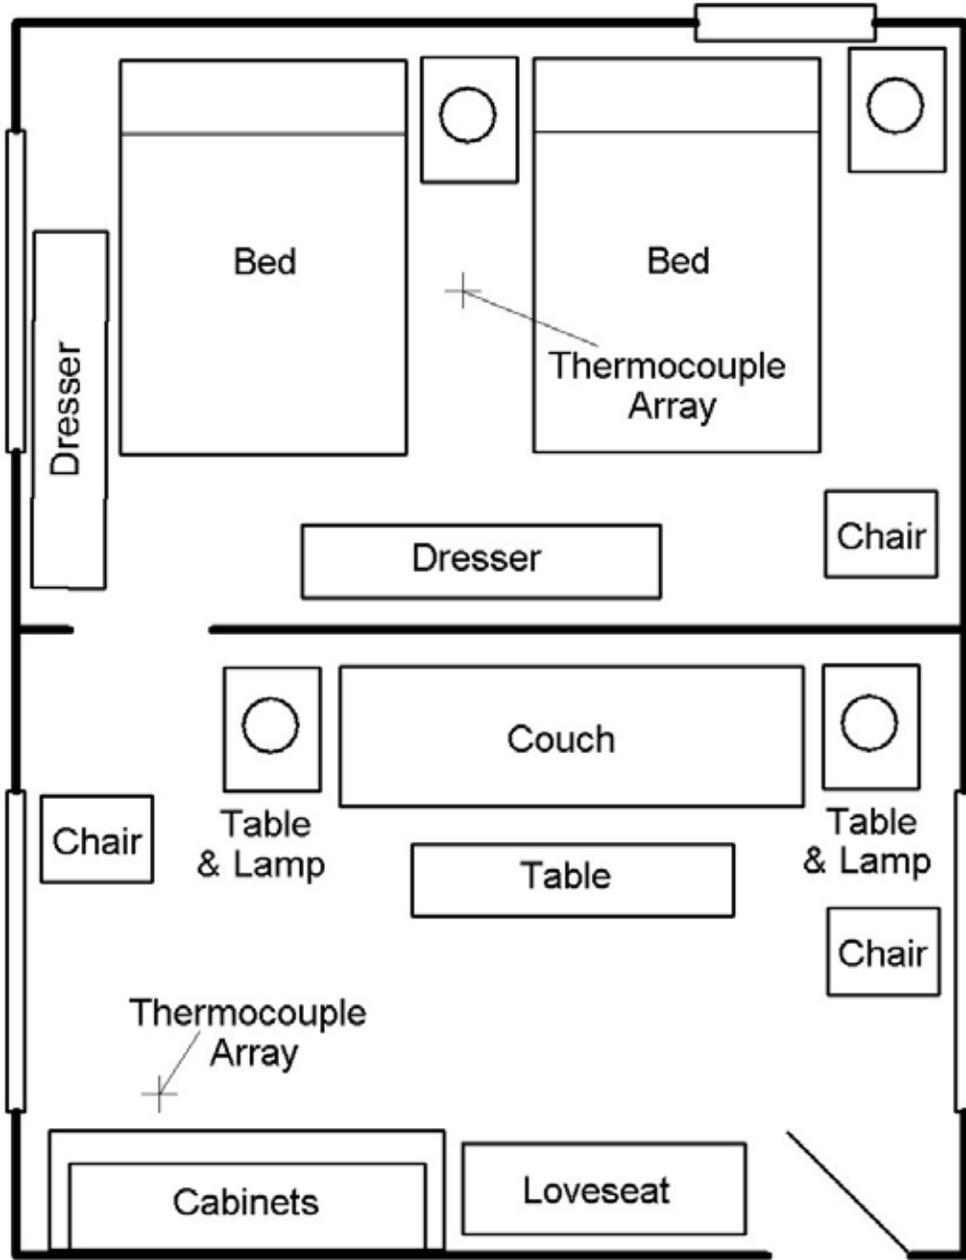
Figure 3. Plan view of generic test structure showing approximate placement of furniture and other items within structure (not to scale).

Each structure consisted of two rooms and an attic space. The rooms were separated by a wall constructed of 2 x 4 wood studs with a layer of 12.7 mm (½ in) gypsum board nailed to each side. There was a doorway, 0.8 m (2.9 ft) wide and 2 m (6.5 ft) high, in the wall between the two rooms with its centerline located 4.5 m (14.9 ft) from one exterior wall and 0.7 m (2.4 ft) from the other exterior wall. Figure 1 is a photograph of the front of one of the structures, and Figure 2 provides a rear view. A typical structure is shown in plan view in Figure 3. The placement of the measurement instruments and dimensions of the structure are shown in Figure 4.

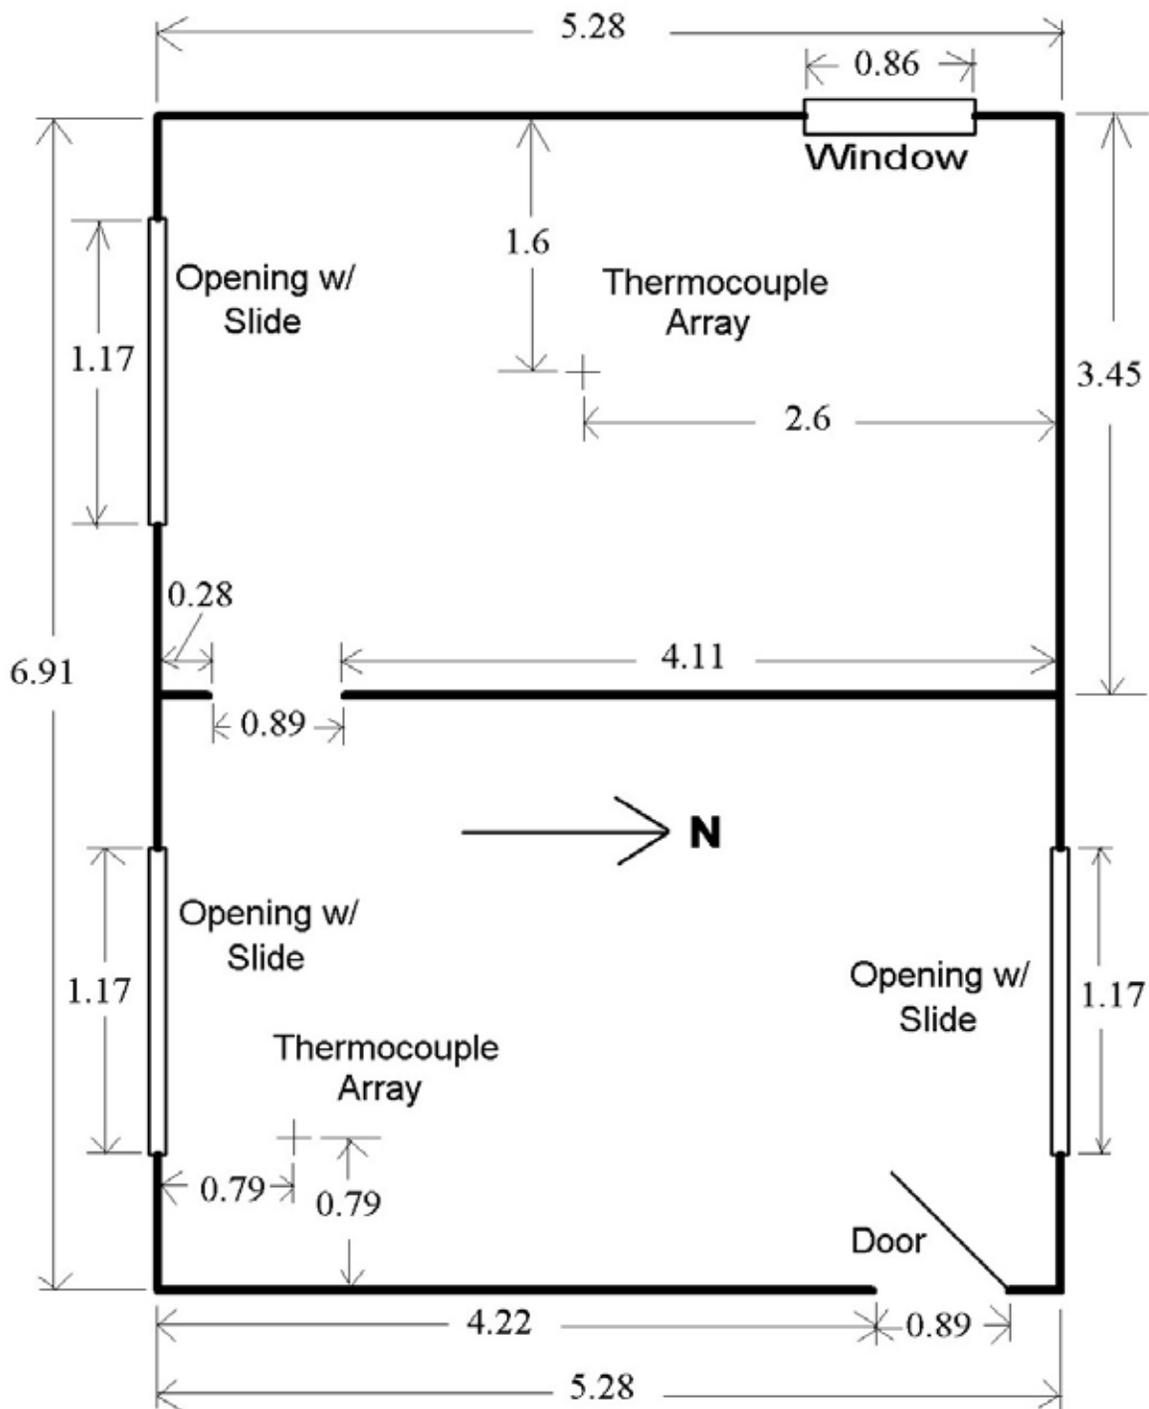
Figure 4. Plan view of generic structure showing locations of measurement instruments and dimensions (all dimensions in m).

Four thermocouple arrays were positioned in each structure to obtain temperature data during the fire test. The first array was located in the living room 0.8 m (2.6 ft) from the front wall and 0.8 m (2.6 ft) from the adjacent wall. The second thermocouple array was placed in the rear room between the two beds, 1.6 m (5.3 ft) from the rear wall and 2.6 m (8.6 ft) from the north wall. These arrays had Chromel-Alumel (Type K)¹ thermocouples located at 25 mm (1 in), 0.3 m (1 ft), 0.6 m (2 ft), 0.9 m (3 ft), 1.2 m (4 ft), 1.5 m (5 ft), 1.8 m (6 ft), and 2.1 m (7 ft) below the ceiling. Two thermocouple arrays were located in the attic space along the attic centerline that ran parallel to the front wall of each structure. These arrays were located 0.8 m (2.6 ft) from either gabled end of each structure. The attic arrays had thermocouples located at 25 mm (1 in), 0.2 m (0.5 ft), 0.3 m (1 ft), 0.5 m (1.5 ft), 0.6 m (2 ft), 0.8 m (2.5 ft), 0.9 m (3 ft), and 1.1 m (3.5 ft) below the attic peak (Figure 11).

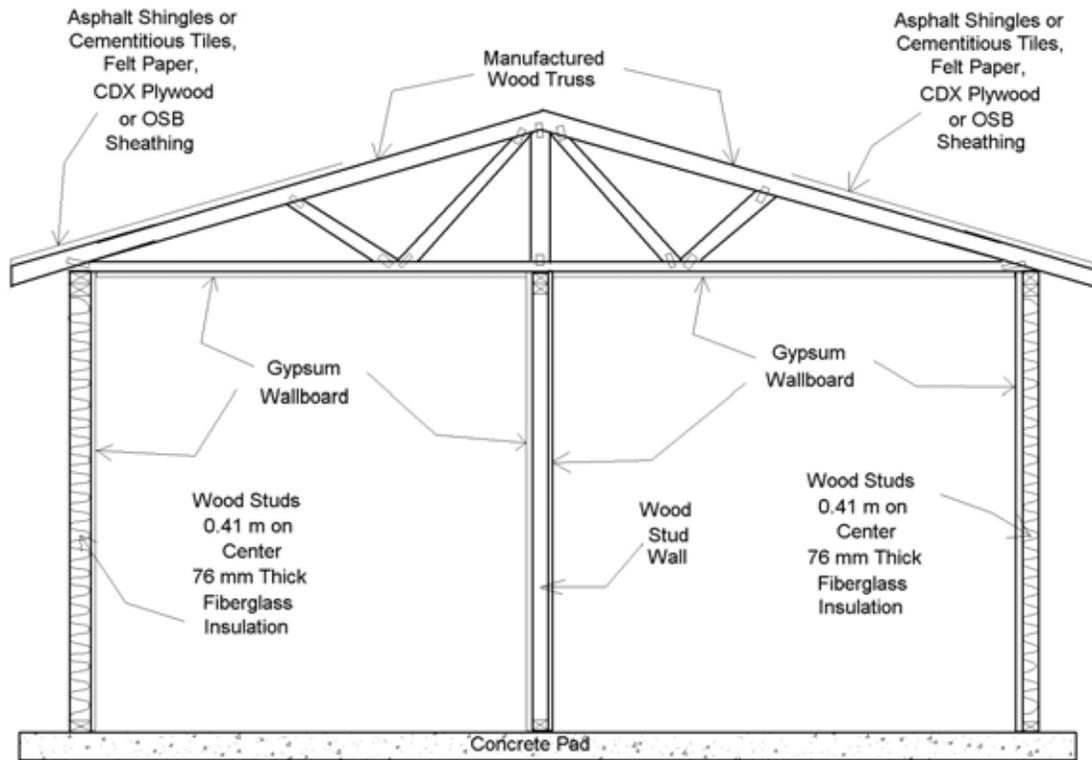
Figure 5. Diagram showing typical construction of the structure.

The roof system was built with manufactured trusses on 0.6 m (2 ft) centers (Figure 5). The gable ends were studded with 51 mm (2 in) by 76 mm (3 in) lumber and covered with 12.7 mm (½ in) high density fiberboard. The trusses were nailed on each end and attached to the top plate with metal hurricane ties. All structures had 2 x 6 boards nailed to the truss tails and the tails on the trusses were cut off at 0.5 m (1.7 ft). The outside rafts were nailed to 2 x 4 boards and attached to the second truss at 1.2 m (4 ft) intervals.

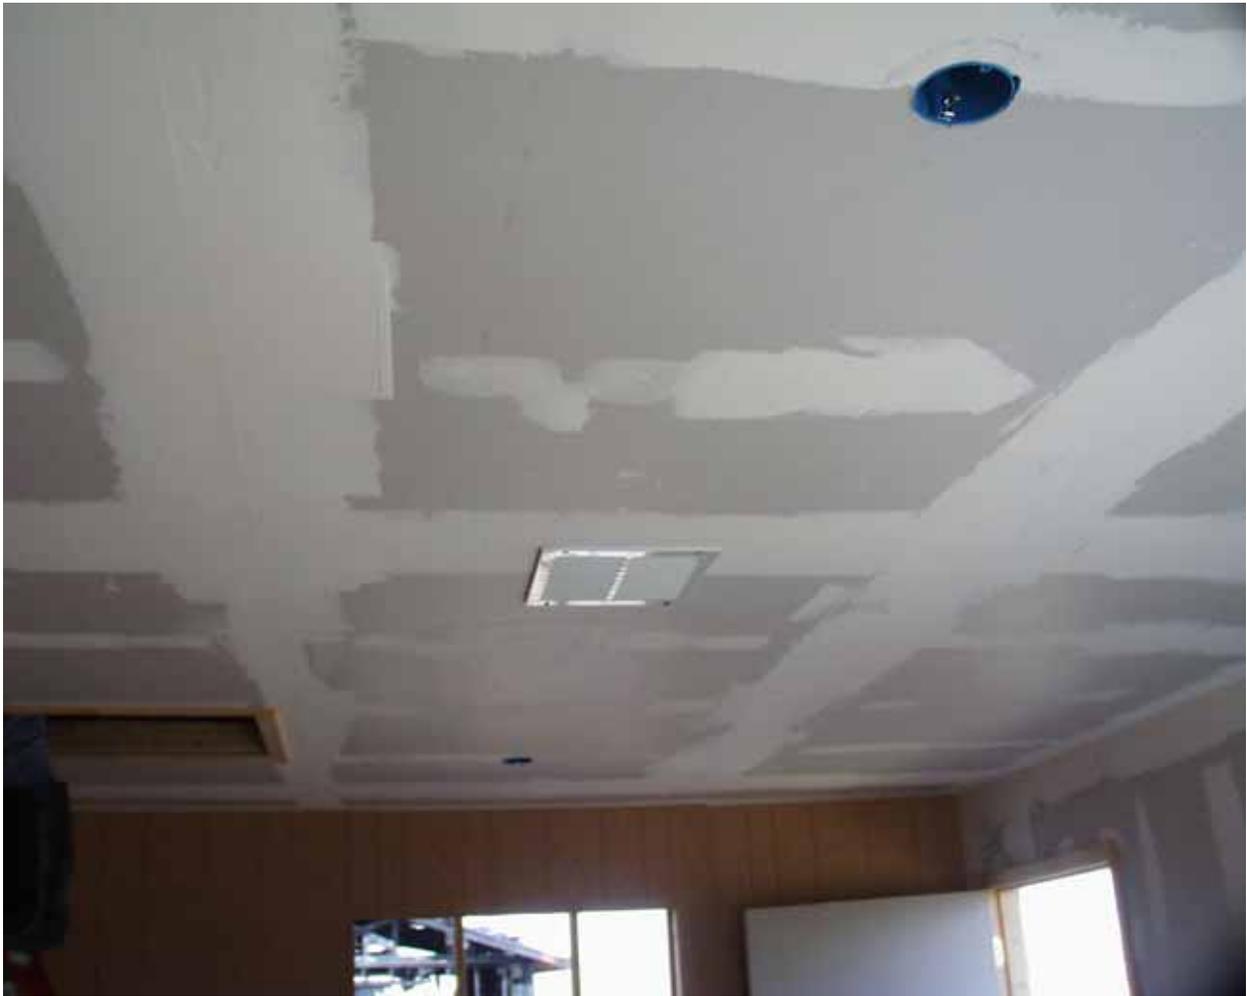
Figure 6. Photograph showing “living room” ceiling with ceiling louvers, electrical boxes, and attic access.

A 1.5 m (5 ft) long base cabinet made of particle board and a counter top were placed along the front wall of the living room. A second 1.5 m (5 ft) long cabinet was nailed to the wall above the first cabinet. Electrical outlet boxes were installed in the walls at various locations throughout the two rooms. A 0.3 m (0.8 ft) by 0.3 m (0.8 ft) hole was cut in the center of the ceiling in the living room and covered with a plastic grill to simulate a vent. The location of this vent was selected to facilitate fire spread into the attic space. A 0.6 m (2 ft) by 0.8 m (2.5 ft) hole was cut in the ceiling of the living room to allow access to the attic space. This opening was covered with a 12.7 mm (½ in) piece of drywall held in place using wood molding strips (Figure 6).

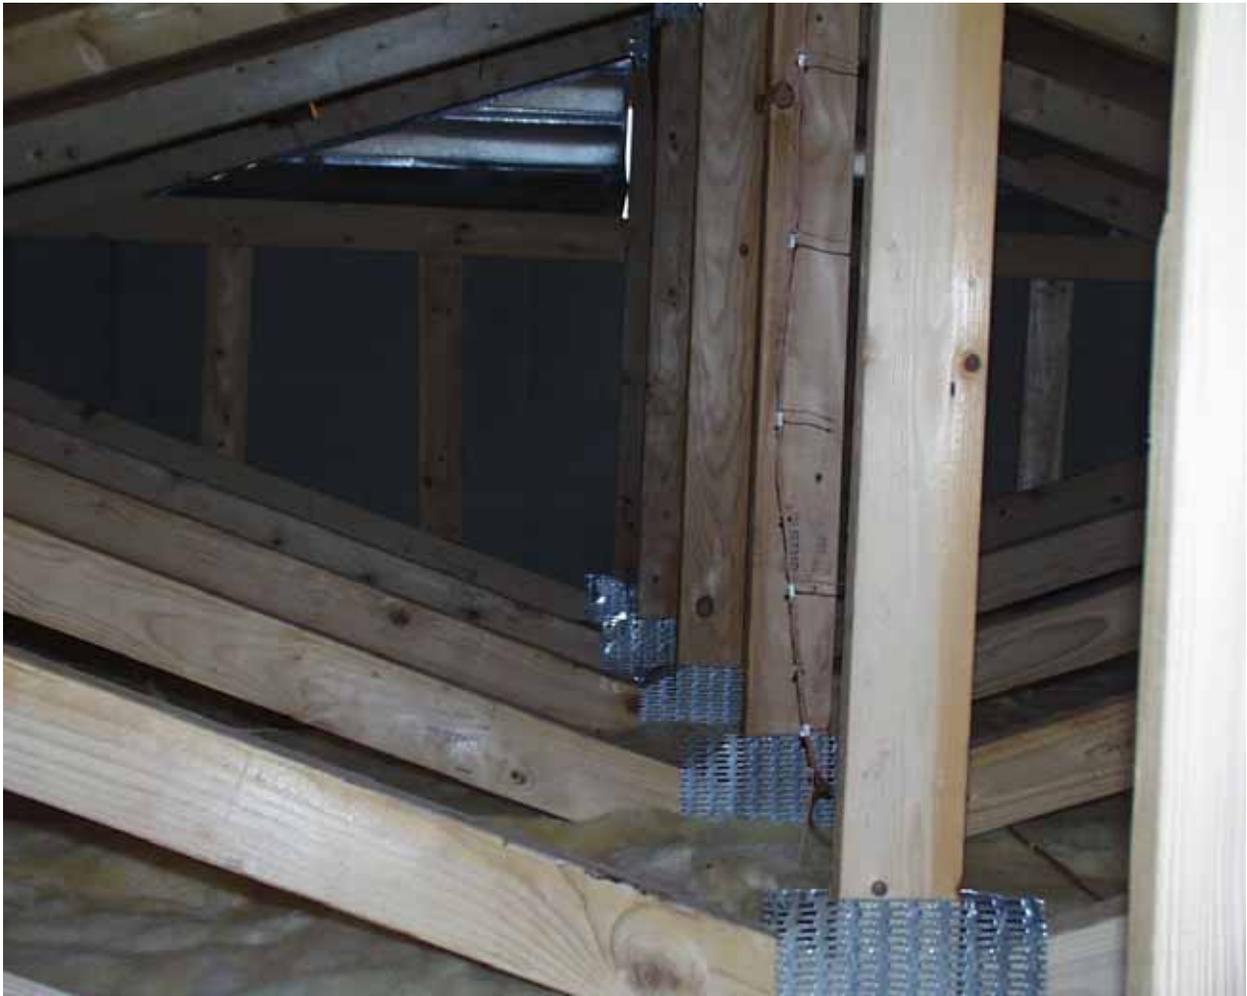
Figure 11. Photograph showing trusses supporting the roof structure with thermocouple array visible in front of second vertical wood member.

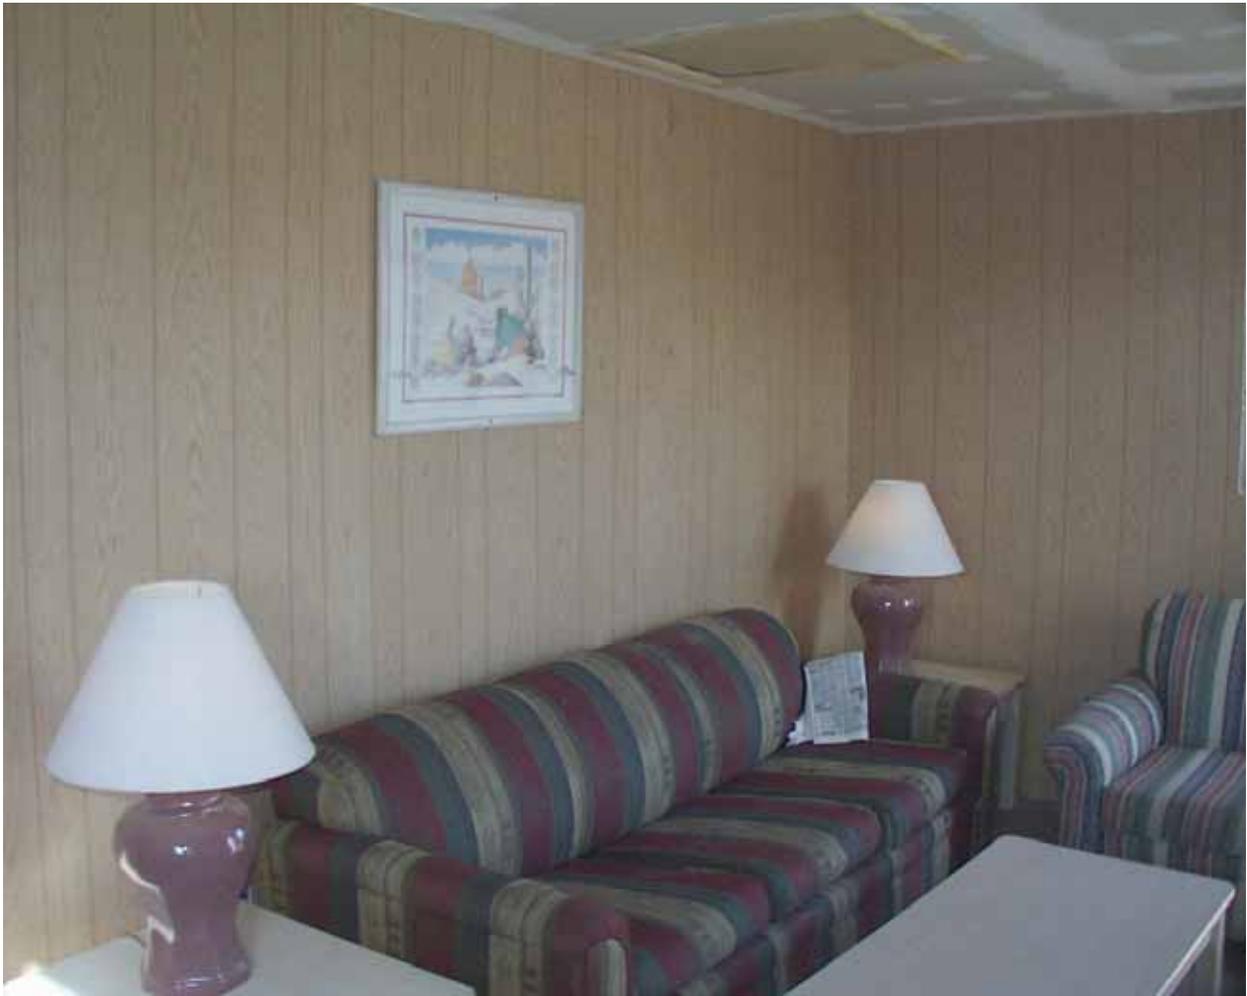
Figure 12. Photograph of “living room” showing ignition location in corner of couch under newspaper.

Two fires were ignited simultaneously in each structure using electric matches. Electric matches are matchbooks with a short length of Ni-Chrome wire wrapped around the match heads. When a small electric current passes through the wire, the wire heats up and ignites the matchbook. One electric match was placed in a slit in the couch in the front room and covered with paper towels and newspaper (Figure 12). A second electric match was positioned in a slit in the chair in the back room and covered with paper towels and newspaper (Figure 13).

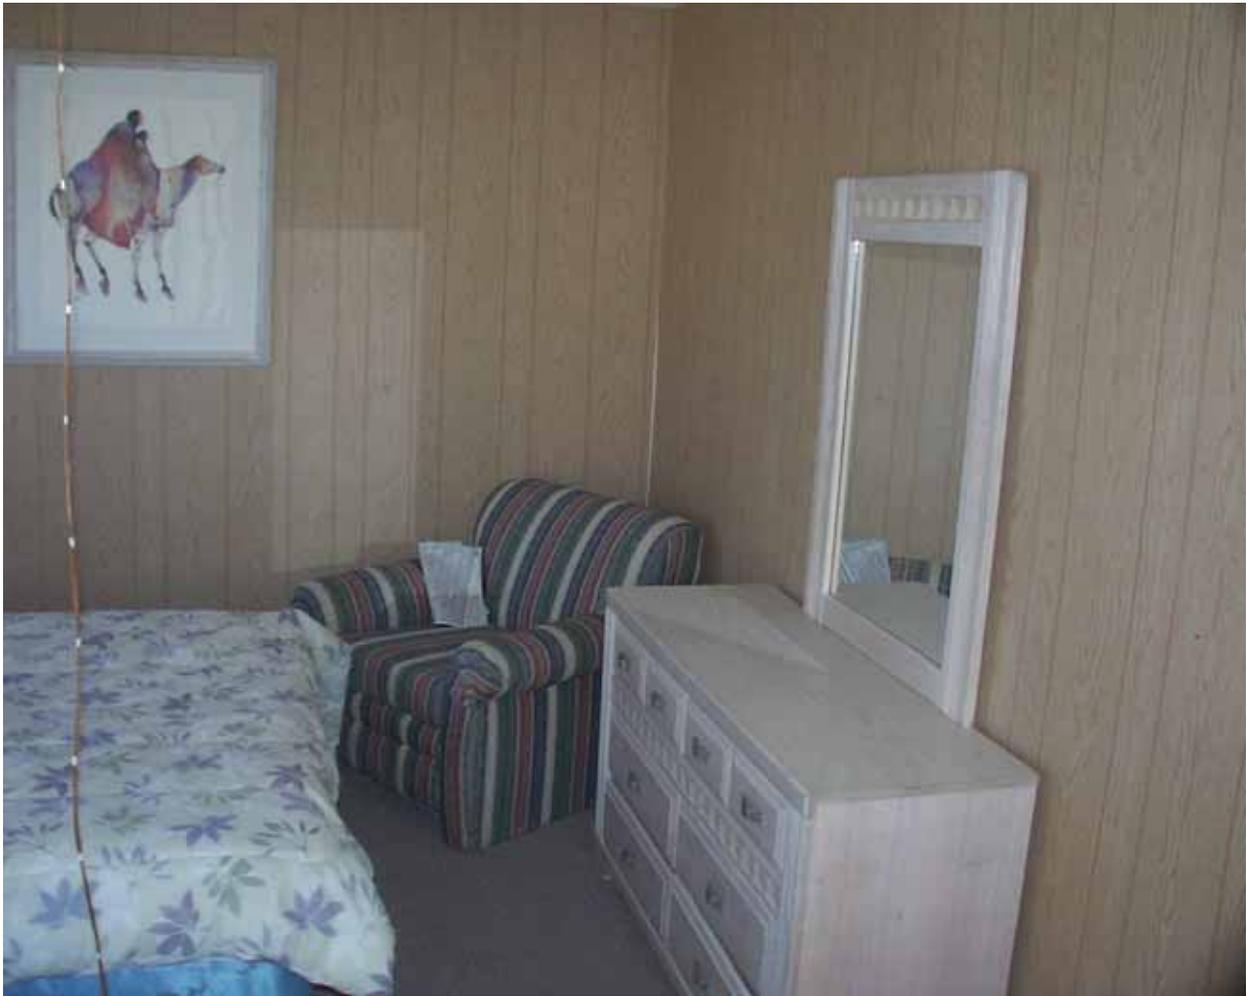
Figure 13. Photograph showing “bedroom” with ignition location in corner of chair under the newspaper.

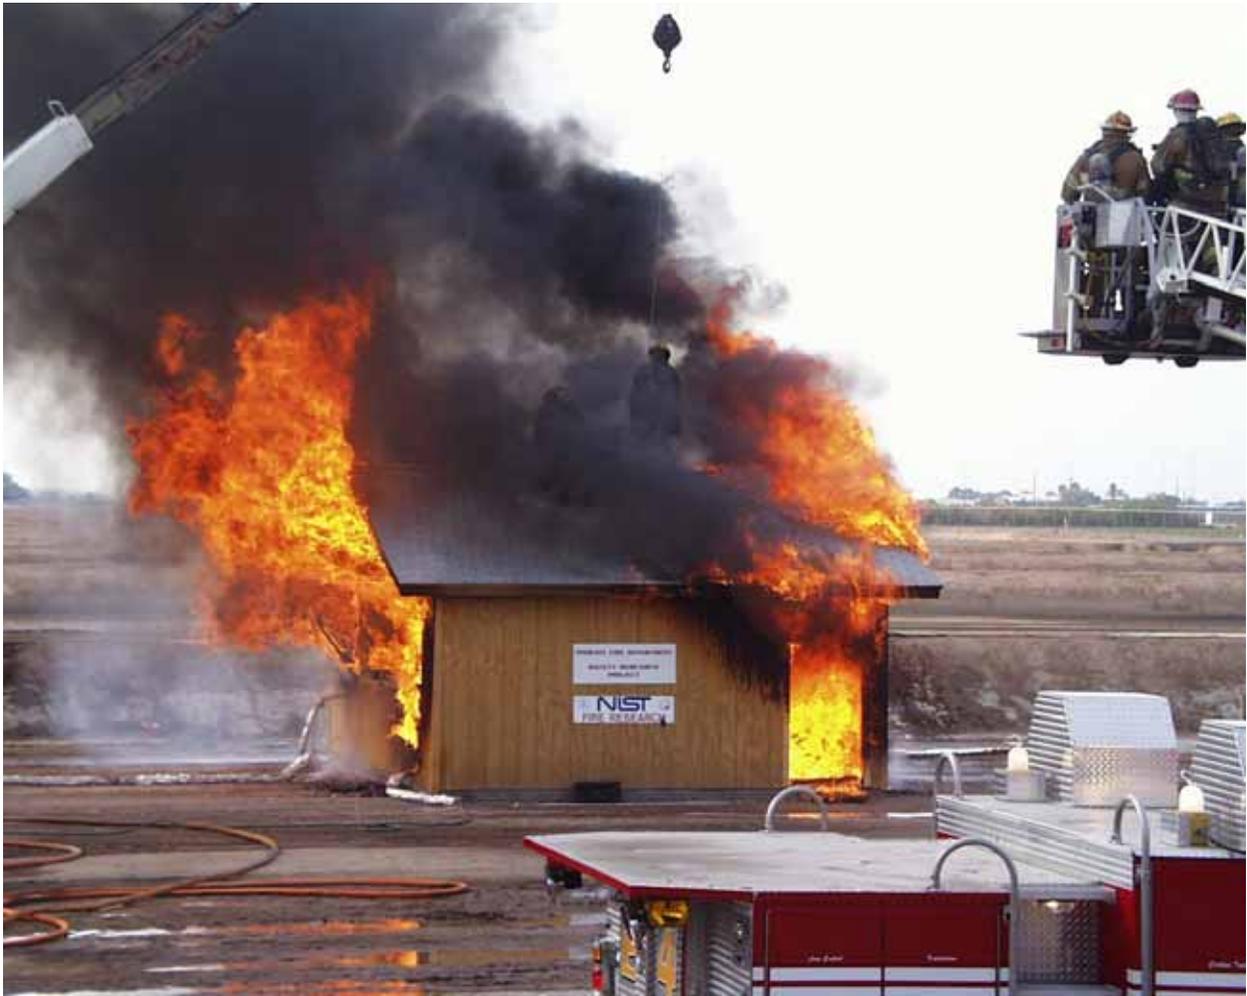
Figure 21. Photograph of test structure at 900 s after ignition when front door has burned away.

combination of water and a fire suppression foam agent. The test sequence is depicted in Figures 14 through 24.

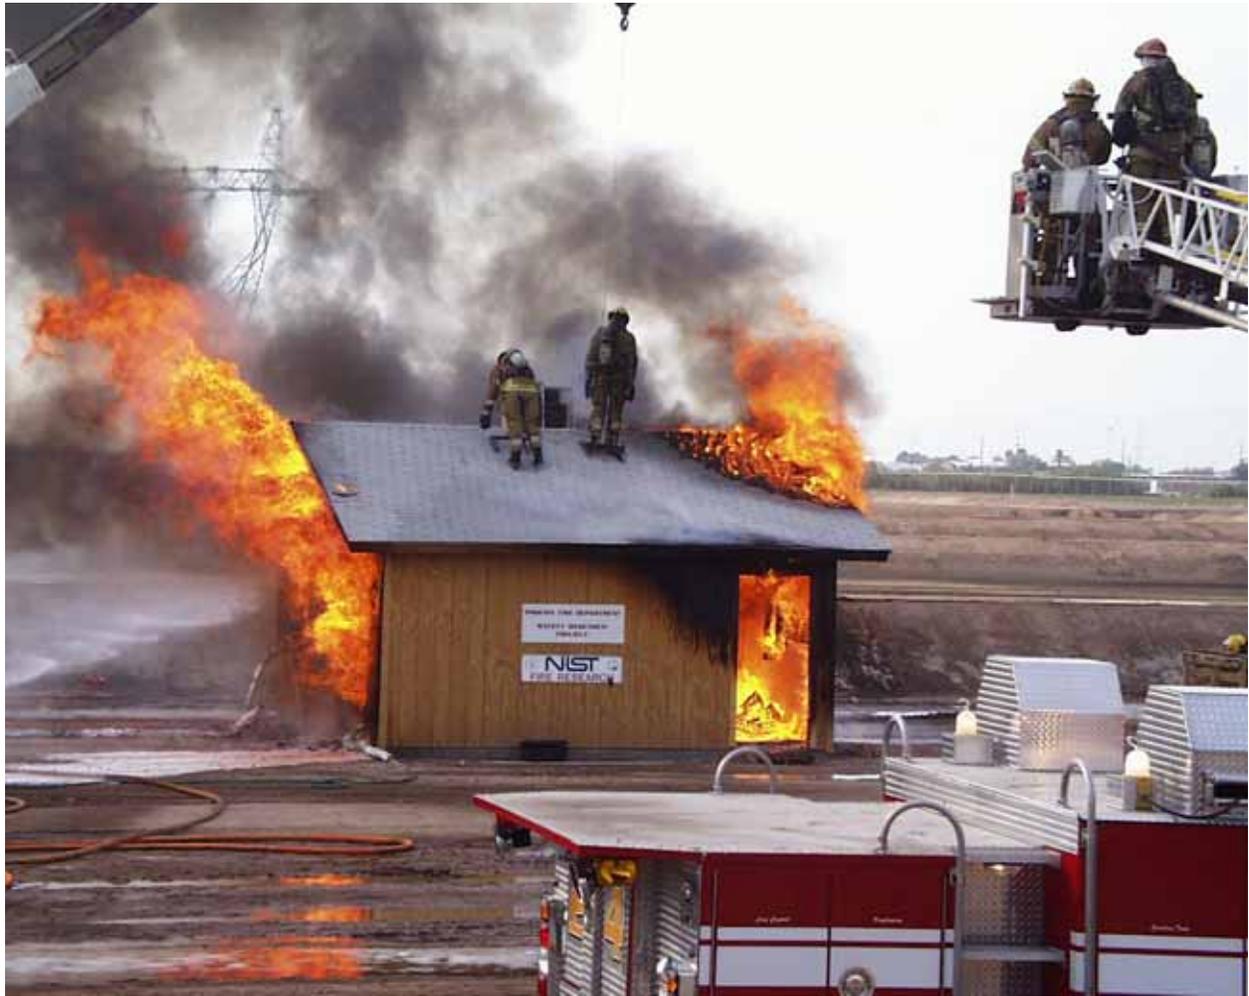
Figure 22. Photograph of test structure at 960 s after ignition with portion of roof structure burning.

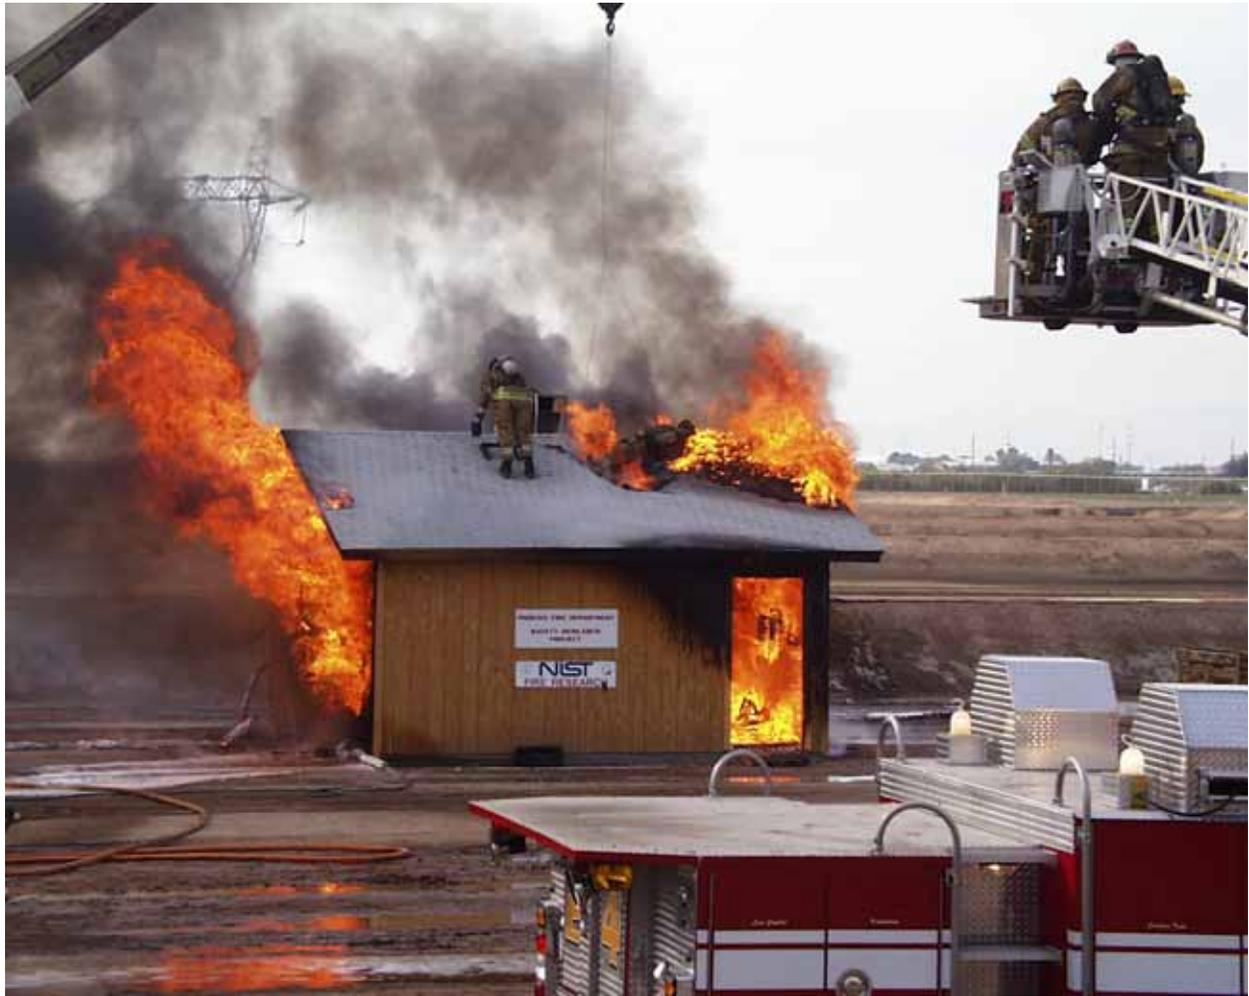
Figure 23. Photograph of test structure at 1010 s after ignition as collapse is starting.

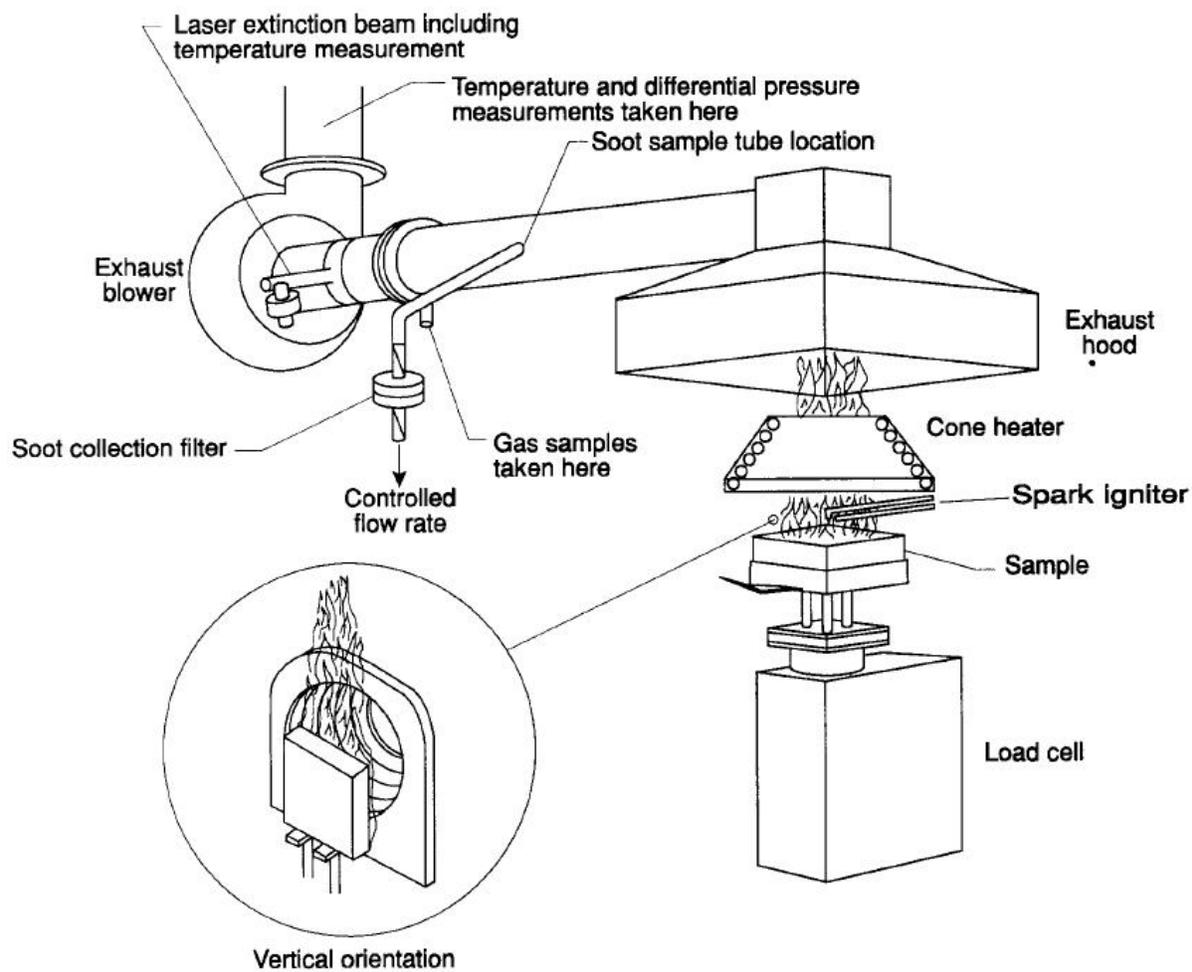
Figure 25. Schematic drawing of the cone calorimeter.

The cone calorimeter consists of a heater, spark ignitor, sample holder, and load cell located underneath an exhaust hood (Figure 25). Typically, the sample is located in the open with free access of air to the combustion zone. The heater consists of a 5-kW electrical heating element inside an insulated stainless-steel conical shell. Samples can be tested in either a horizontal or vertical orientation. When tests are performed in the horizontal configuration, the specimen is positioned approximately 25 mm (1 in) beneath the bottom plate of the cone heater. Flames and products of combustion pass through a circular opening at the top of the heater. The heater can expose samples to a maximum irradiance of approximately 100 kW/m².

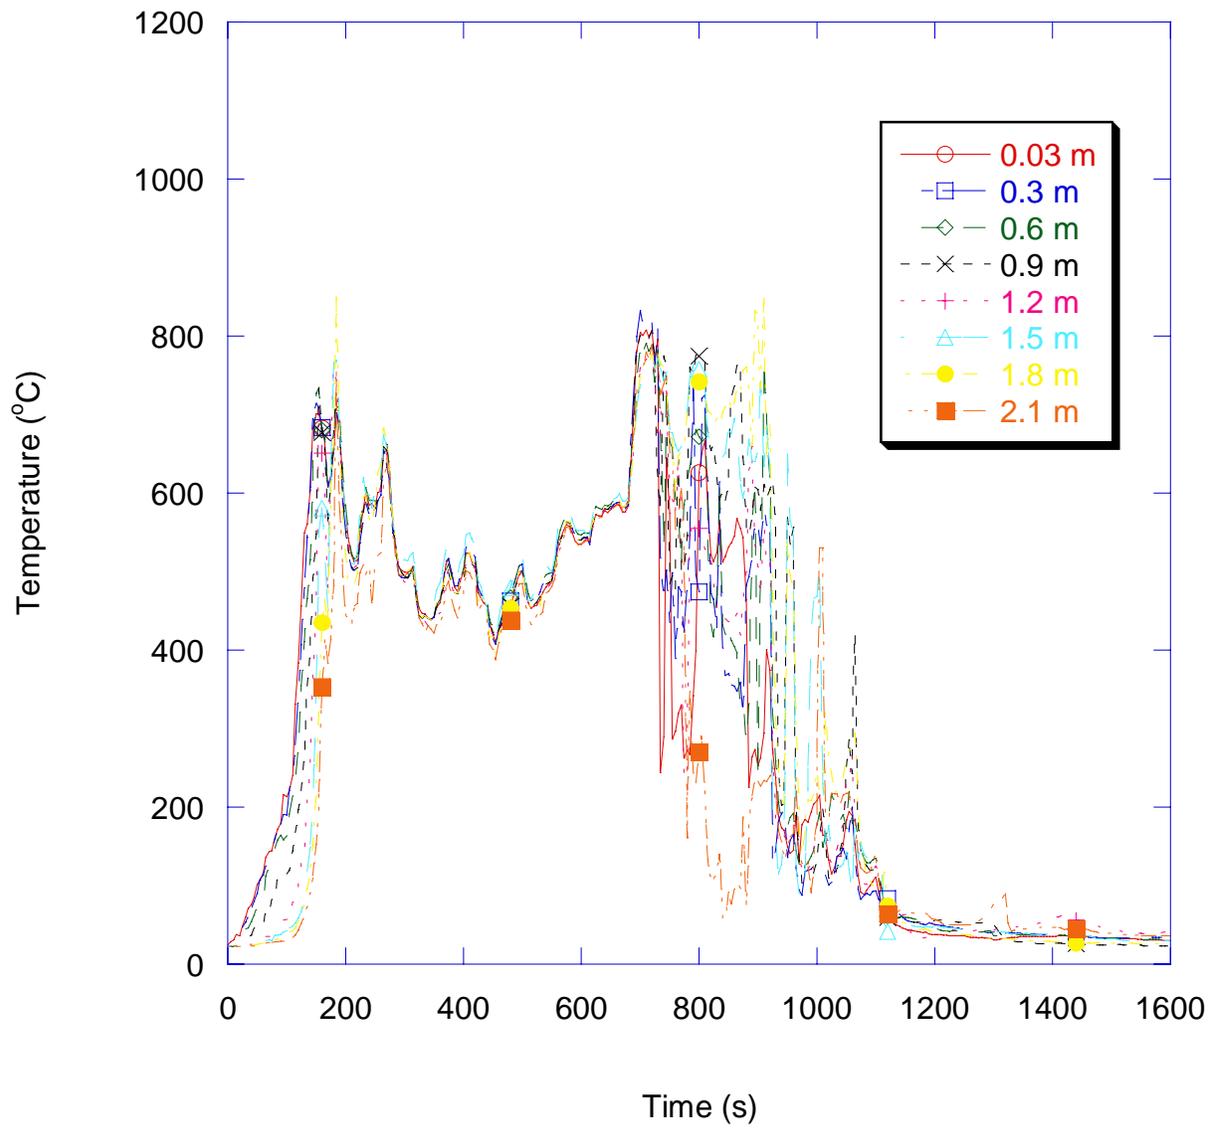
Figure 26. Graph showing temperatures measured in the living room during the first test (distances measured from ceiling downward).

The temperature histories obtained for the first test are shown in Figures 26 through 30. As the fire in the living room grows to flashover, the stratified fire environment is evident from the distinct temperature histories obtained at the eight sampling locations (Figure 26). At about 200 s, the temperature plots indicate a “well stirred environment” with an average temperature of about 500 °C (930 °F). The fire in the bedroom takes longer to reach flashover temperatures; it reaches that point at about 420 s. At this point, the environment becomes well mixed with a temperature of about 600 °C (1100 °F) (Figure 27). Both the north (Figure 28) and south (Figure 29) thermocouple arrays in the attic indicate a stratified environment until about 700 s. The two peaks evident in both figures, one at about 180 s and the second at 200 s to 250 s, are most likely the result of periodic flame penetration into the attic space through the ceiling penetrations (Figure 6). At about 700 s, flashover appears to have occurred in the attic with the environment becoming well mixed at an average temperature of 750 to 800 °C (1380 to 1470 °F). The temperature plots suggest that some portions of the ceiling begin failing at about 800 s. In addition, the front door failed at about 840 s. The roof begins to collapse at 1050 s and suppression is started at 1120 s. The temperature data obtained on the roof surface beneath the fire fighter mannequin boots during the fire test is shown in Figure 30. Once flashover occurs in the attic at about 700 s, the temperatures under the boots increase rapidly to 800 °C (1470 °F), approximately the temperature within the attic space. Subsequently, the temperatures decrease correspondingly with decreasing temperatures within the attic space, possibly the result of failure of the ceiling. The temperatures gradually increase until roof collapse at which point the mannequins become surrounded by flames until their removal.
