NISTIR 7094

Structural Collapse Fire Tests: Single Story, Wood Frame Structures

Structural Collapse Fire Tests: Single Story Wood Frame Structures

A series of fire tests was conducted in Phoenix, Arizona to collect data for a project examining the feasibility of predicting structural collapse. The fire test scenario was selected as part of a training video being prepared by the Phoenix, Arizona Fire Department. Multiple fires were started in each structure to facilitate collapse; the fires were not intended to test the fire endurance of the structures. Four structures with different roof constructions were used for the fire tests. Temperatures were measured as a function of time in four locations within each structure. Furniture items were placed in the front and back of each structure to simulate living room and bedroom areas. The living room and bedroom areas of each structure were ignited simultaneously using electric matches. Peak temperatures obtained during the tests ranged from approximately 800 °C (1500 °F) to 1000 °C (1800 °F). The roof of each structure collapsed approximately 17 minutes after ignition. In addition to the full scale tests, the plywood and oriented stra

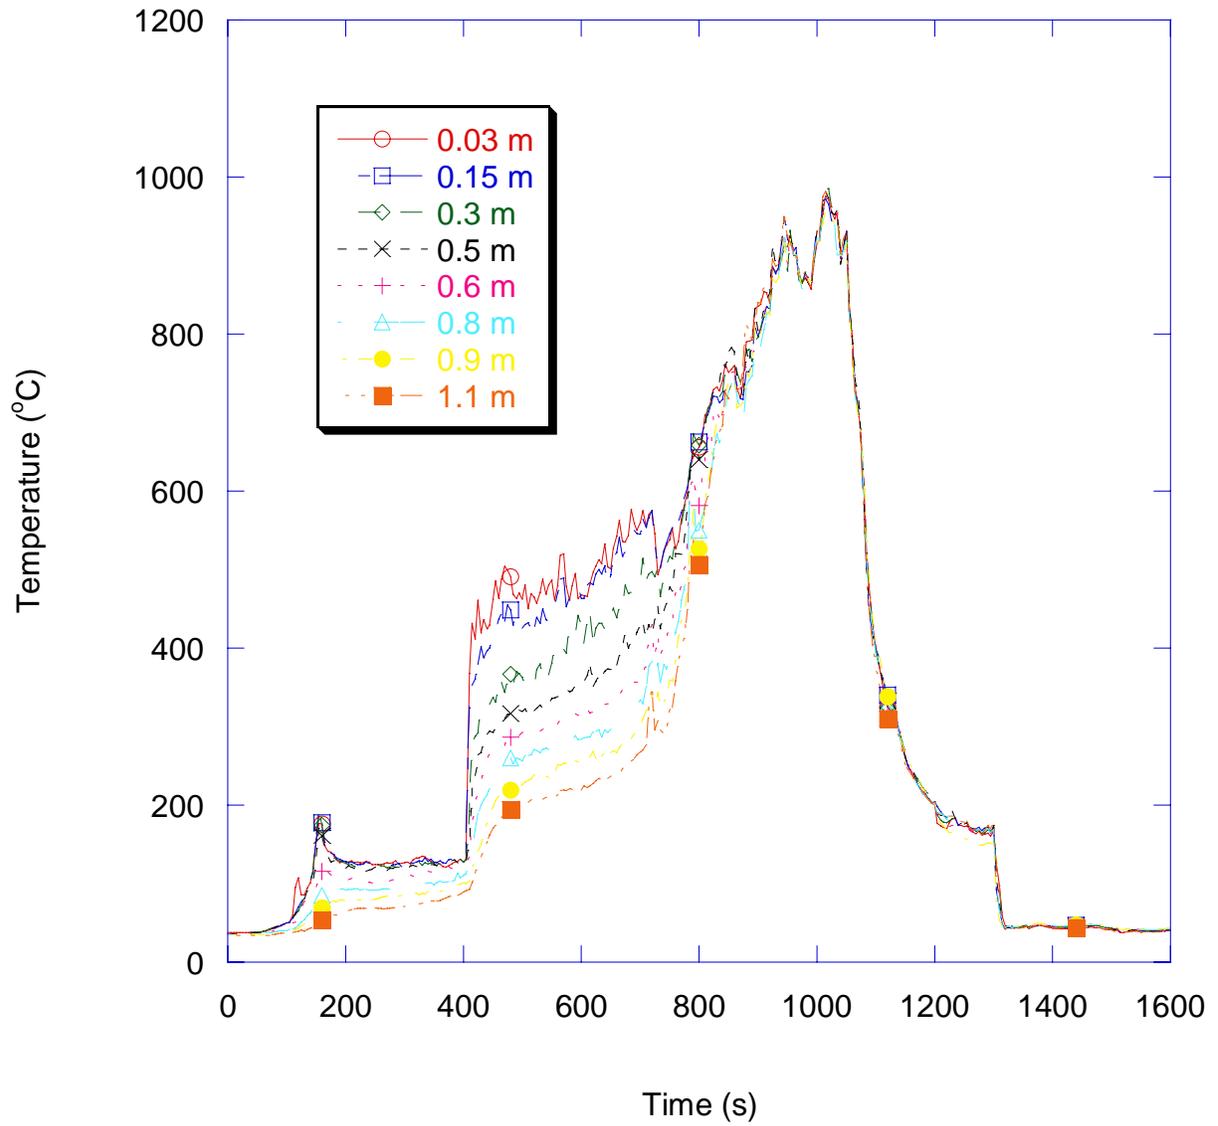
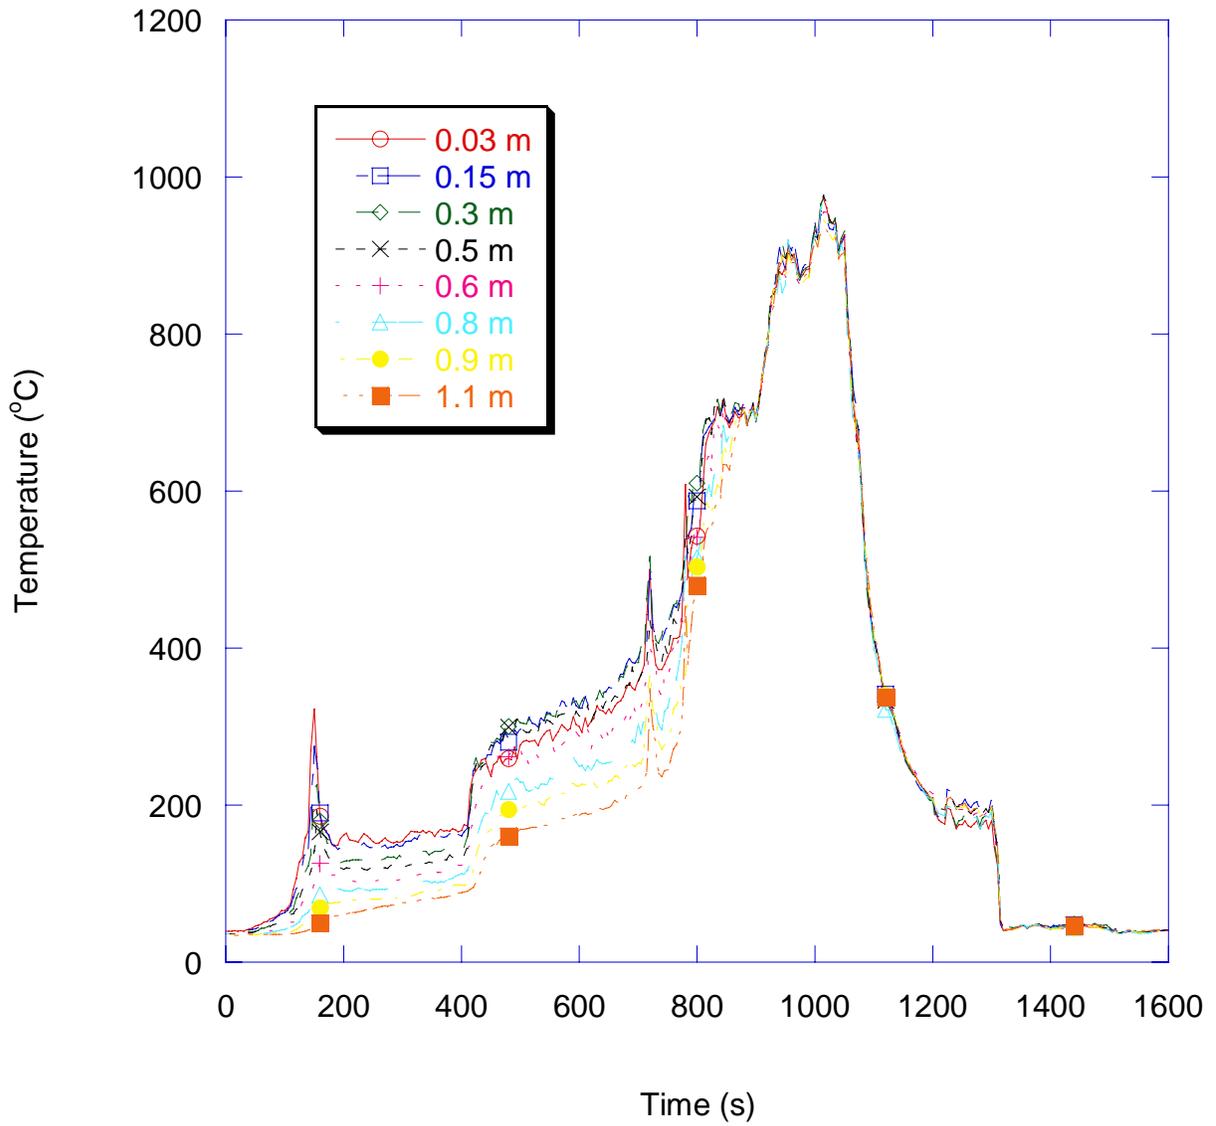
Figure 33. Graph showing temperatures measured in the north portion of the attic during the second test (distances measured from roof peak downward).

Figure 34. Graph showing temperatures measured in the south portion of the attic during the second test (distances measured from roof peak downward).

The temperature histories obtained for the second test are shown in Figures 31 through 35. In the living room, the fire grows to a temperature indicative of impending flashover, approximately 600 °C (1100 °F) within 180 s after ignition. After this initial period, the fire environment becomes stratified with a temperature gradient of 300 °C (570 °F) to 550 °C (1020 °F) for a period of about 180 s (Figure 31). At approximately 350 s after ignition, the entire living room area appears to flashover with a peak temperature of 700 °C (1300 °F). At this point, the environment in the living room becomes well mixed with a uniform temperature throughout most of the remainder of the test. The decrease in temperature occurring at approximately 400 s is the result of failure of some portion of the living room ceiling. After the fire begins spreading into the attic area, temperatures in the living room begin a steady climb to a peak of 1200 °C (2200 °F). The front door fails at about 840 s leading to a reduction in living room temperatures. Except for a few brief moments, the temperatures in the bedroom area never exceed 600 °C (1110 °F) (Figure 32). With the exception of the point at which the roof section collapsed at 1020 s, the environment in the bedroom remains stratified throughout the duration of the test. The first peak evident in Figures 33 and 34 at 180 s is most likely the result of flames

momentarily extending into the attic area through the ceiling ventilation louvers. A comparison of Figures 33 and 34 suggests that the attic access panel and possibly a portion of the ceiling near the ignition location failed at 400 s. The brief peak in Figure 34 at 725 s is probably the ignition of plastic light boxes in the ceiling. The attic area reaches a flashover condition at about 900 s. A portion of the roof under the fire fighter mannequins collapses approximately 4 min after flashover in the attic area. The temperature data obtained on the roof surface beneath the fire fighter mannequin boots during the fire test is shown in Figure 35. As the attic space approaches flashover conditions at about 800 s, the temperatures under the boots increase to 750 °C (1380 °F). At approximately 1020 s, the roof structure begins to collapse.

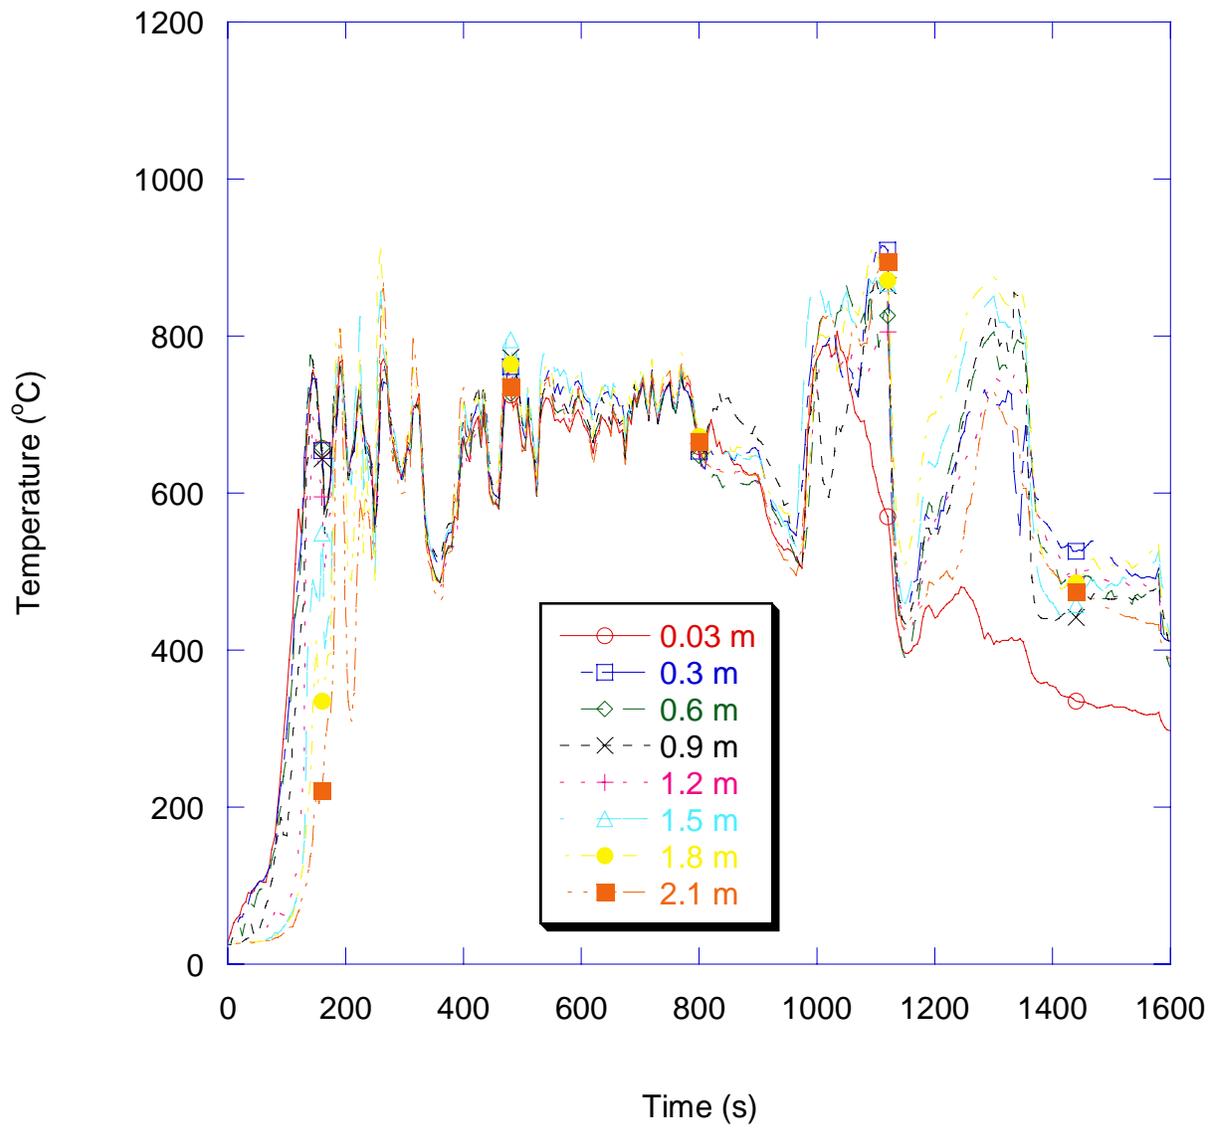
Figure 41. Graph showing temperatures measured in the living room during the fourth test (distances measured from ceiling downward).

The temperature histories obtained for the fourth test are shown in Figures 41 through 45. The temperature data obtained in the living room (Figure 41) indicates that the fire grew rapidly producing temperatures in excess of 600 °C (1110 °F). The environment in the living room remained at flashover temperatures and well mixed until about the time of roof collapse. The environment in the bedroom (Figure 42) remains stratified with a peak temperature of 420 °C (790 °F) until some portion of the ceiling fails at 450 s. After ceiling failure, the temperatures become somewhat erratic varying between 400 °C (750 °F) and almost 800 °C (1470 °F). At approximately 800 s, the temperatures in the bedroom become uniform and decrease then rapidly increase then decrease again. The most likely cause of this phenomenon is failure of additional portions of the ceiling as a result of flashover in the attic space. Temperature increase in both the north (Figure 43) and south (Figure 44) parts of the attic is relatively continuous with only slight discontinuities at about 450 s and 850 s. These discontinuities indicate ignition of materials in

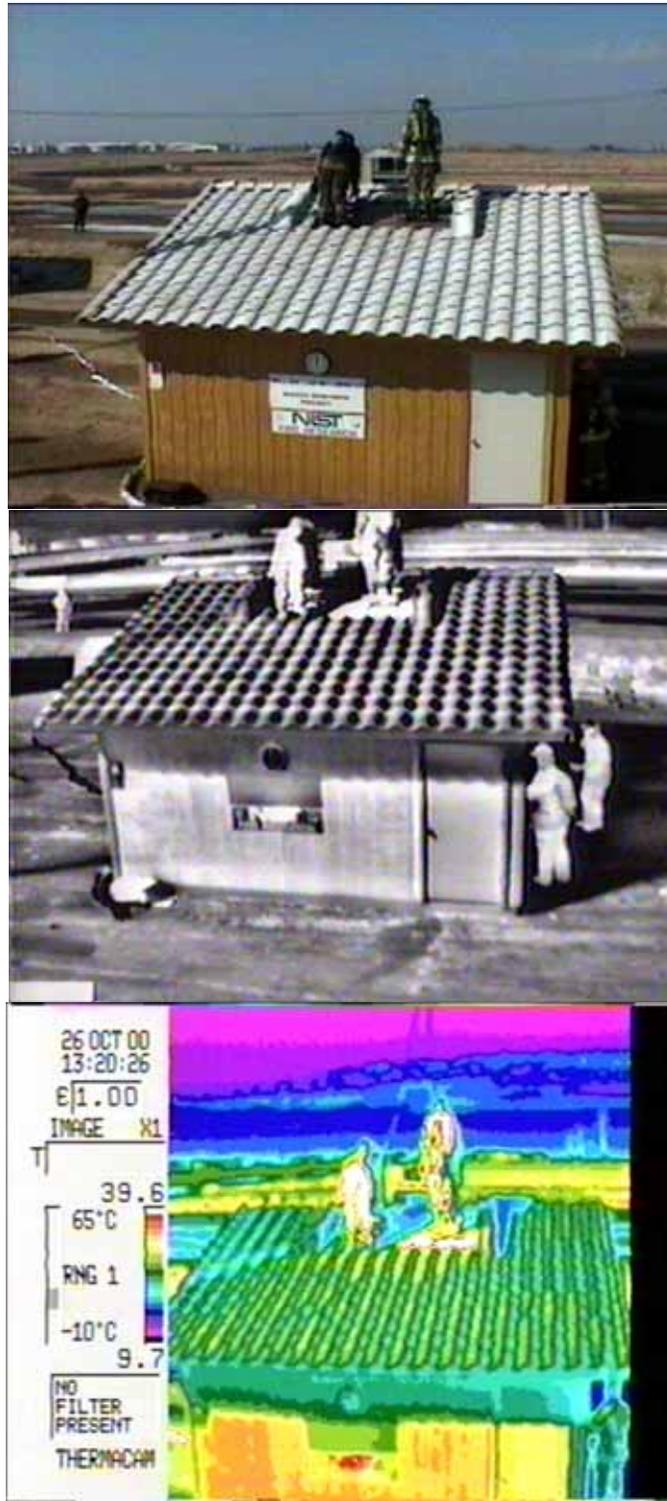
Figure 46. Test 3 shown a few seconds after ignition (top – normal video, middle – fire department thermal imager, bottom – high end, quantitative infrared camera)

During these tests, the standard video camera documented that the roof began to sag or drop slightly just before failing completely. The time between the first appearance of a noticeable depression on the roof and the complete collapse of the roof appeared too short to allow any personnel on the roof to escape safely. The thermal images provided by the infrared cameras were also examined for evidence of an imminent collapse. The thermal images did not provide any warning of the roof collapse. The thermal radiation from the smoke plumes on both ends of the roof was radiated back to the surface of the roof. This reradiated energy appeared to wash out any thermal signature of the energy being conducted through the roof. Another factor that could make it difficult to see via thermal imager the energy being conducted through the roof would be the presence of water on the shingles or tiles. During one of the experiments, the fire department attempted to cool the boom of the extraction crane and the wind carried some of the water droplets onto one side of the roof. The temperature of the roof appeared to decrease, and the temperature difference across the wetted portion of the roof disappeared. The presence of hot smoke plumes or water from suppression activity or rain make it very difficult to see the thermal

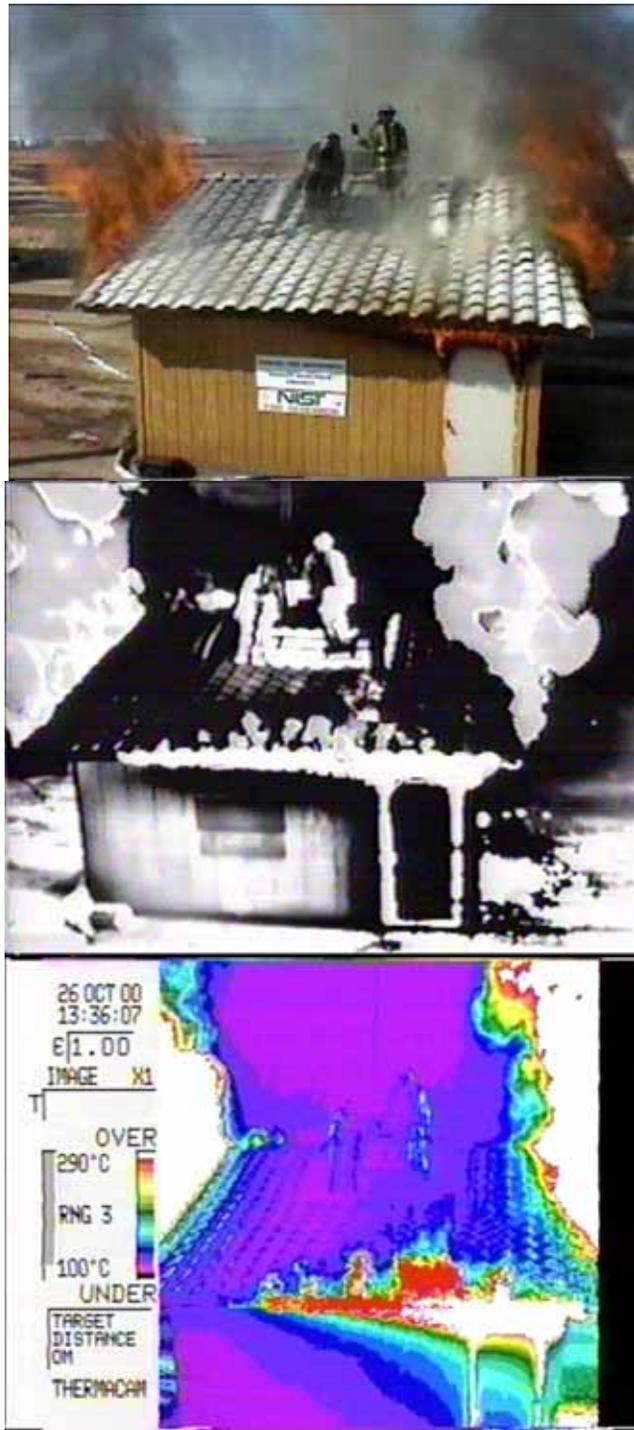
Figure 47. Test 3 shown approximately 10 s before collapse of the roof structure (top – normal video, middle – fire department thermal imager, bottom – high end, quantitative infrared camera)

signature of the fire through the roof. For this limited set of burn experiments, the thermal imagers did not appear to provide sufficient warning to allow fire fighters to escape before the roof collapsed.
