**NISTIR 6959**

# **Structural Collapse Fire Tests: Single Story, Ordinary Construction Warehouse**

David W. Stroup  
Daniel Madrzykowski  
William D. Walton  
William Twilley

May 2003

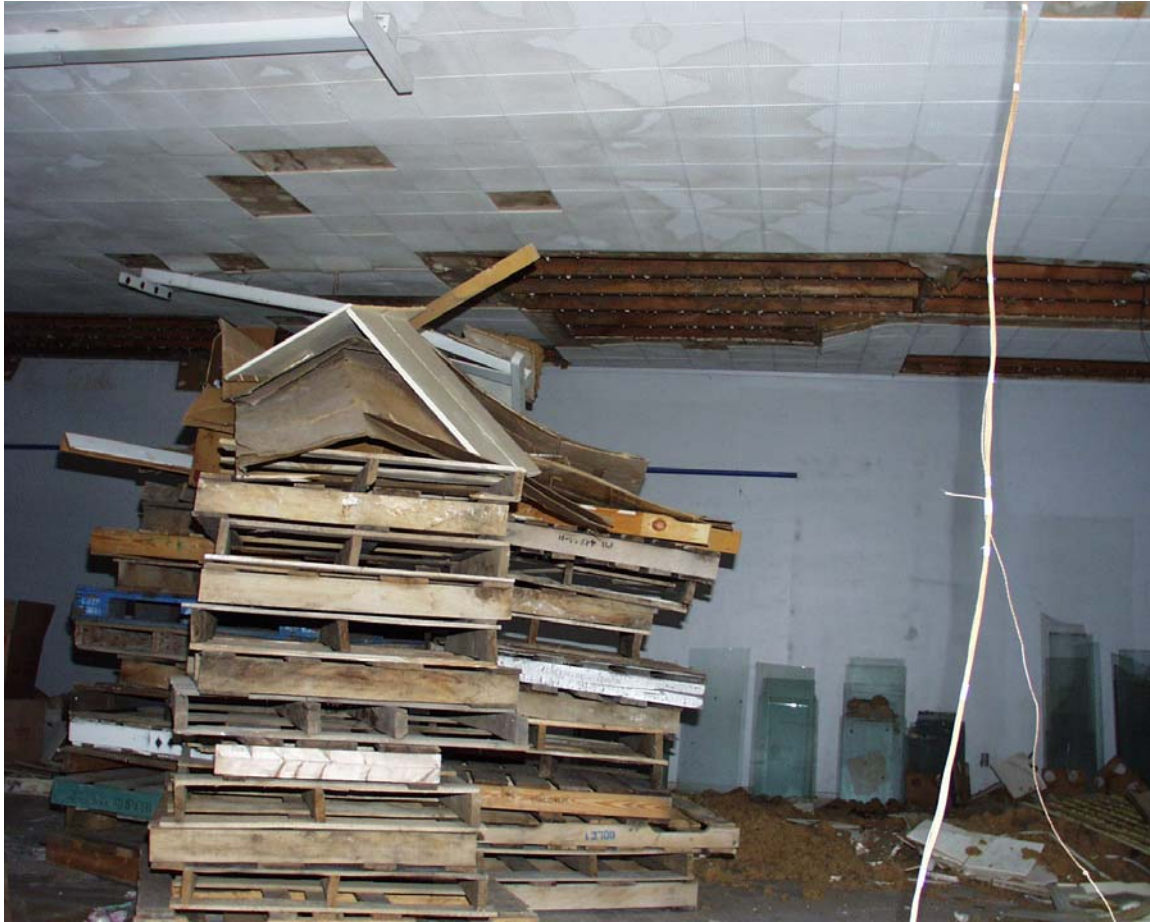
Figure 5. Photograph showing the placement of wood pallets in the front part of the warehouse used for the first test.

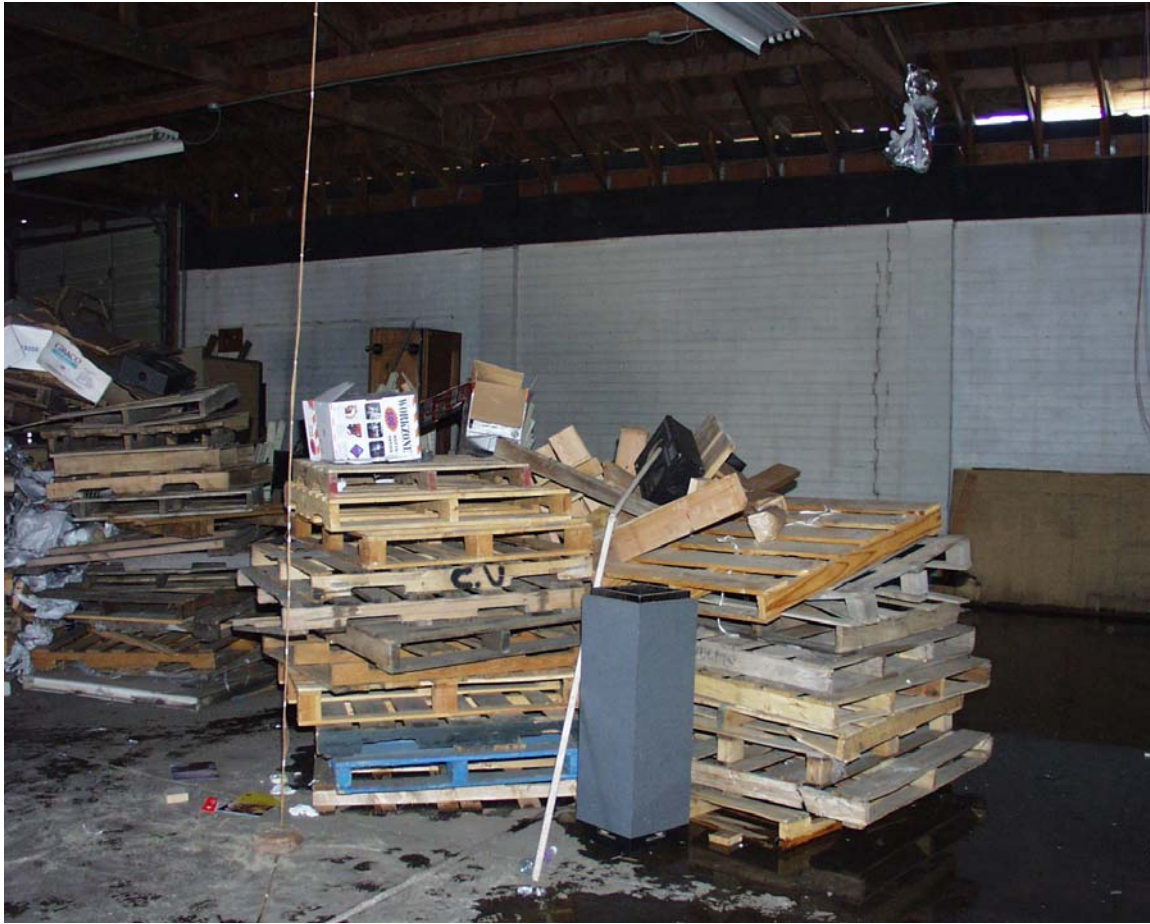
Figure 7. Photograph showing placement of wood pallets and adjacent thermocouple tree in the portion of the warehouse used for the second test.

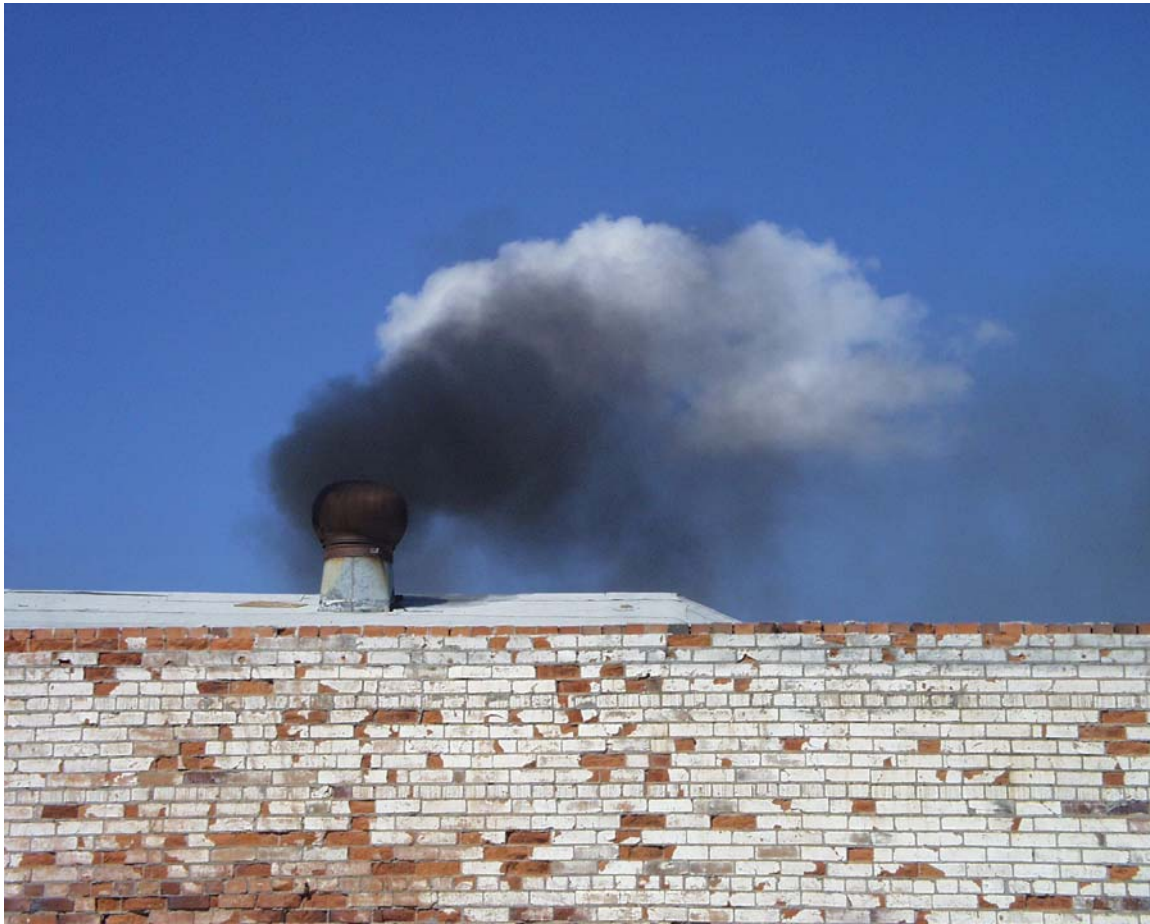
Figure 9. Photograph of smoke coming from roof top ventilator during the first test.

For the first test, the flames reached the top of the pallet stacks 40 s after ignition (Figure 8). Smoke became visible coming from a roof top ventilator approximately 60 s after ignition (Figure 9). At approximately 1  $\frac{1}{2}$  min after ignition, flames had reached the ceiling and started spreading along the underside. The entire array of pallets in the front half of the first burn area was involved in fire within 2 min. Adjacent items began igniting due to radiant energy 2  $\frac{1}{2}$  min after ignition. At 3 min after ignition, flames were observed coming from the roof top ventilator. The roof area around the ventilator started burning at 4 min. About this same time, the interior picture became obscured in smoke and the camera was removed at the 4 min mark. At approximately 4  $\frac{1}{2}$  min after ignition, the heavy smoke coming from the structure began to diminish, and the roof fires were mostly out by 5 min after the start of the test (Figure 10). As the test measurements indicated the fire was becoming oxygen deficient, the glass in the front door was removed at 8 min to provide additional oxygen for the fire.

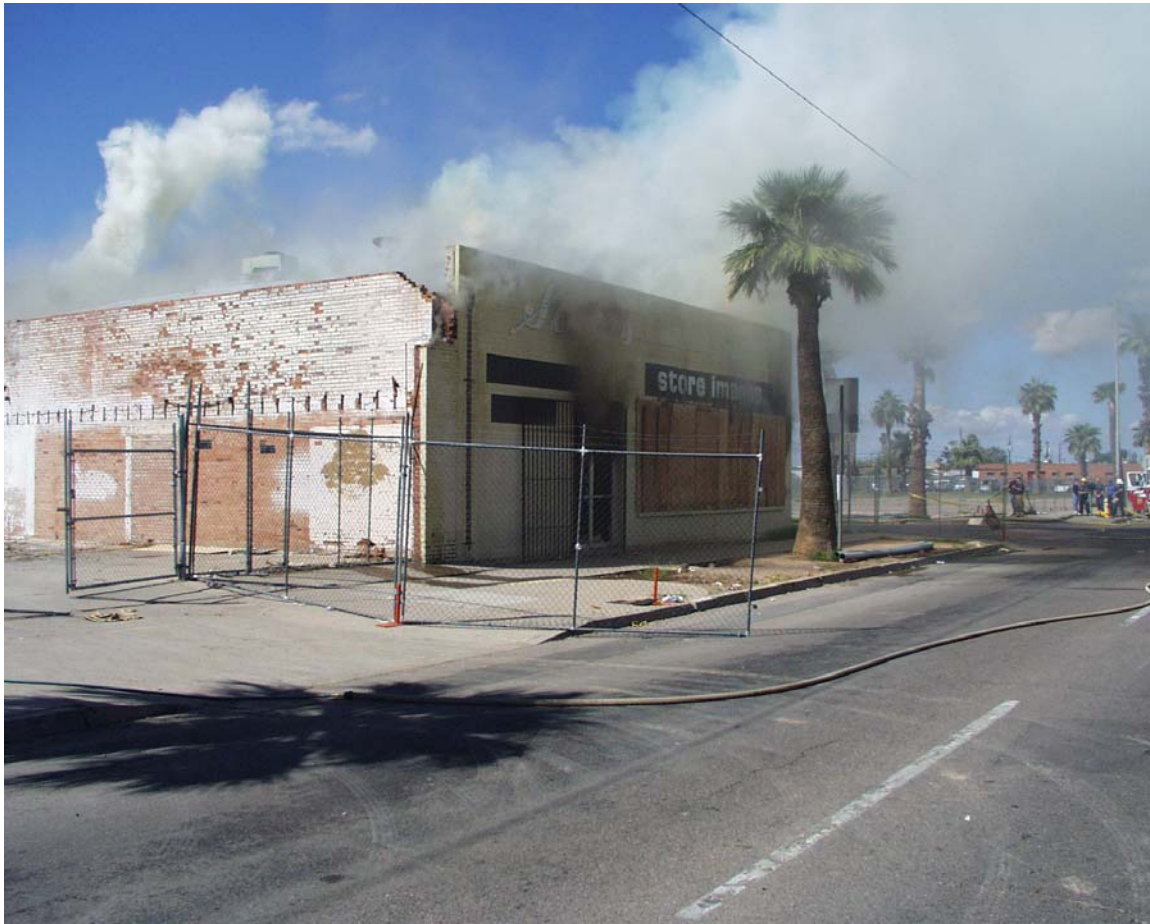
Figure 10. Photograph showing smoke coming from roof and front of warehouse as fire is becoming oxygen deficient during the first test.

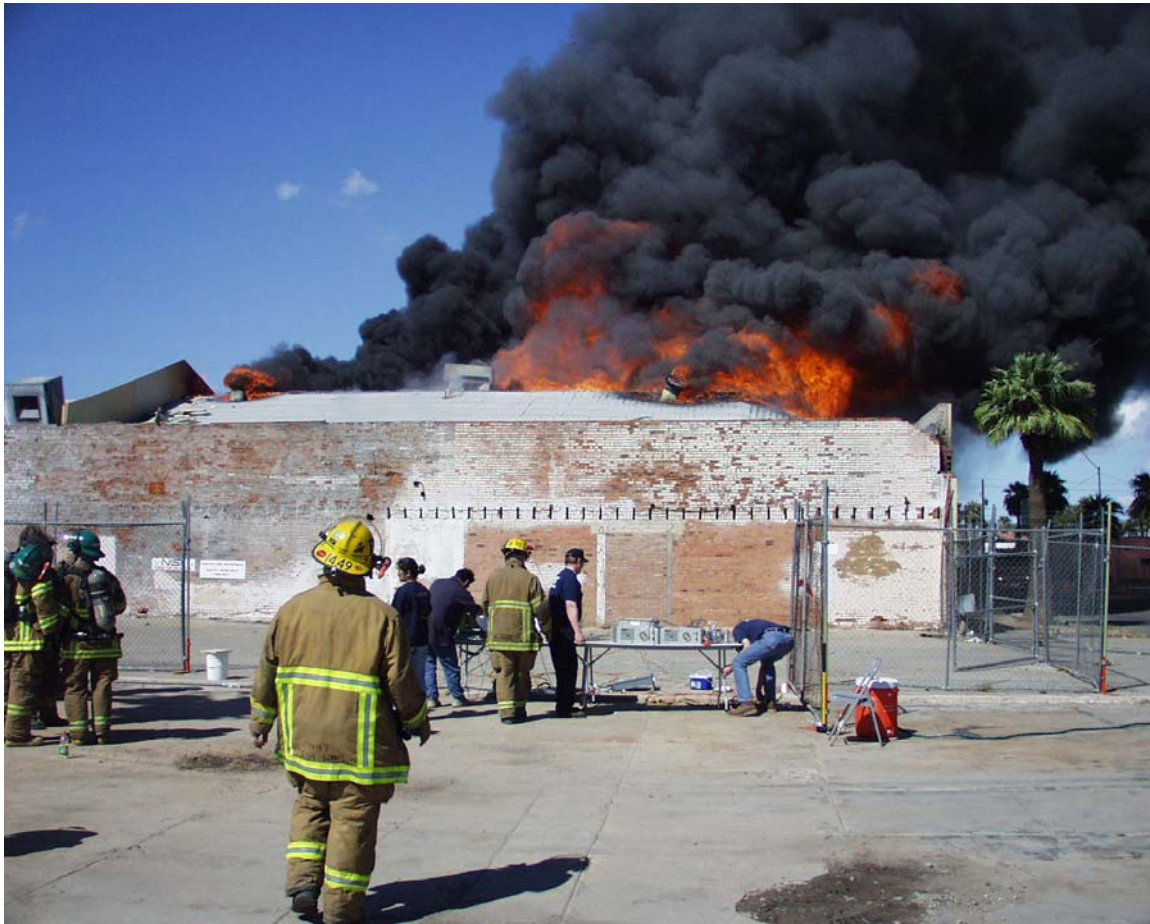
Figure 11. Photograph showing fire involving significant portion of roof structure with partial collapse beginning.

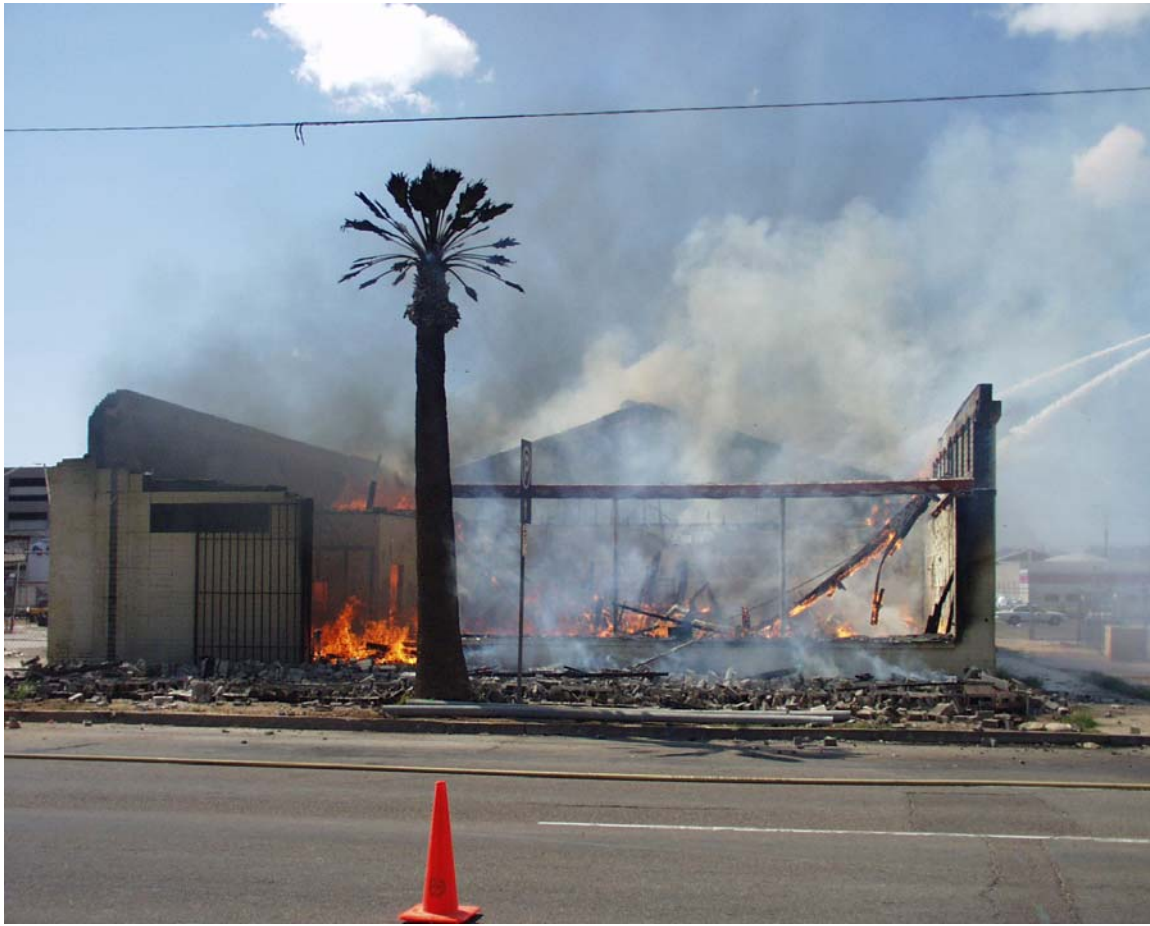
Figure 12. Photograph showing the warehouse at the conclusion of the first test with the roof structure over the front half completely gone.

the front windows had started burning and had fallen out of the windows. One minute later, the upper portion of the front wall collapsed into the street. At 23 min, the east section of the roof between the trusses 18 m (60 ft) and 23 m (75 ft) from the front wall collapsed. The test was terminated approximately 25 min after ignition (Figure 12).

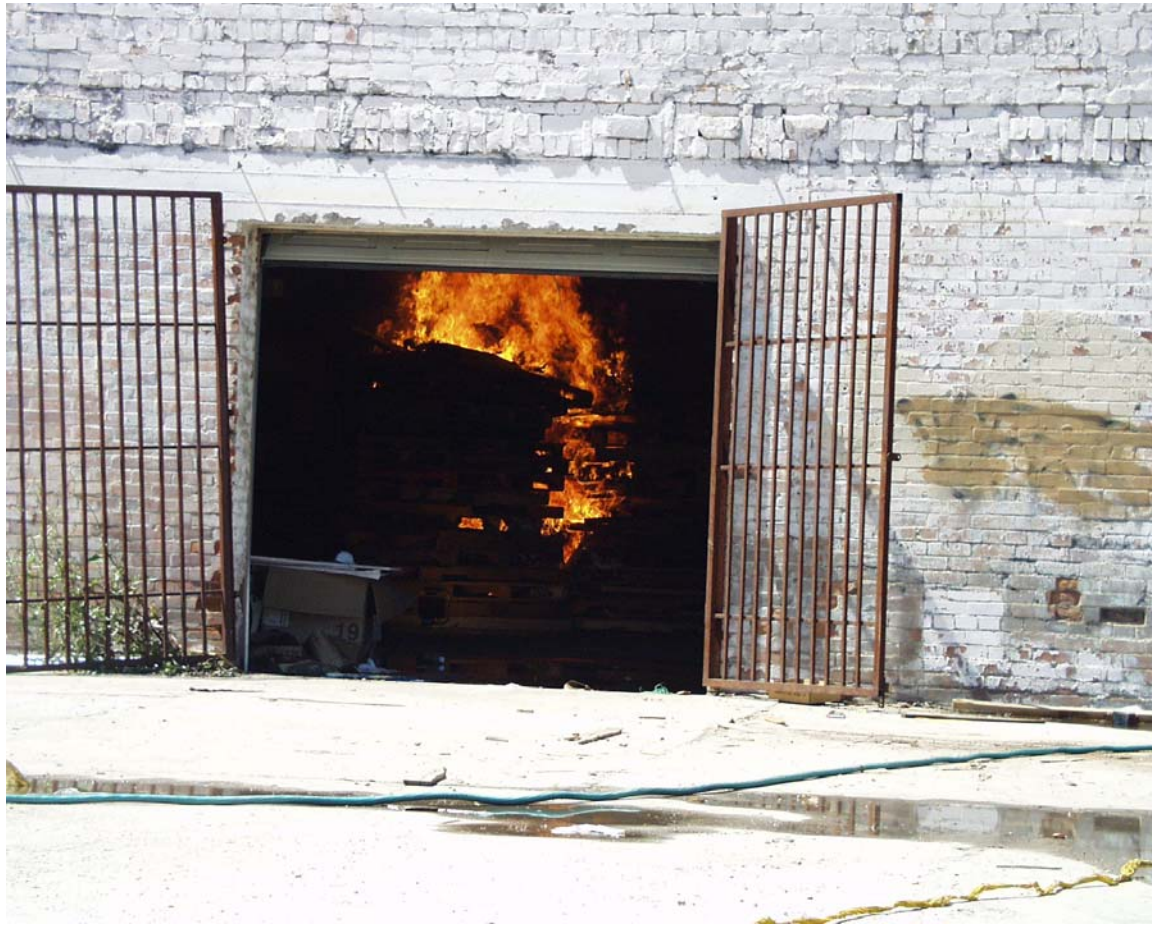
Figure 13. Photograph of fully involved fuel package through open door after the start of the second test.

For the second test, the flames reached the top of the pallet stacks 45 s after ignition. The entire array of pallets was involved in fire within 2 ½ min (Figure 13). At approximately 3 min after ignition, flames had reached the ceiling and started spreading across it. Smoke started coming out of the open doorway at approximately 3 ¼ min (Figure 14). Adjacent items began igniting due to radiant energy 3 min 20 s after ignition. The smoke layer appeared to reach the top of the pallet stack at 4 min. At 5 min, the interior picture became obscured in smoke and the camera was removed. Flames started coming out of the doorway at 6 ½ min (Figure 15). At 9 min, various edges of the roof started to burn. The roll-up door collapsed at 13 ½ min and partially blocked the open doorway. Data collection was terminated at 14 min.

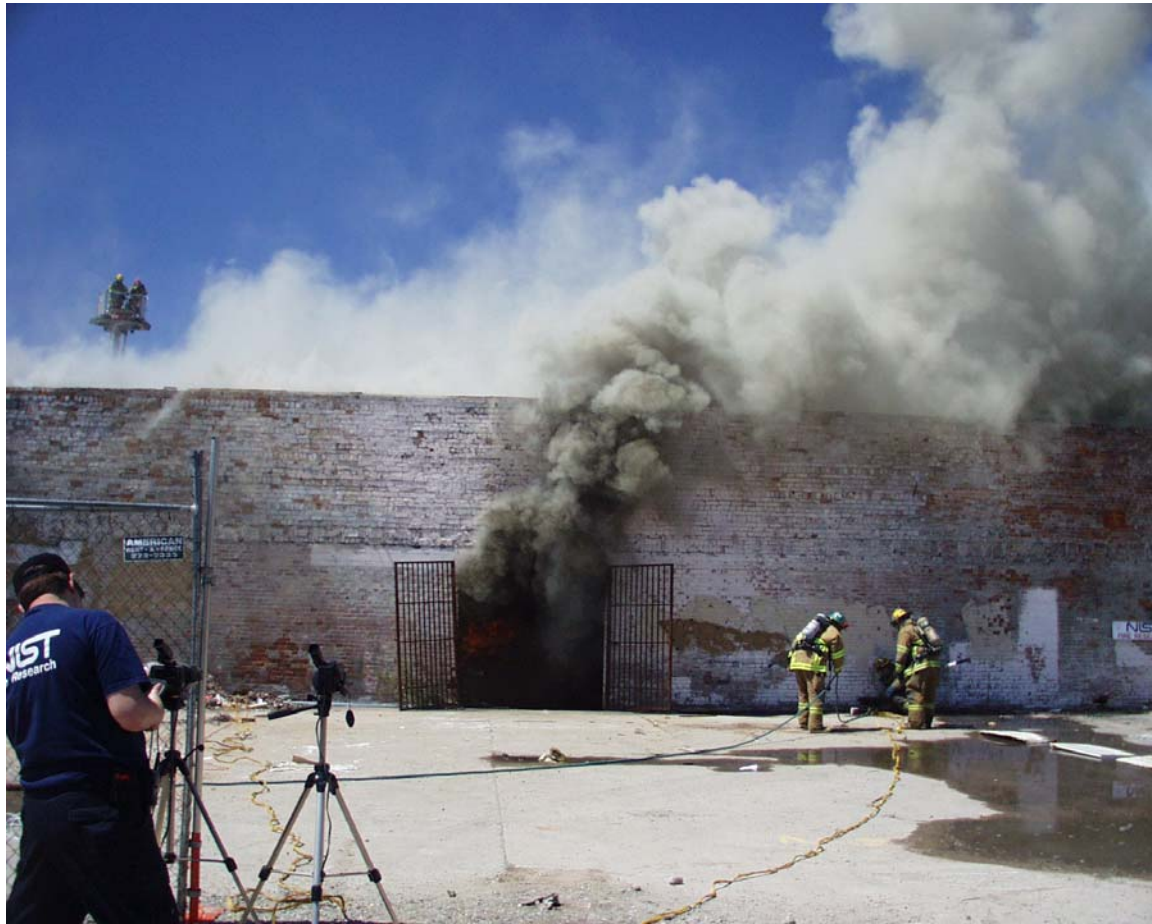
Figure 14. Photograph of smoke coming from open door during second test.

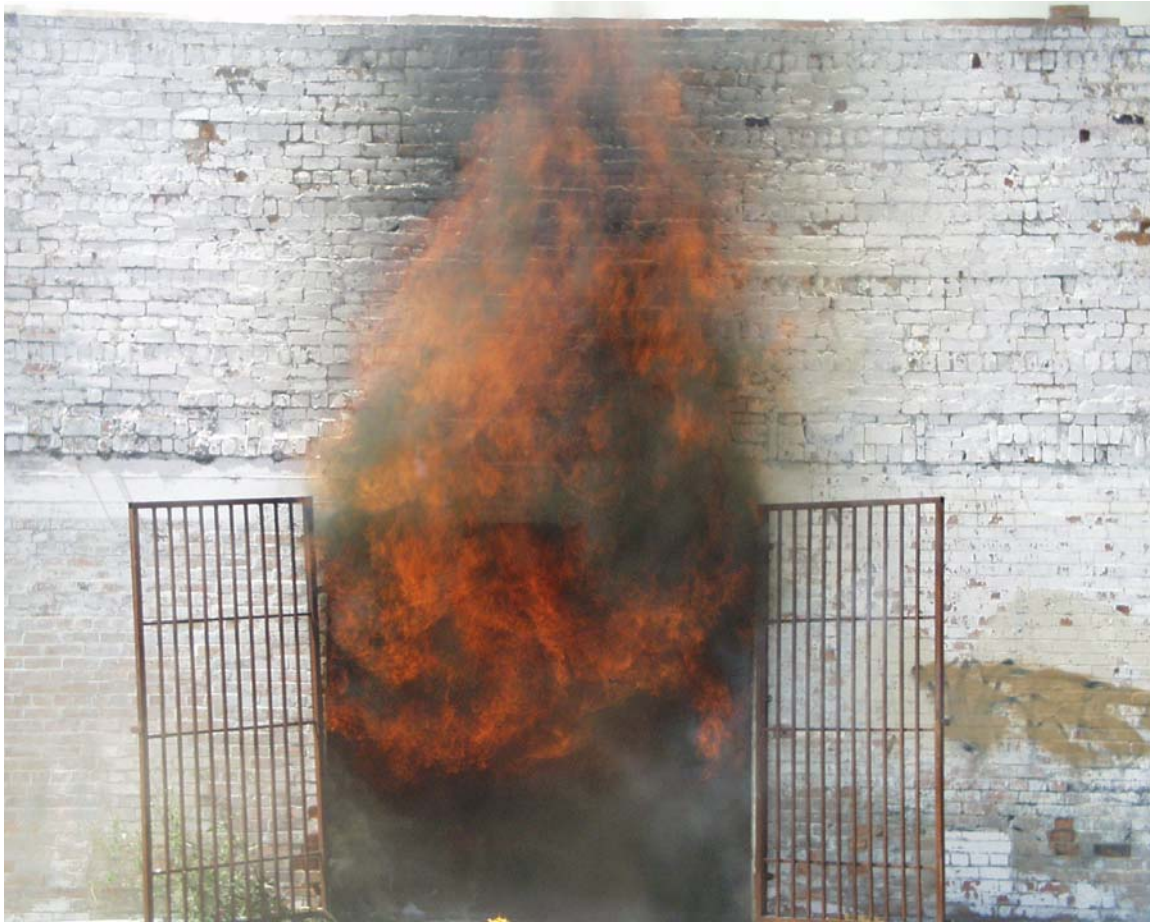
Figure 15. Photograph showing flames coming from open door during second test.

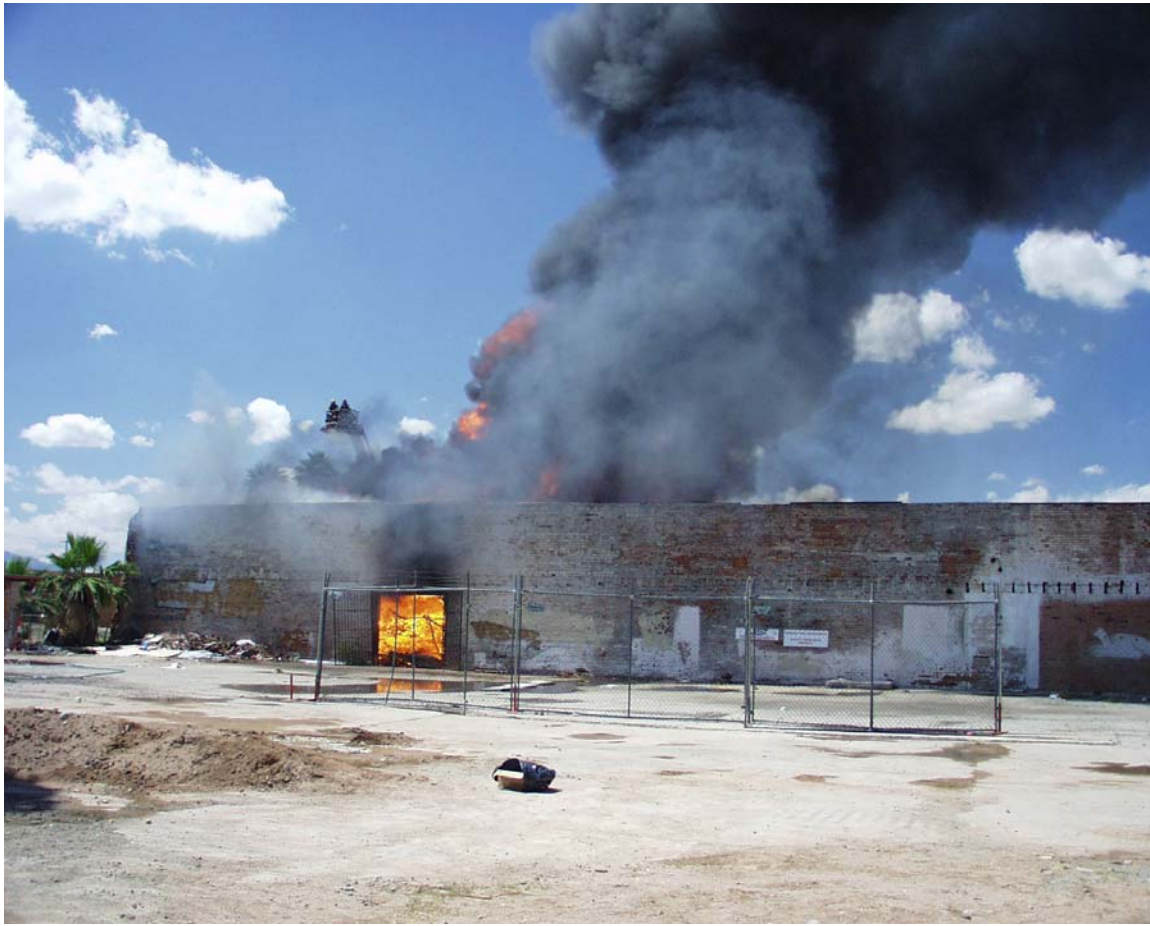
Figure 16. Photograph showing flames through open door and burning roof during the second test.

Significant portions of the roof were burning at the 14 min mark. A partial collapse of the roof occurred at 15 min and 20 s. At 16 ½ min, additional portions of the roof collapsed with the roof being mostly destroyed by 19 ½ min (Figure 16). An unused door in the southwest portion of the west wall had been sealed with a single course of cinder blocks. These blocks collapsed into the street 24 min after ignition (Figure 17). The upper portion of the rear wall collapsed at 29 min and further monitoring was terminated.

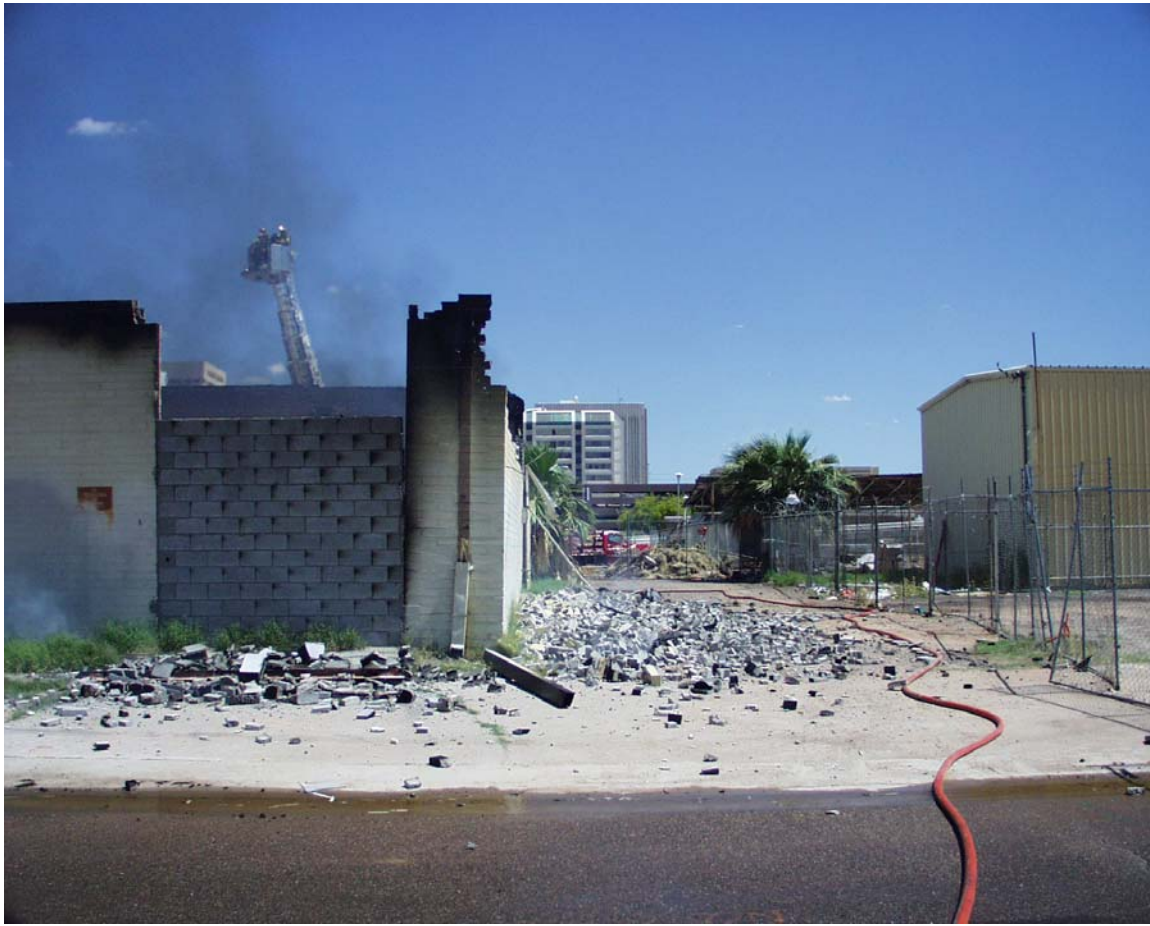
Figure 17. Photograph showing partial collapse of the rear and side walls after the second test.

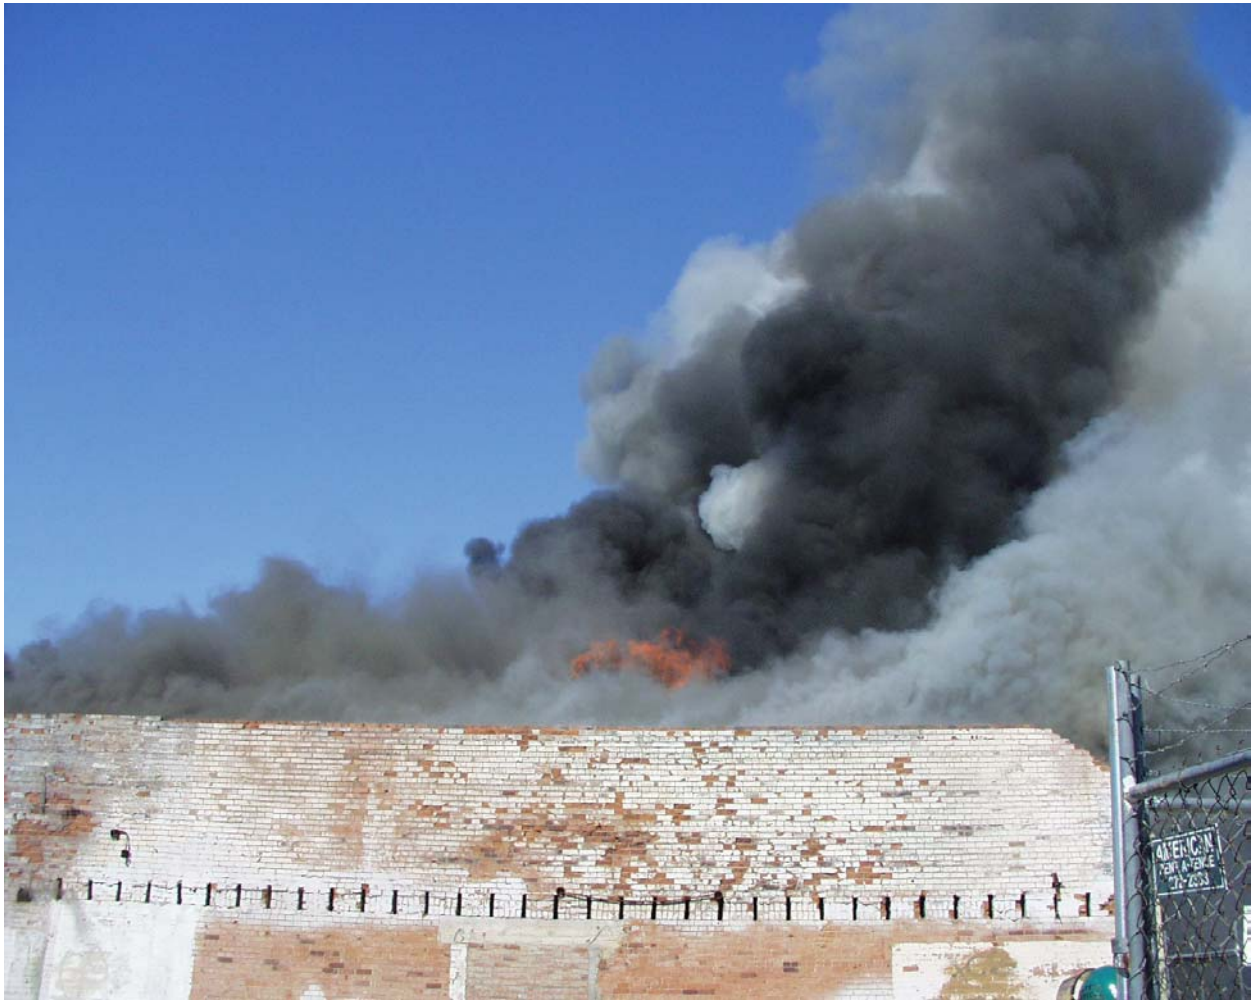
Figure 26. Photograph of roof area showing flames coming from ventilator during first test.

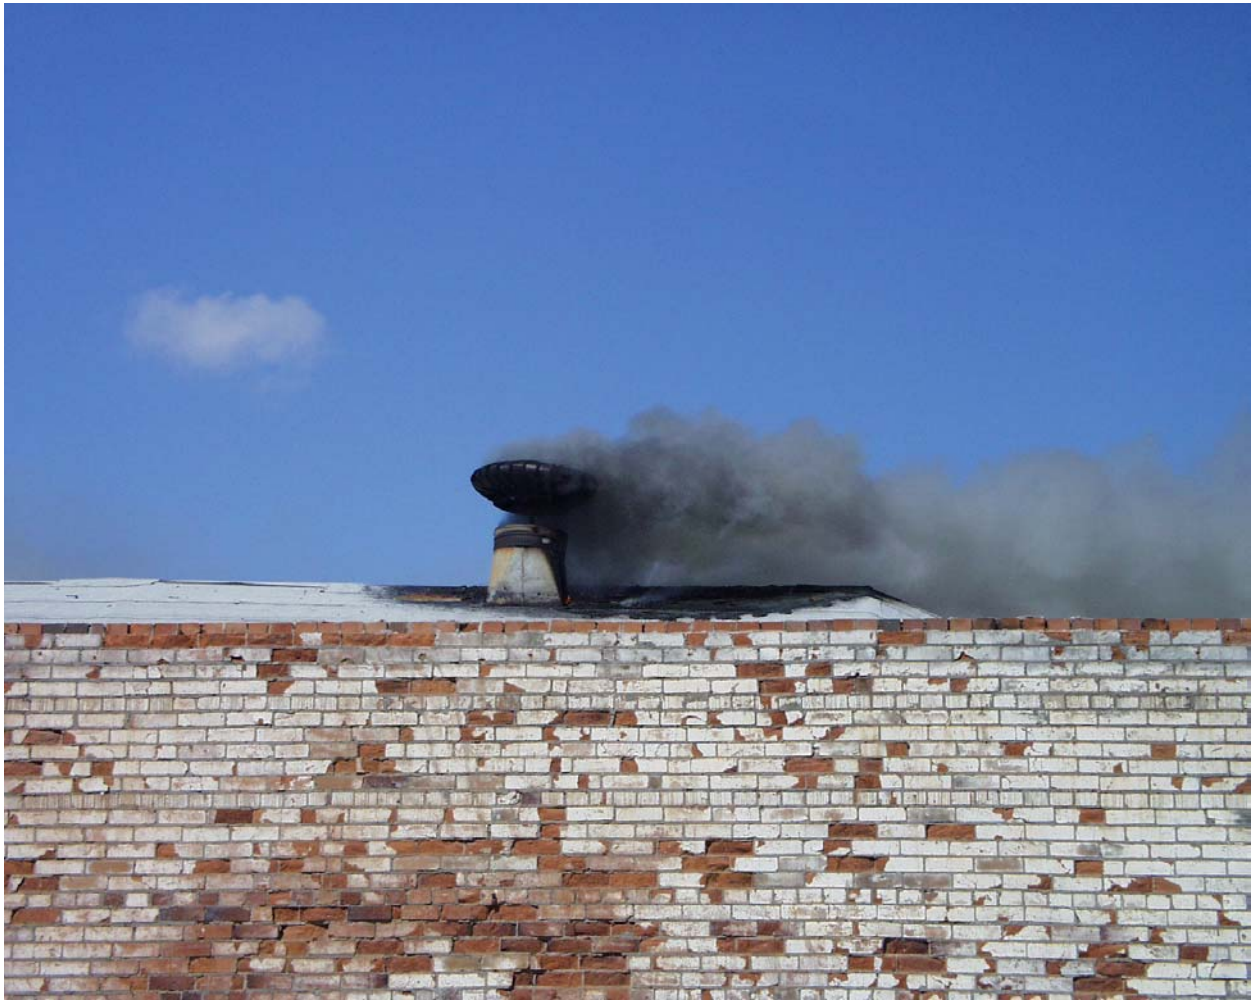
Figure 27. Photograph of roof top ventilator after it collapsed due to severe heat exposure.
