### **NIST Response to the World Trade Center Disaster**

### Federal Building and Fire Safety Investigation of the World Trade Center Disaster

### August 26, 2008

Dr. S. Shyam Sunder Director and Lead Investigator Building and Fire Research Laboratory National Institute of Standards and Technology U.S. Department of Commerce

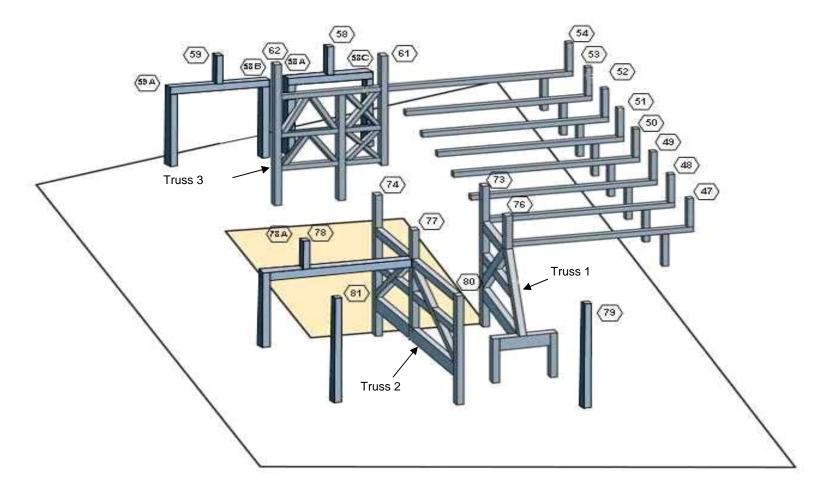
### **Transfer Trusses and Girders**

The layout of the WTC 7 columns did not align with the building foundation and the Con Edison columns. Therefore, a set of *column transfers* were constructed between the 5th and 7th floor slabs.

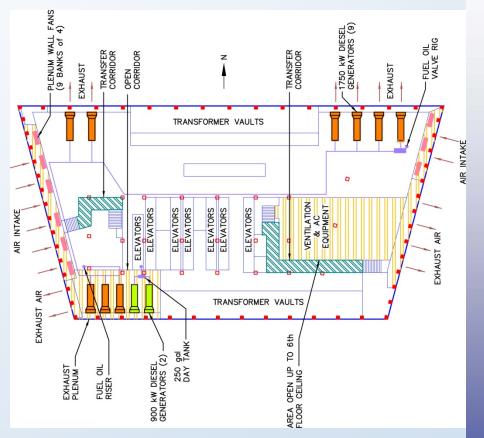
Schematic of 5<sup>th</sup> floor showing location of emergency power system components.

- Both 6,000 gallon tanks were found to be damaged and empty in the rubble pile several months after the collapse. This fuel might have contributed to a fire on Floor 5, a possibility that could not be distinguished from the fuel being consumed or dissipated in the burning rubble fire subsequent to the collapse of WTC 7.

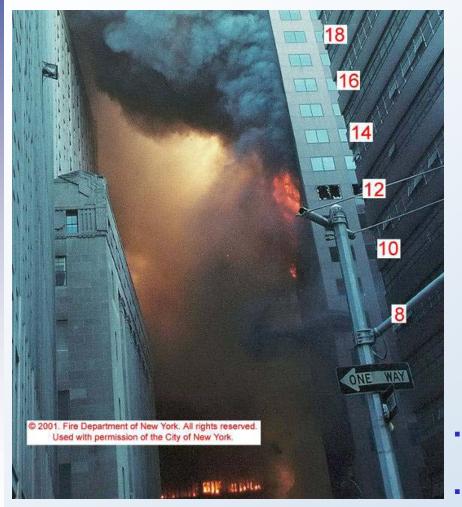
Growth and Spread of Fires.

- Fires on the lower floors (Floors 7 to 9 and 11 to 13) grew and spread since they were not extinguished either by the automatic sprinkler system or by FDNY because water was not available.
- Fires were generally concentrated on the east and north sides of the northeast region beginning at about 3 p.m. to 4 p.m.
- The local fires on the upper floors (Floors 19, 22, 29, and 30) were not observed after approximately 1 p.m.
- Cropped photograph showing east edge of the north face and oblique view of east face of WTC 7.
- It was likely taken between 3:20 p.m. and 3:40 p.m.

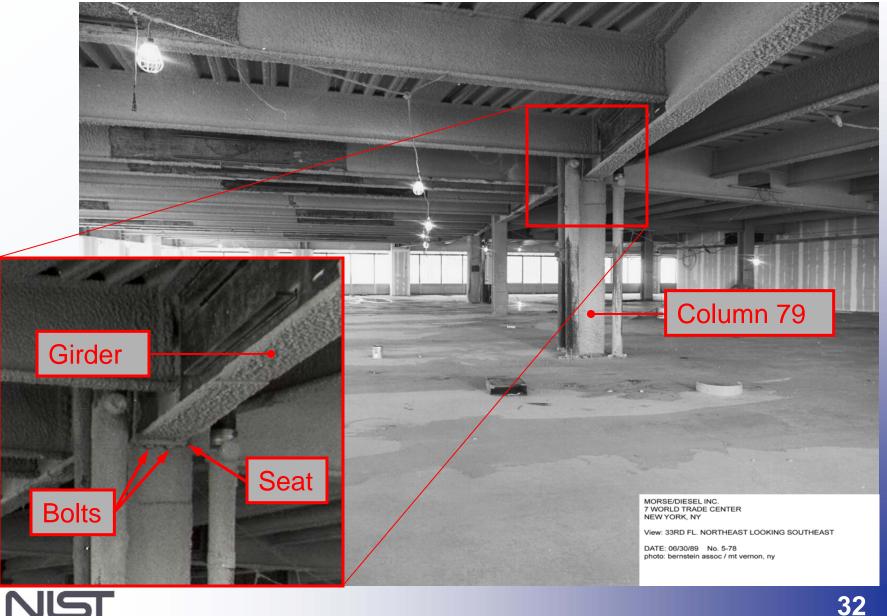
### **North East Floor System Near Column 79**

- Initial Local Failure for Collapse Initiation.
  - Fire-induced thermal expansion of the floor system surrounding Column 79 led to collapse of Floor 13 that triggered a cascade of floor failures.
  - This, in turn, led to loss of lateral support to Column 79 over nine stories, resulting in the buckling failure of Column 79.

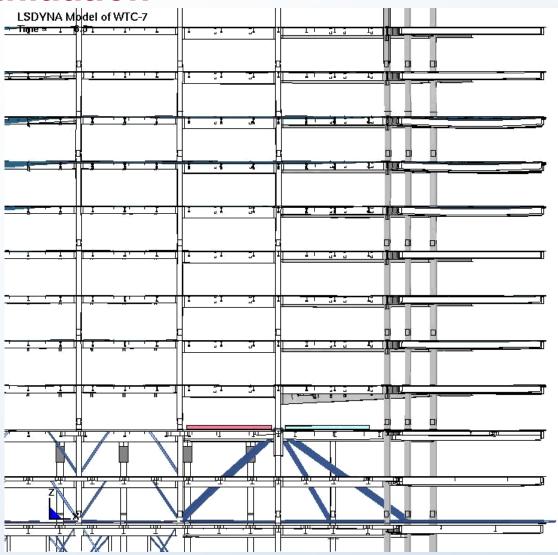
### Physics-Based Visualization of WTC 7 Collapse Initiation

- Buckling of Column 79 (the collapse initiation event) triggered a vertical progression of floor system failures to the east penthouse and subsequent cascading failure of the adjacent interior columns on the east side of the building (i.e., Columns 80 and 81).
- Vertical progression of floor system failures spread to include the entire east region all the way to the top of the building.

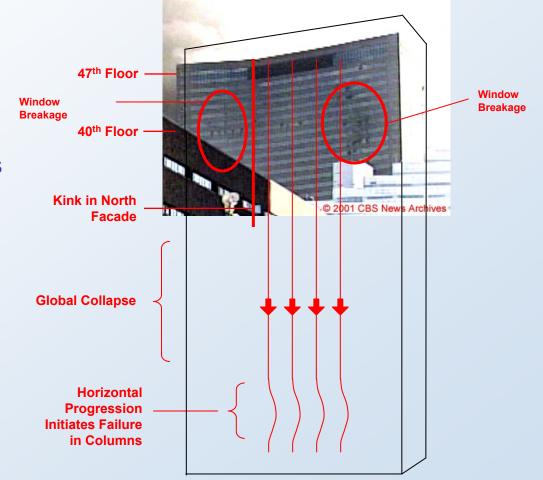
#### **Exterior Observations**

- Screenwall and West Penthouse Sink
- North Façade Kinks at Edge of Core
- Windows break on West Side of North Face

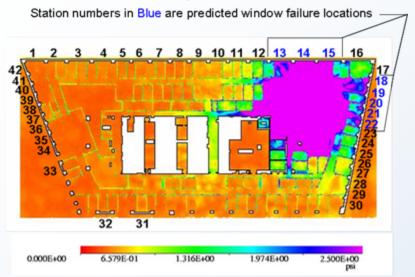
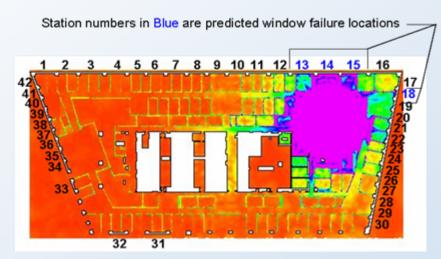
Peak over pressures for 9 lb shaped charge (left) and 2lb charge (right).

- Hypothetical blast events did not cause the collapse of WTC 7. NIST concluded that blast events did not occur and found no evidence of any blast events.

- The minimum explosive charge (lower bound) required to fail a critical column (i.e., Column 79) would have:
  - produced a pressure wave that would have broken windows on the north and east faces of the building near Column 79.
