Independent Investigation Report

The Baltimore City Fire Department
Live Fire Training Exercise
145 South Calverton Road
February 9, 2007

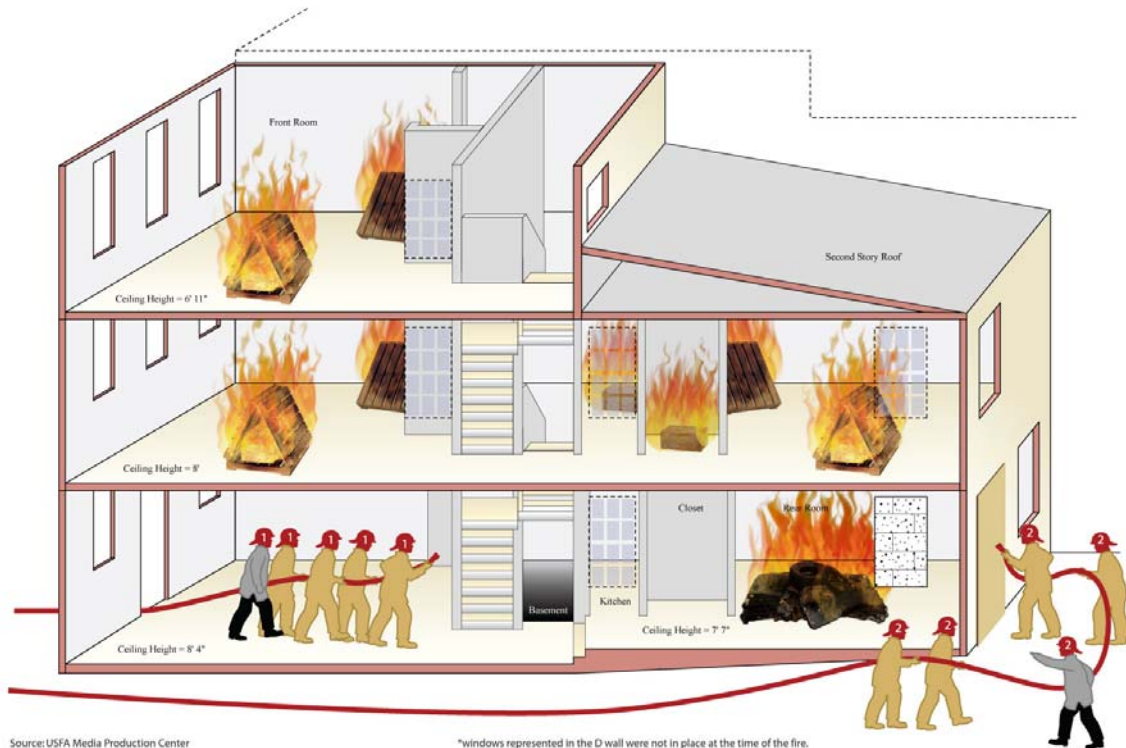
Figure 1

Engine 1 initially followed the instructions they were given and were the first to enter the building. EVD Ryan Wenger led the crew with Racheal Wilson on the nozzle, or “pipe”, followed by Stephanie Cisneros, Angel Perez, and Ben Lichtenberg. The crew took a 1 ¾ inch hose line equipped with a combination nozzle and entered the building through the front door. None of the members of the crew reported seeing a fire on the first floor when they entered the structure. As Engine 1 personnel entered the front room, Engine 2 was pulling hose to the rear of the building in preparation of entering through the back door, as shown in Figure 1.

Engine 1 entering structure, Engine 2 preparing to enter the rear.

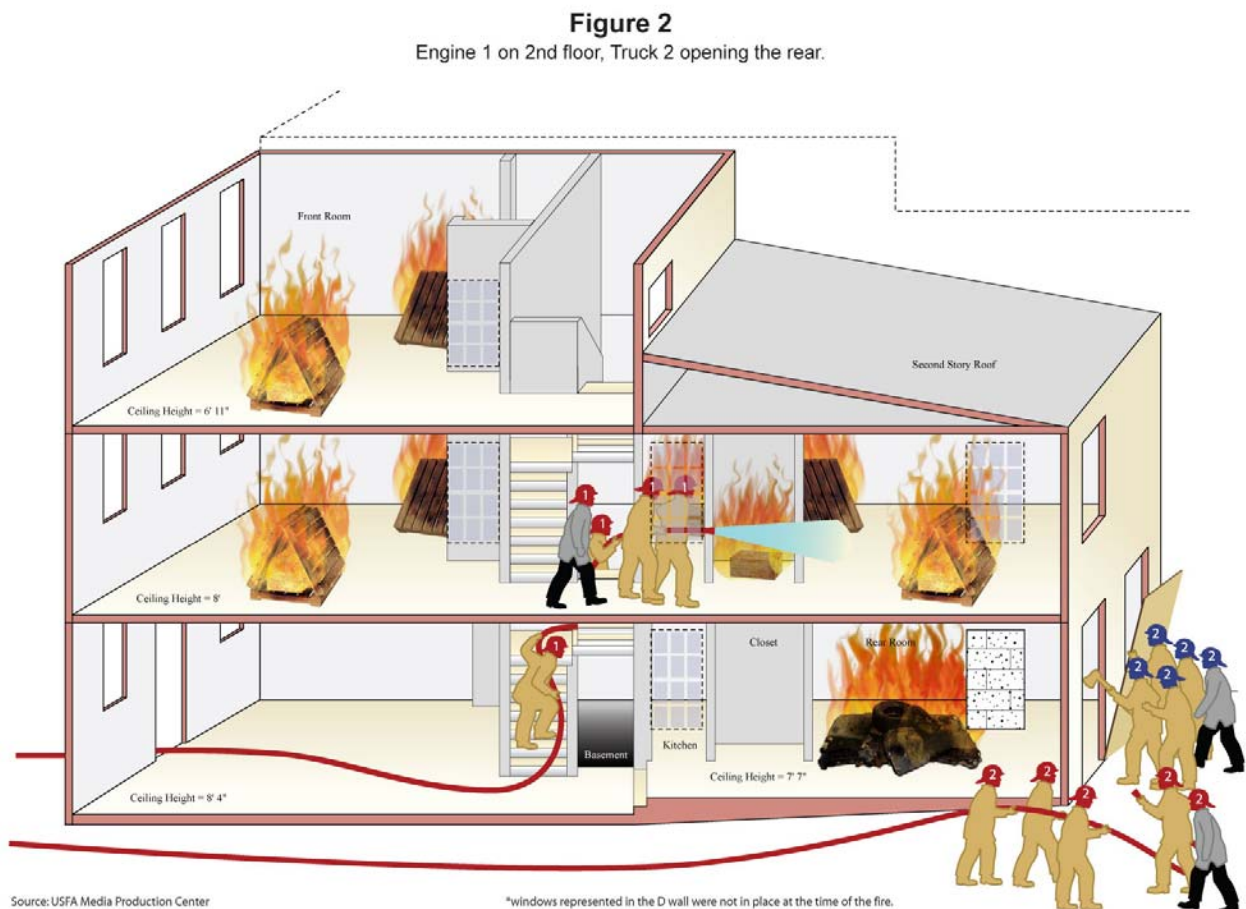
The crew of Engine 1 made their way up the stairs to the second floor. Meanwhile, Engine 2's crew had stretched a hose line (also a 1 ¾ inch with a combination nozzle) to the rear and waited until the crew of Truck 2 had simulated a forcible entry through the rear door (Figure 2). Once they reached the second floor, the crew encountered severe fire conditions. Although their instructions were to go to the third floor, Wenger did not feel comfortable proceeding without extinguishing some of the fire on the second floor. He told Wilson to open the nozzle and put water on the fire. When opening the nozzle, Wilson fell, so Wenger took the hose line and confined the fire to the point where he felt he could proceed to the third floor. He gave the hose line back to Wilson and the crew continued to proceed to the third floor.

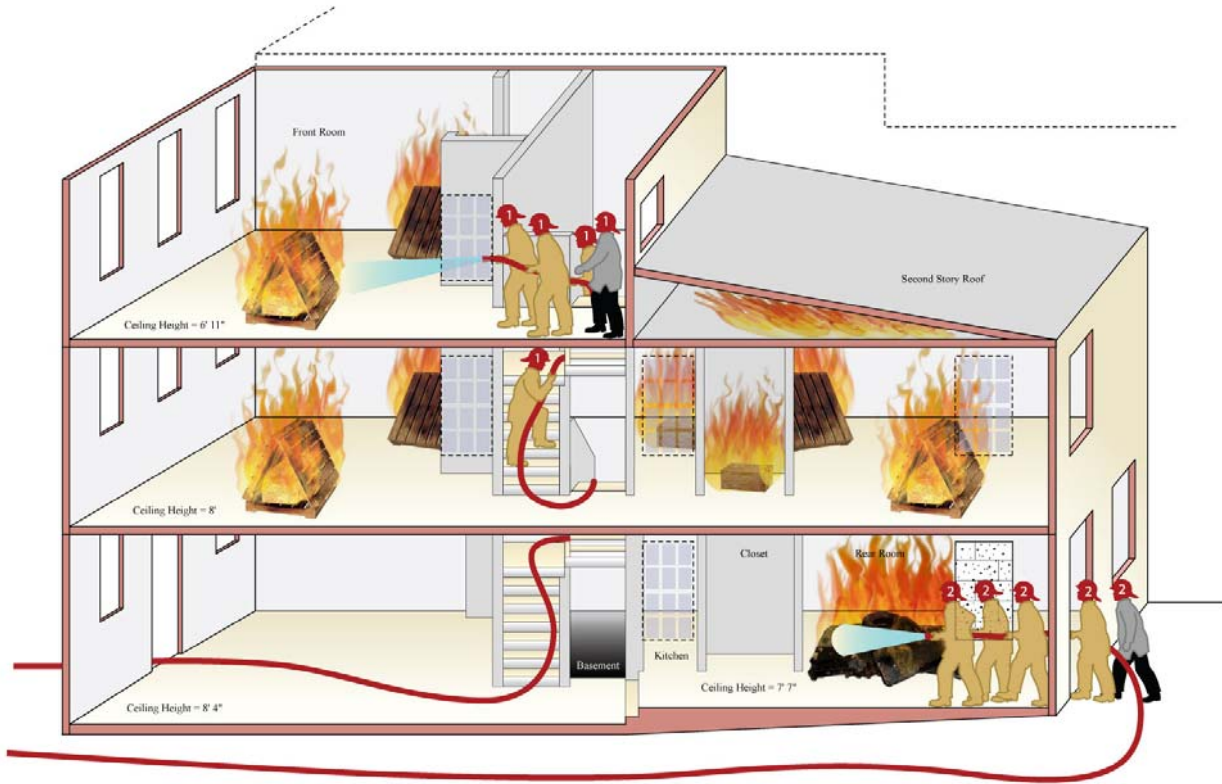
Figure 3

At this point Engine 2 entered the rear of the structure and encountered a rubbish fire in the back room that was not discussed during the briefing (Figure 3). Wenger stated that the heat at the third floor landing was intense, so he leaned out the window in an effort to gain an understanding of the fire conditions. Without a radio, he had no means to communicate his observations or circumstances with the Incident Commander or receive further instructions.

Engine 1 on 3rd floor, Engine 2 attacking fire 1st floor rear.

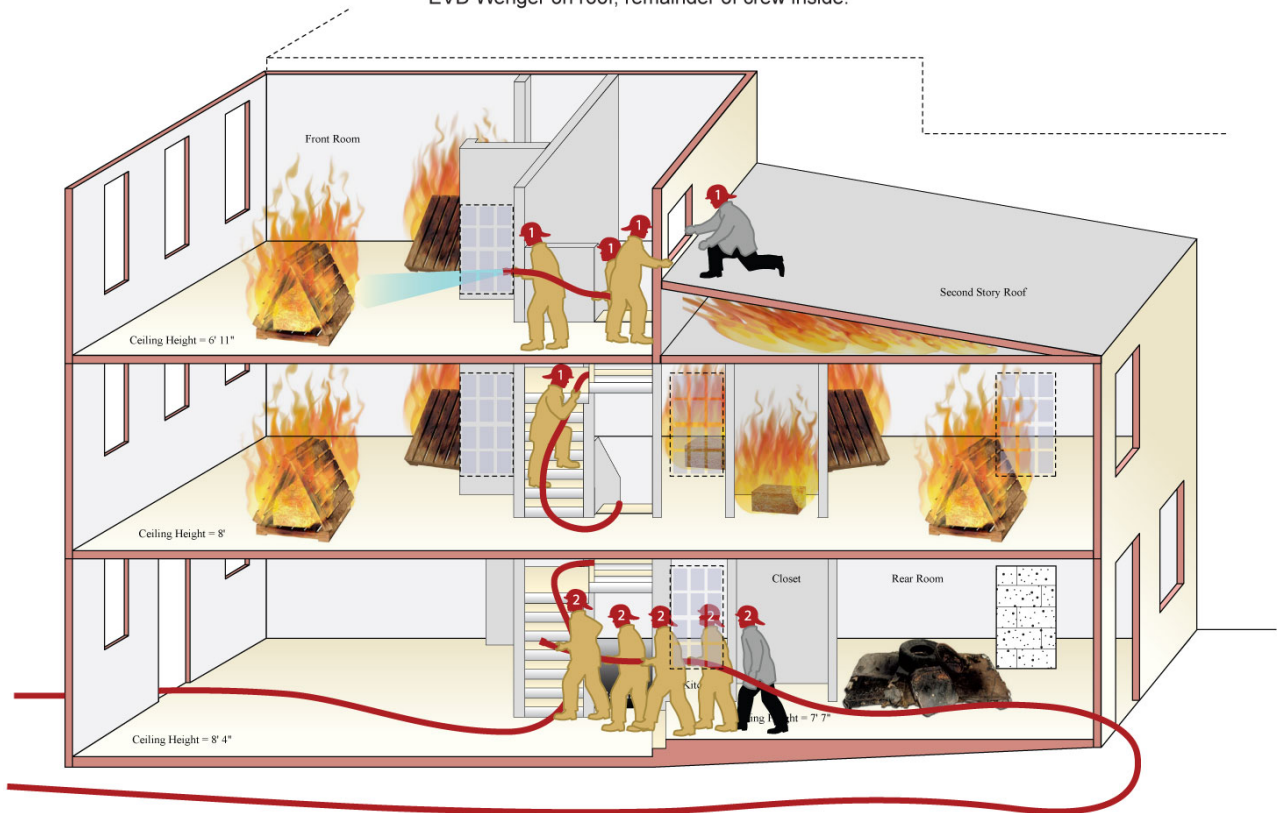
Figure 4

Cisneros stated that she told Wenger the second floor was well involved in fire, but he did not acknowledge her. She was told to go down the steps to pull more hose and at that time, she felt her legs starting to burn from the heat. She proceeded to the third floor landing and told Wenger she had to get out of the building, due to the intense heat. At that time, Wilson still had the nozzle and was near the window. Neither Cisneros nor Wenger reported that Wilson appeared to be in any distress at that time. EVD Wenger then climbed through the 'exit' window on the third floor to the second floor roof. Engine 2 had, by this time, extinguished the fire on the first floor and was proceeding to the second floor (Figure 4).

Engine 1 personnel on 3rd floor and Engine 2 advancing to 2nd floor.
EVD Wenger on roof, remainder of crew inside.

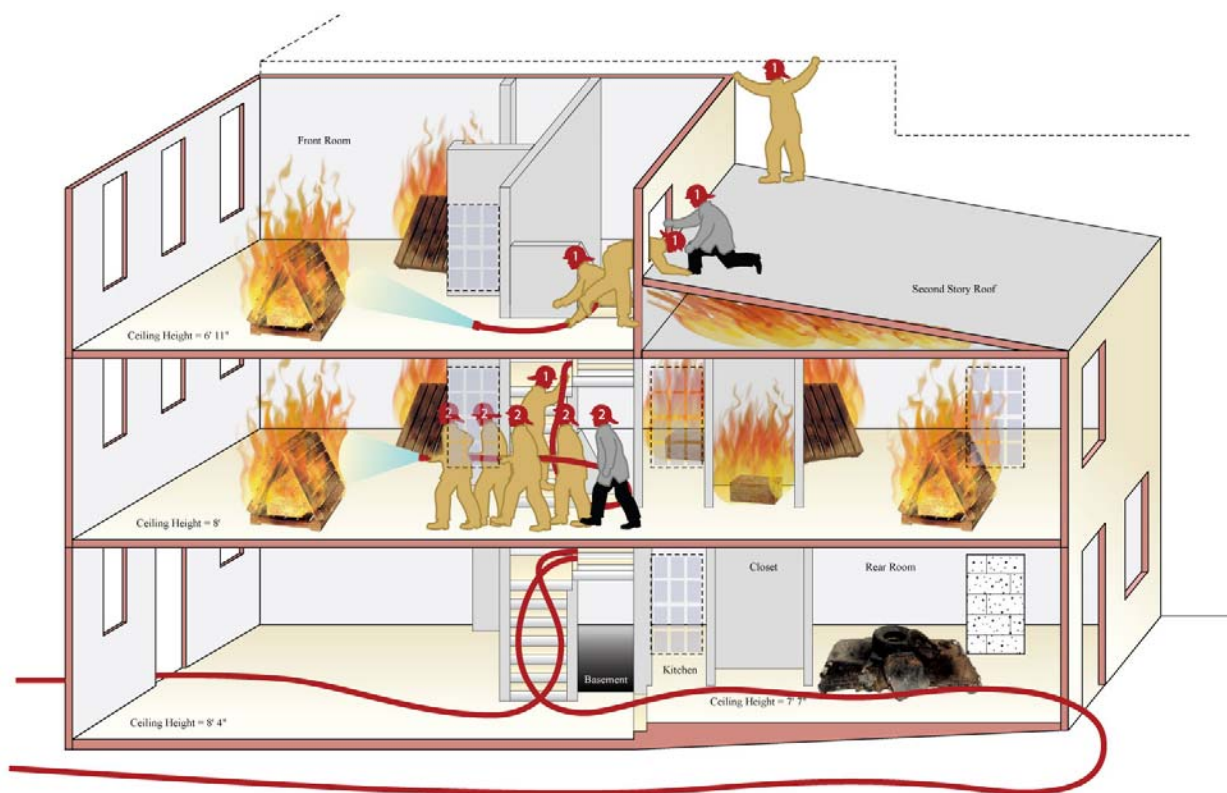
Figure 5

According to Perez, Wilson saw him at the landing and warned him to retreat and get out of the building. Perez noticed that she had abandoned the hose line and the nozzle was still open, flowing water (Figure 5). He and Lichtenberg heeded Wilson’s warning and went back down the stairs, taking the hose line with them. They then used the hose line to partially extinguish the fires on the second floor to the point where they were able to exit the structure without injury.

Engine 1 crew evacuating to roof, Engine 2 suppressing fire on 2nd floor front.

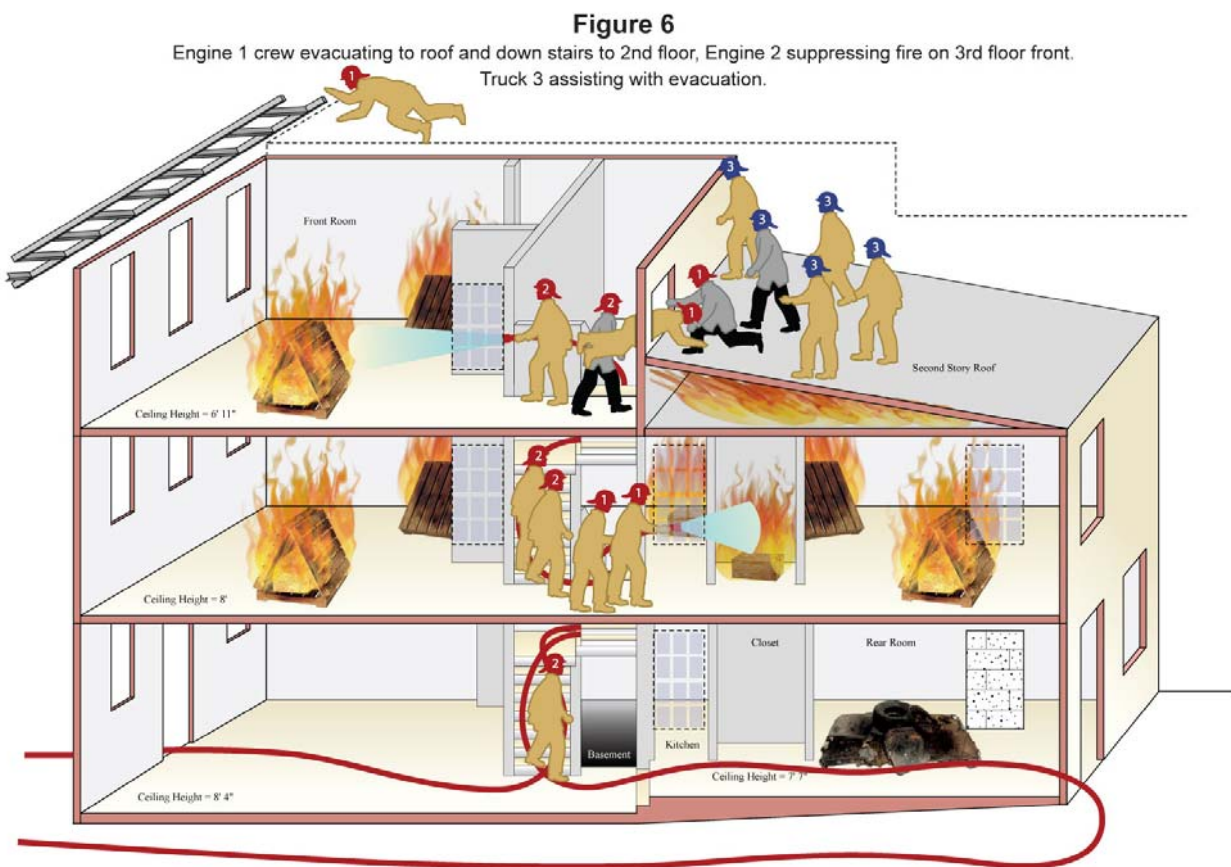
Hiebler and Robinson then tried to assist Wenger by grabbing Wilson's legs and trying to push her out of the window. Hiebler, who was concerned the fire on the third floor was getting out of control, told Robinson to extinguish the fire and he would assist Wenger with Wilson's rescue (Figure 6). Hiebler lifted Wilson's legs and with the assistance of those pulling from the outside, was able to remove her from the building. Hiebler stated that once he gained control of Wilson's legs, she was removed from the building without difficulty.

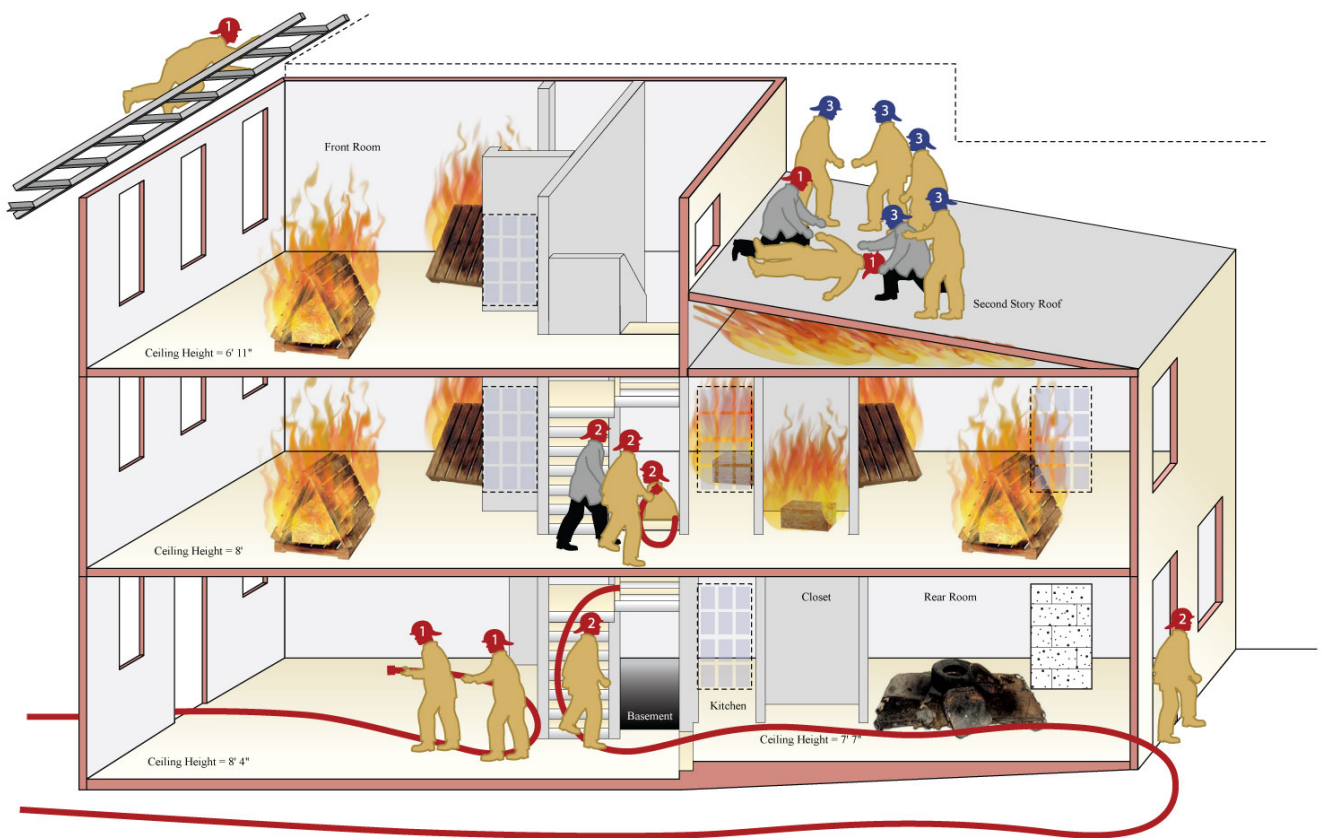
Figure 7

Once Wilson had been removed from the building, Hiebler and Robinson returned to the second floor to locate Norman and Wright, the remaining members of their crew. The four of them then exited the building, along with the remaining members of Engine 1 (Figure 7).

Racheal Wilson rescued, CPR initiated. Other crews evacuating structures.

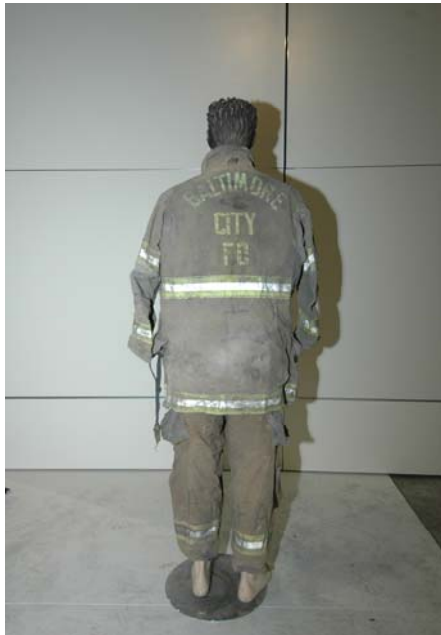
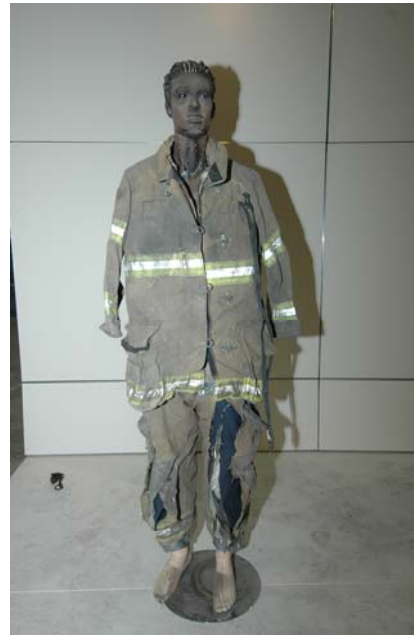
addition, the neck strap, which is attached to the face piece itself, had been torn loose. Whether the face piece was dislodged during the rescue attempt, or Wilson removed it herself remains a matter of conjecture.

Chief William Jones. The items were fully photographed in a static display, then placed onto a mannequin to portray the manner in which the garments were actually worn by FPA Wilson.

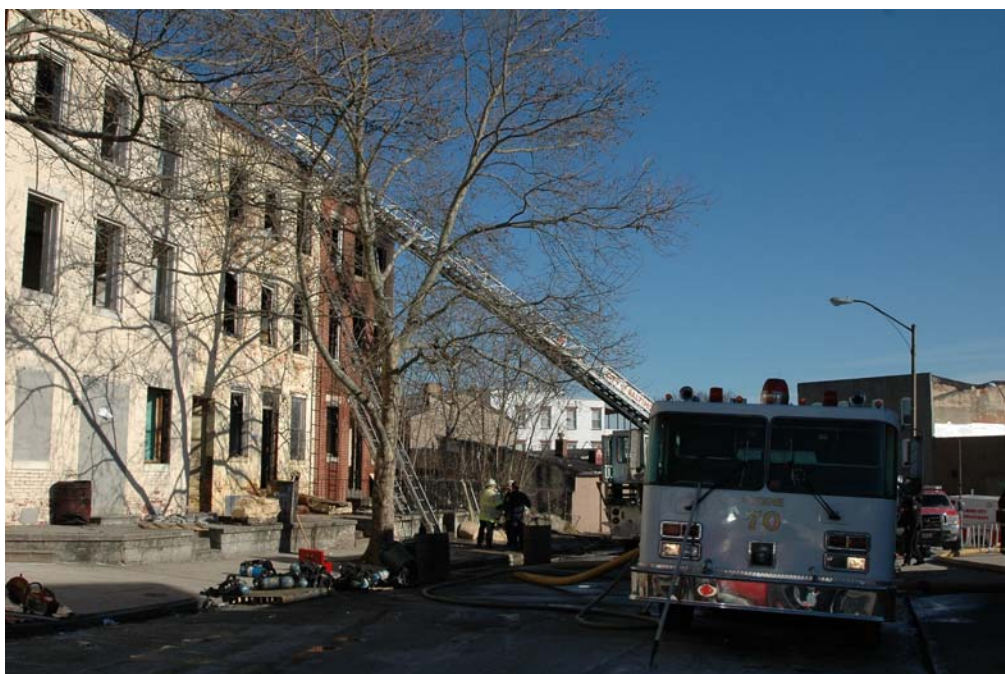
Finding: There is no evidence that an effort was made or a plan was in place to protect any exposed structures.

Discussion: The dwelling used was the end unit of a three unit block section that also included similar structures 143 and 141 South Calverton Road. The unit at 143 South Calverton was attached to 145 South Calverton and easily could have been involved as well. In addition, there is a structure across a ten foot alley that also could have been considered an exposure.

141, 143, and 145 South Calverton Road.
