Contra Costa County Fire Protection District

Investigation Report: Michele Drive Line of Duty Deaths

July 21, 2007

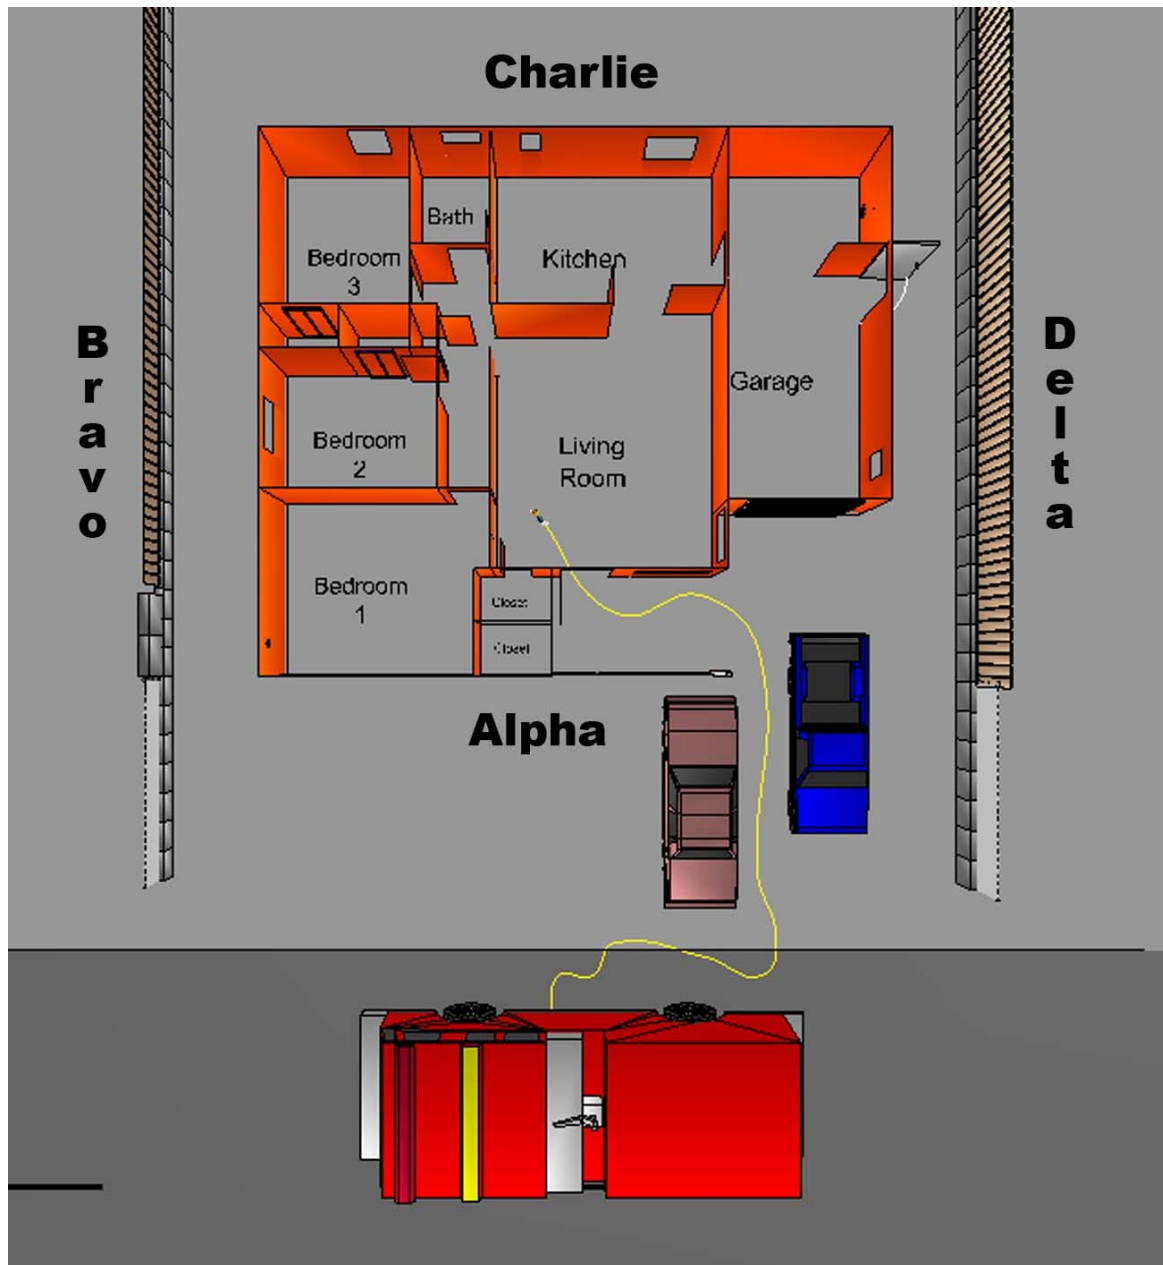
Figure 4 - Position of hoseline 1

asked Captain 70 what he needed. Captain 70 asked for a thermal imaging camera (TIC). Captain 70 and Firefighter 70 initiated fire attack, advanced the hoseline three to five feet inside the front door, and quickly knocked down the visible fire in the living room (Figure 4).

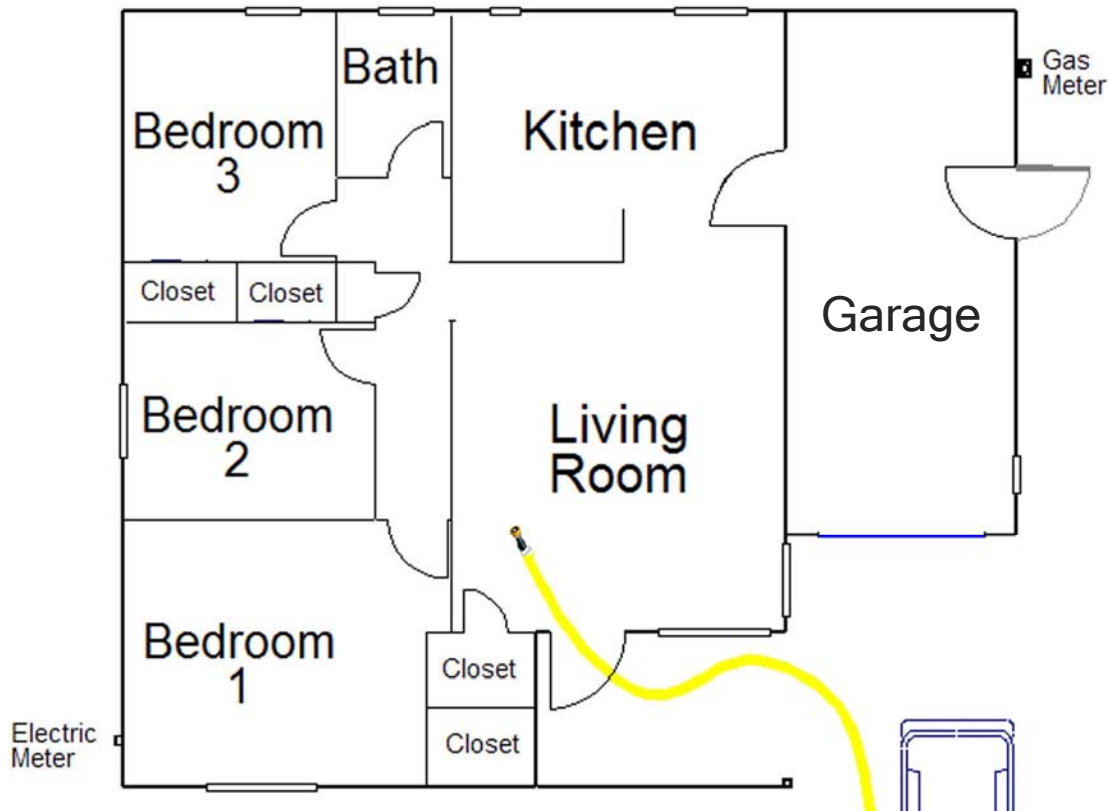
Figure 6 - Location of utilities

Engineer 70 asked Engineer 73 to secure the utilities. Engineer 73 shut off the natural gas supply valve on the “Delta” side but was unable to shut off the electrical breakers at the “Alpha” / “Bravo” corner because the breaker box was locked (Figure 6). (See Figure 4 for Alpha, Bravo, Charlie, and Delta references.)

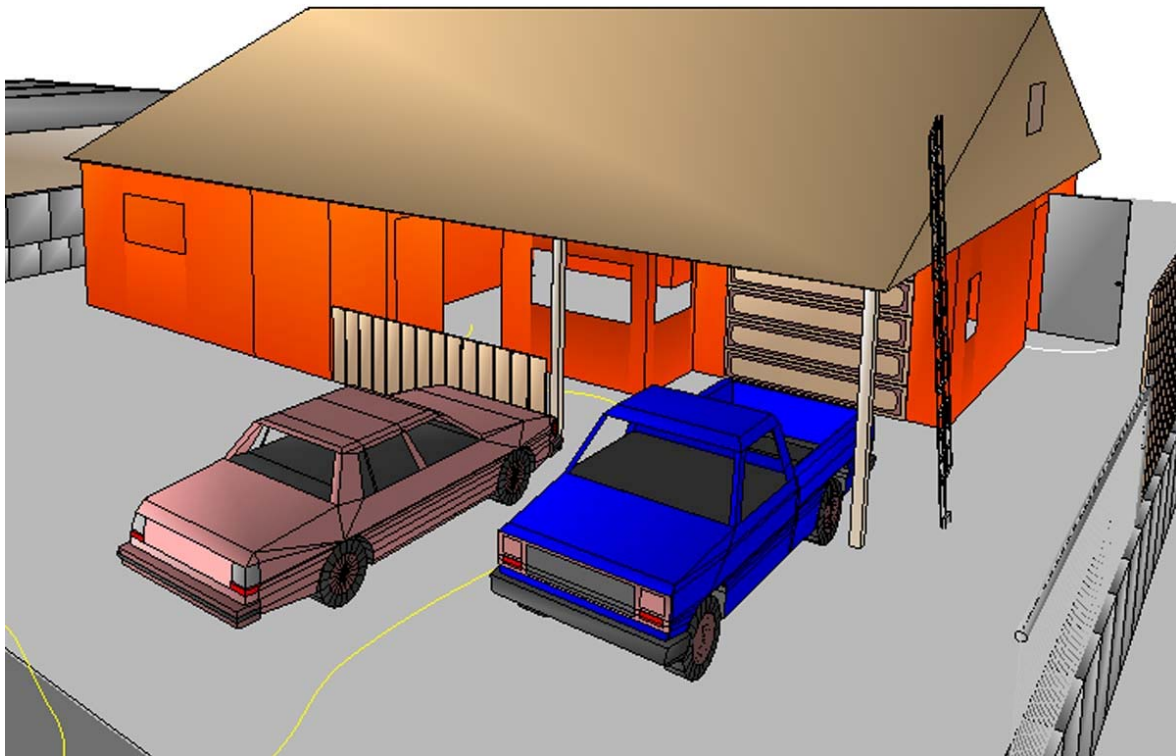
Figure 7 - Ladder location on Alpha / Delta corner

At 01:57:13, E69 arrived on scene. Captain 69 directed Firefighter 69 to ladder the roof. Engineer 69 obtained a chainsaw in anticipation of a rooftop ventilation assignment. Captain 69 conducted a quick size-up for rooftop ventilation while Firefighter 69 placed a 14' roof ladder on the "Alpha" / "Delta" corner (Figure 7). During this time, Engineer 70 asked Captain 69 what he thought about putting a blower in front of the building for some positive pressure ventilation. Captain 69 agreed it was a good idea and advised him to initiate that operation.

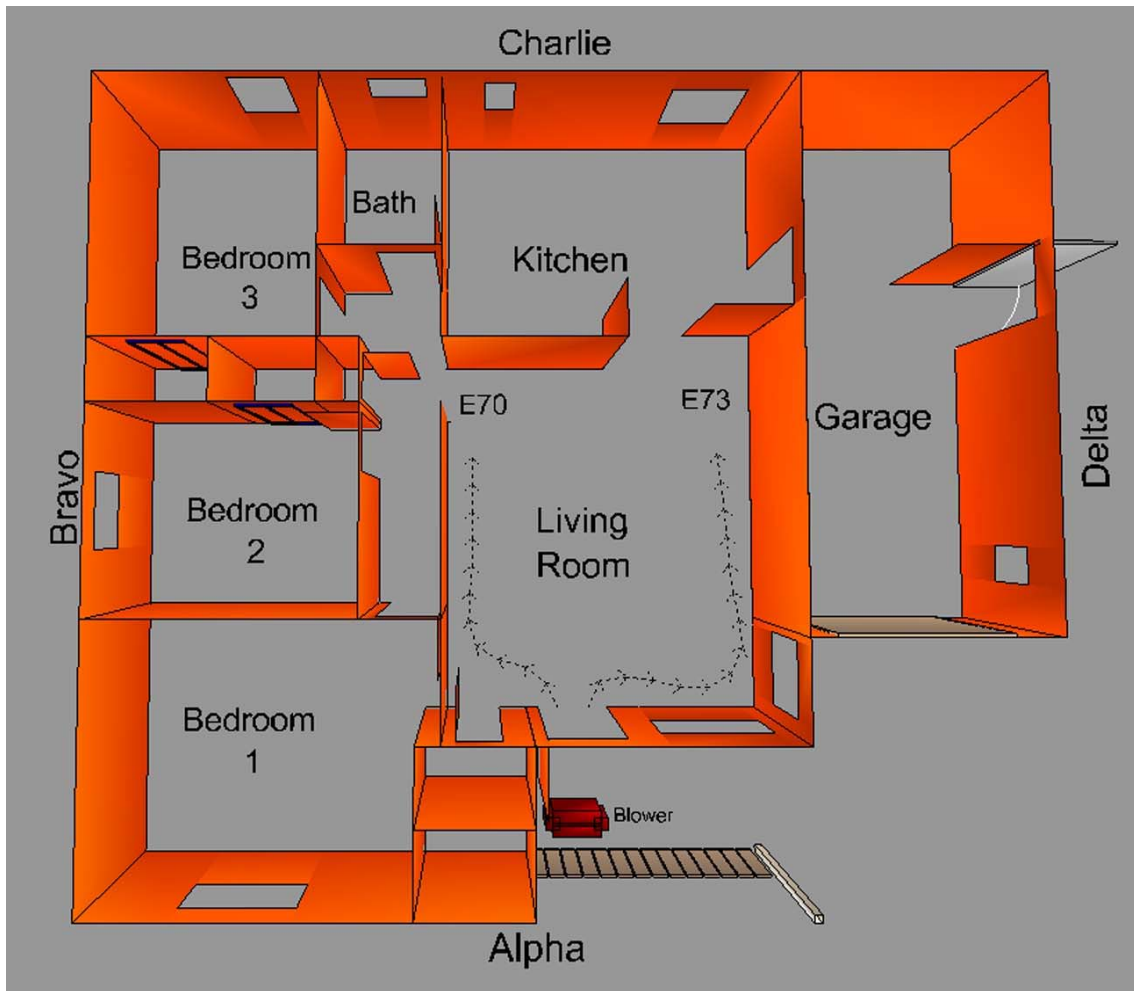
Figure 8 - Location of blower

Engineer 70 and Engineer 73 removed the blower from E70 and moved it towards the front of the structure. Engineer 70 positioned and started the blower approximately three feet from the front door due to a small wall that partially enclosed the porch (Figure 8).⁸

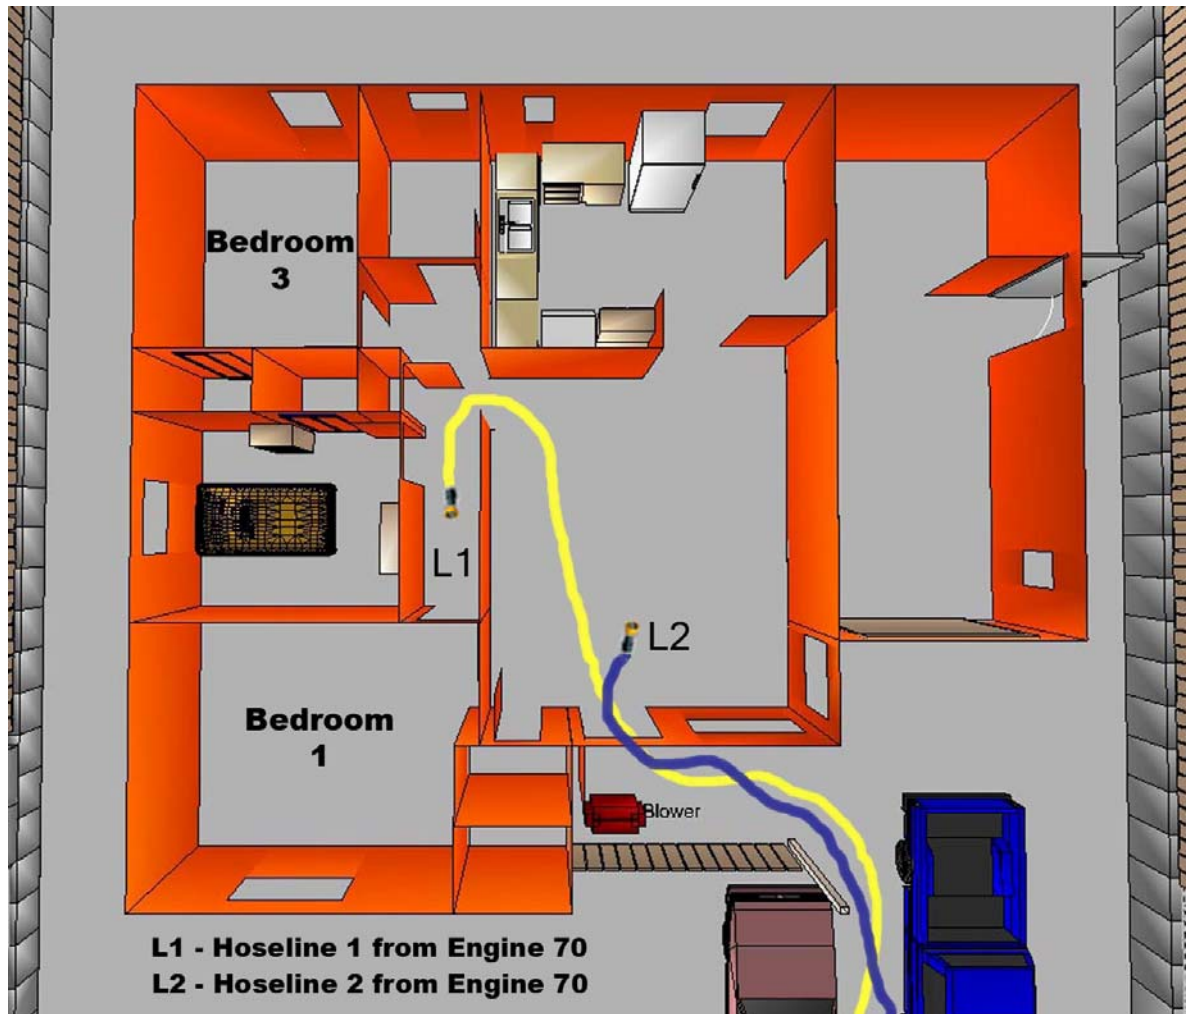
Figure 9 - Location of hoselines

During the interior attack, Captain 76 and Firefighter 76 encountered poor visibility and high heat conditions as they entered the hallway. They observed heavy fire from bedrooms #1 and #2, with flames rolling across the hallway ceiling. They initially knocked down fire in bedroom #2 while pushing the fire back down the hall to bedroom #1 (Figure 9). Captain 76 scanned bedroom #2 with a TIC, but did not identify any victims. They continued to knock down the fire while advancing into bedroom #1. The hoseline was moved back to the doorway of bedroom #2. As Q76’s crew directed a straight stream into bedroom #2, the gypsum board between the two bedrooms failed, allowing the stream to penetrate into bedroom #1. From the doorway of bedroom #2, they observed heavy fire in the attic through a 4” hole in the hallway ceiling. They attempted to attack the fire in the attic through the hole with no noticeable effect.

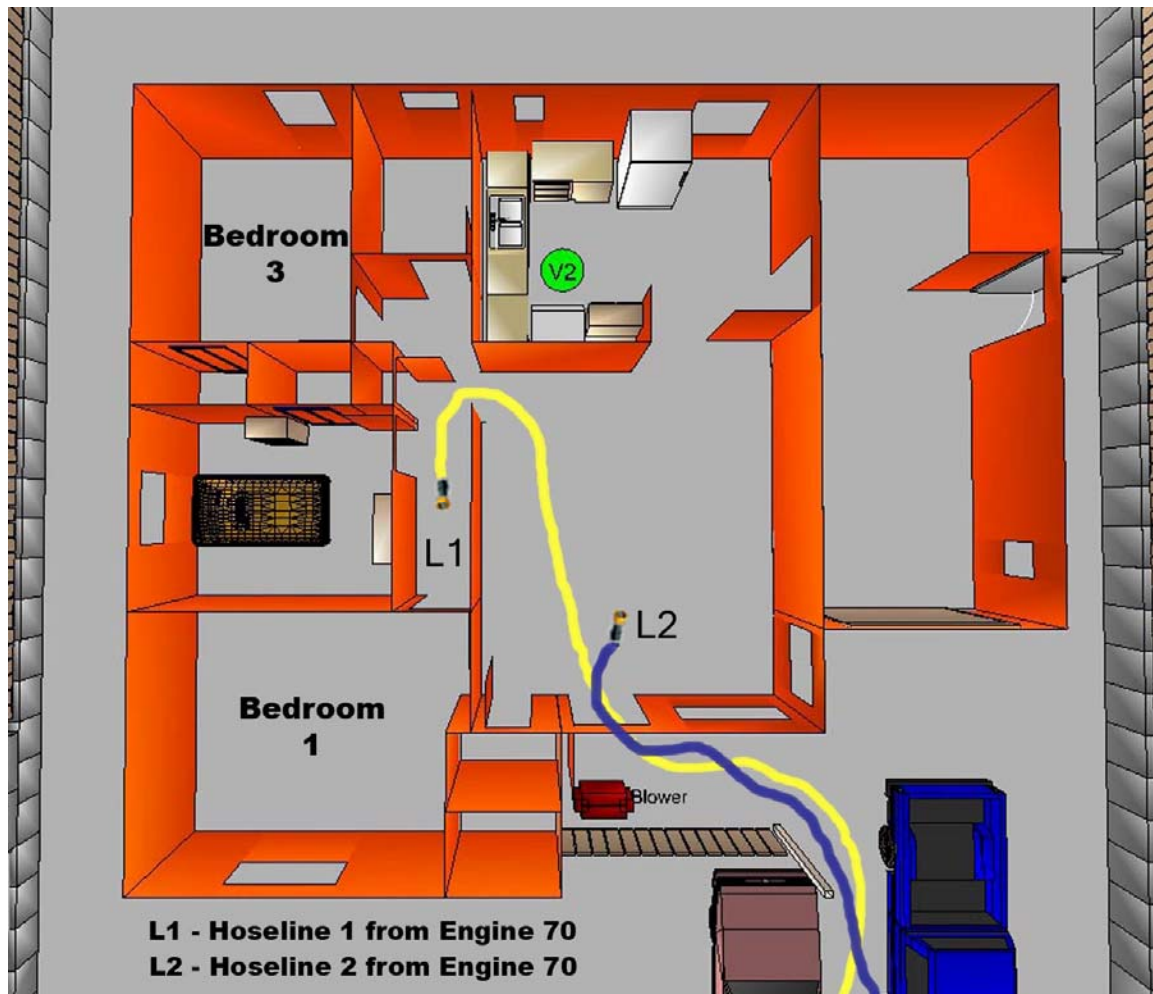
Figure 10 - Location of Victim 2 (V2)

Captain 69 replaced his SCBA air cylinder and rejoined his crew inside to search for the second resident. Using a TIC, Engineer 69 located an unresponsive male resident in the

kitchen (V2, Figure 10). The patient was assessed where he was found and determined to be non-viable. The crew exited to obtain a tarp to remove the victim due to his large size.

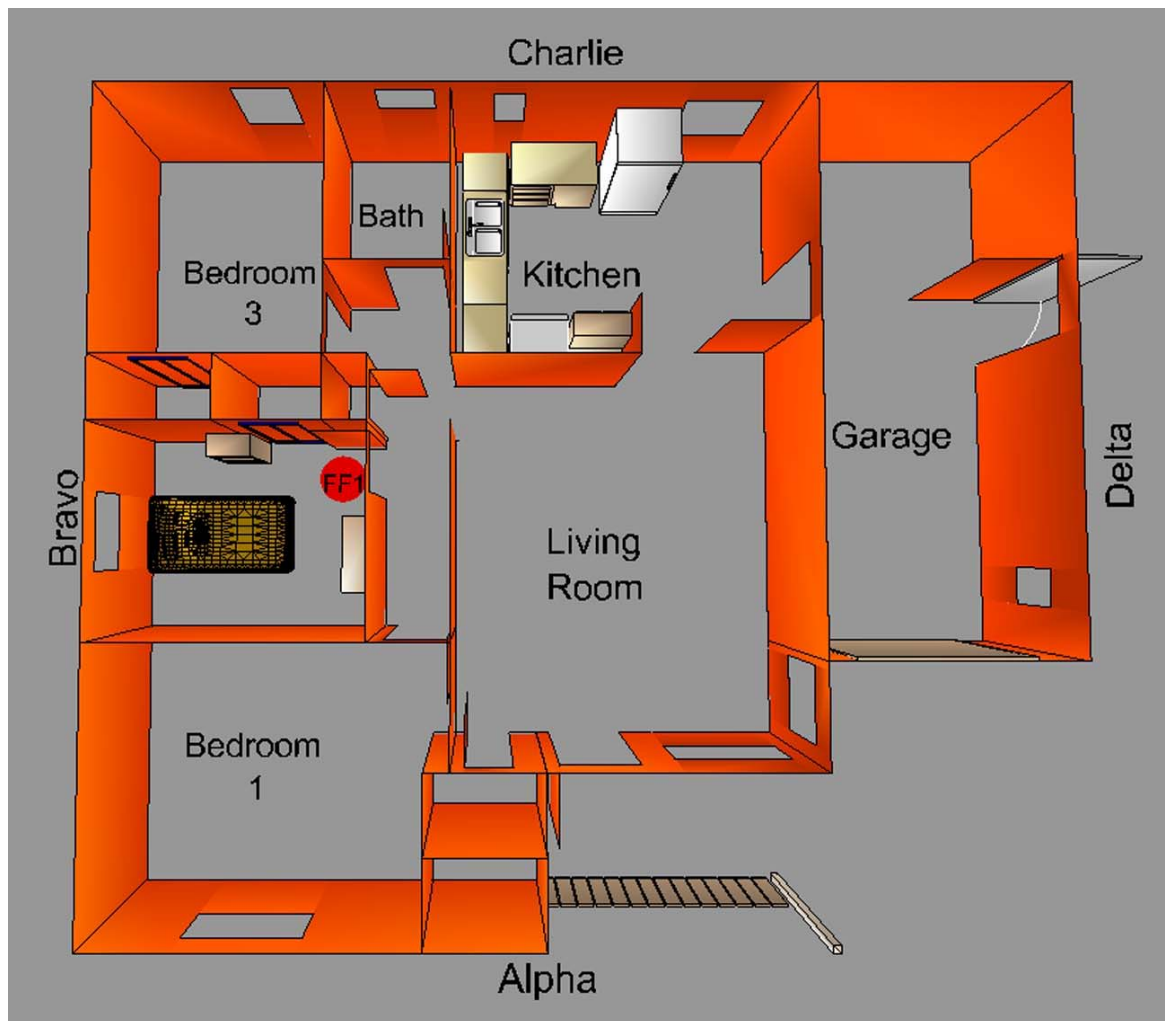
Figure 12 - Location of Firefighter 1 after being moved

When Firefighter 76 entered bedroom #2, he encountered a body just inside the doorway and quickly realized it was a firefighter (FF1, Figure 12). (Note: Firefighter 76

stated he was surprised to find a body in this location, as it had not been there a few minutes earlier when he was involved in fire attack.) Firefighter 76 yelled for assistance and a flashlight. Firefighter 76 lifted the victim's upper torso from behind as the fire began to increase along the wall between bedroom #1 and bedroom #2. He was quickly joined by additional personnel, including Captain 68 who grabbed the lower legs of the victim. They worked together to move the firefighter out of the bedroom and into the living room. Firefighter 69 re-entered and assisted Captain 69 with the removal. When they arrived at the front porch, they were joined by other personnel who helped move the firefighter to the front yard. Initial resuscitation efforts were initiated by Engineer 73 and Firefighter 73, but it was quickly determined that the injuries were fatal. (Note: The estimated removal time was 02:28 hours).

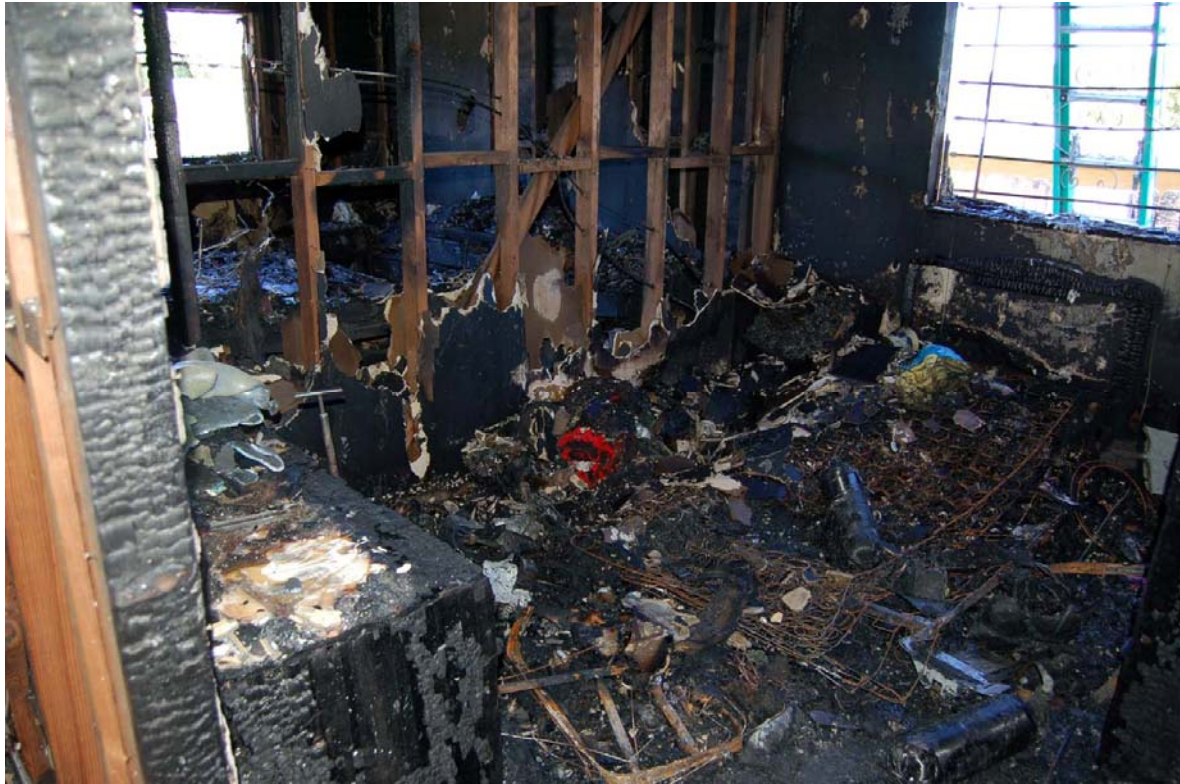
Picture 11 - Bedroom #2

evacuate the structure, but based on the urgency of his assignment and the tenable conditions, he decided not to evacuate immediately. At approximately 02:22 hours, while searching bedroom #2, Engineer 69 spotted a leather turnout boot along the right side of the bed. After moving some light debris, he realized it was a downed firefighter (FF1, Figure 11). Engineer 69 rolled the firefighter on his side and determined that he was still wearing an SCBA facepiece and the low air alarm (secondary bell) was slowly ringing. He immediately began to extricate him, but struggled because parts of the SCBA straps and turnouts were damaged to the point of failure. He yelled to Firefighter 69 for assistance. Together they struggled to remove the firefighter, and were able to move him to just inside the bedroom doorway. Visibility in the room decreased as the smoke conditions worsened. Near the point of exhaustion and with his SCBA low air alarm activated, Engineer 69 was briefly disoriented. Firefighter 69 assisted Engineer 69 toward the front door.
