MODULE 4: TYPE III OR ORDINARY CONSTRUCTION

CHARACTERISTICS OF ORDINARY CONSTRUCTION

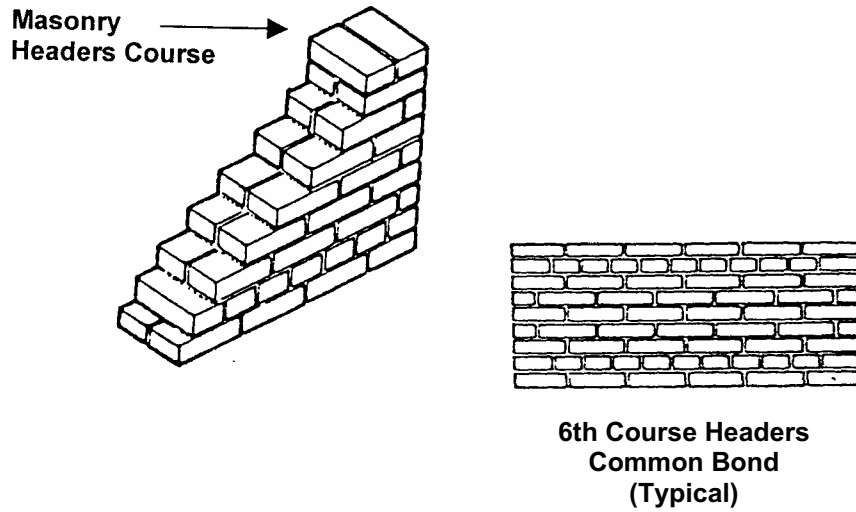
Solid Walls

Exterior walls of ordinary construction generally are constructed of brick. A true brick wall is two or more courses of brick thick. If a solid brick wall is being built, it is customary to lay five to six layers of brick lengthwise (stretcher rows) in the wall and then lay one at a 90-degree angle (header row) to the courses of brick below. This serves to tie the wall together as a solid unit. The bricks laid lengthwise are called "stretchers" and the rows laid at a 90-degree angle, where only the end of the brick is seen, are called "headers." Some walls have been constructed with the headers laid in a pattern in every course or every other course. This usually will be represented by a header, one or two stretchers, and another header with the pattern repeated. One continuous vertical section of masonry wall one brick in thickness is called a "wythe." A true brick wall has two or more wythe, while a fascia or decorative wall will have only one wythe of brick. In reading a building, the fact that there are both headers and stretchers could be one indication that it is a solid brick wall.

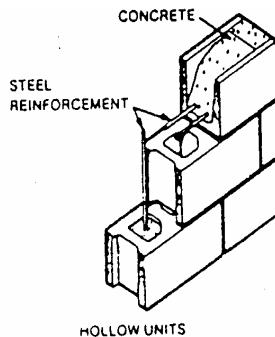
Cavity Walls

Some older buildings used a clay terra cotta block in place of today's modern concrete block as the load-bearing wall. Terra cotta is a material similar to brick, which is fired in a kiln to harden the material. A tile used to line a chimney is similar to that used for wall construction, except that the construction tile has numerous divisions inside the tile for strength. The terra cotta block wall was brittle and subject to being broken when struck with heavy objects. The exterior wall was faced with one layer of brick similar to the technique used for block walls. One danger of veneered walls placed adjacent to block walls is that it is possible, through various building connections, that gases from a fire, such as carbon monoxide, could accumulate in the small cavity between the two walls.

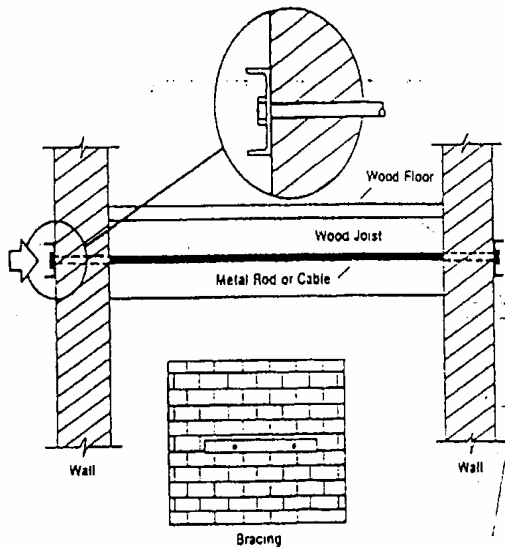
Load-Bearing Walls

12"	3rd Floor
24"	2nd Floor
36"	1st Floor

Bearing walls carry the load of the structure, which is transferred to the wall from the floor joists and roof rafters. Failure of a load-bearing wall can result in catastrophic structural collapse. It is critical that all emergency scene personnel be able to identify the load-bearing walls and understand the dangers associated with wall failure. Bearing walls are typically the longest walls of the structure. This may be the front (street side) or, most

often, the sides of the building. The longest walls typically are used to support the load, since this requires the shortest span for the floor joists and roof rafters inside the building.

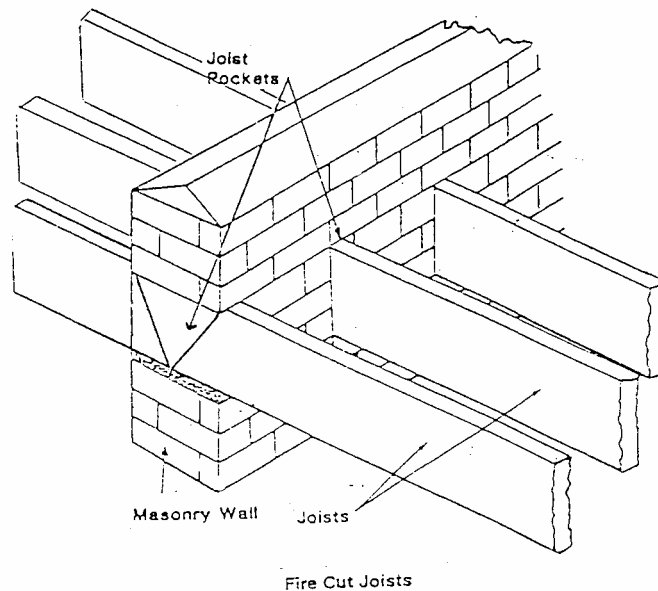
Common walls between two buildings often were used in ordinary construction. This was particularly true when the same developer was constructing multiple buildings adjacent to each other. The single wall not only separated the two buildings, but also provided the support for a load-bearing wall for both buildings. A catastrophic event, such as an explosion, on one side of the wall could have catastrophic results for the neighboring building if the common wall was damaged. As the buildings were constructed, a joist pocket would be built into the wall and the floor

joists or roof rafters from both buildings would share the opening in the wall. This "good-neighbor policy" also raises concerns under fire conditions, with the potential for fire to extend from one building into the next through the common wall joist pocket. A typical tactical objective is to enter the exposure building and open ceilings to inspect for common joist pockets and to evaluate fire, smoke, or heat travel. Another concern is if a significant fire should occur in one building and the structural supporting members holding the floors and roof should be lost is that the load applied to the common wall is totally from one side. This could raise concerns for the possibility of collapse. Often, when a building has been removed from one side of a common wall, special bracing is provided for the wall. To keep floor joists from pushing the wall down should they fall from the joist pocket, the floor joists were cut on an angle which is called a "fire cut." The fire cut provided the maximum surface for the joist to rest on the bottom, but was cut to provide minimum clearance for the top of the joist pocket.

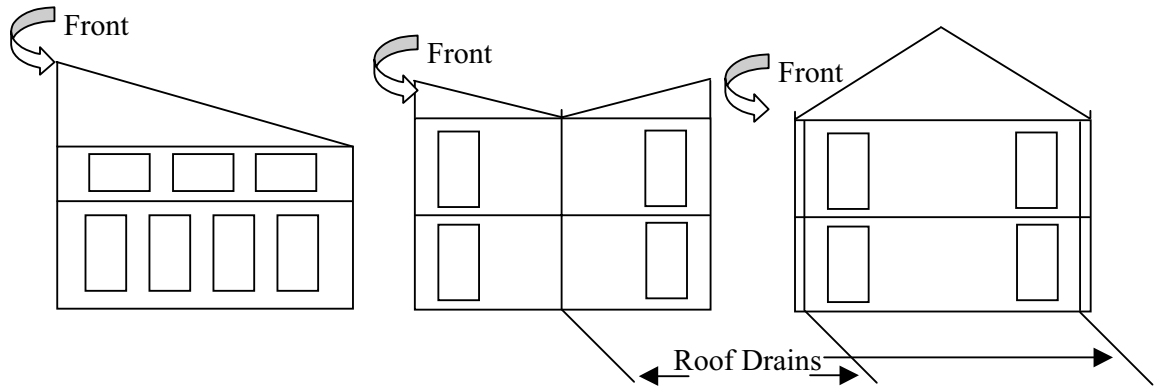
Roofs are installed on ordinary construction using a variety of methods. The most basic roof is sloped from the front wall to the rear wall with an adequate slope to provide drainage. Another method is a nearly flat roof with just enough slope to drain the water to centralized roof drains with a piping system which brings the water from the roof to the basement and sewer system. A third type is a peaked roof with roof drains at the lowest ends of the roof pitches. Roof rafters are placed on a support system that carries the exterior roof load to the load-bearing walls, similar to the floor joists below. In newer buildings the roof structure may be constructed from truss rafters or from rafters constructed with a wooden "I" beam arrangement. Roof boards or plywood are placed over the rafters and a roofing material is applied. Roof materials may include an asphalt-based paper and hot tar, rubber or vinyl sheets cemented to the roof, or corrugated steel sheets. In some instances an asphalt roof may be covered with a layer of stone to protect the asphalt material from the daily expansion and contraction from the heating and cooling process. In addition, many vinyl or rubber roofs may be protected with lightweight concrete blocks intended to be used for persons walking on the roof to service equipment located there.

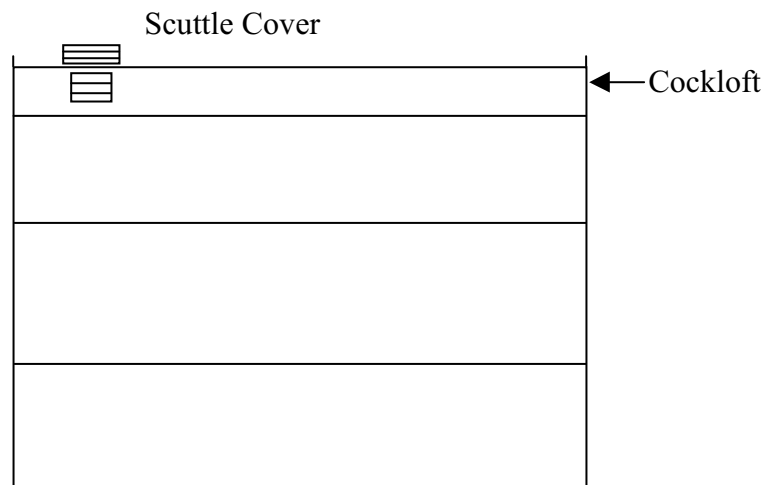
Each roof structure will provide a void area that is a critical concern for fire extension. This area often is referred to as a "cockloft." This cockloft usually is accessible from within the building via a scuttle hole and ladder, commonly placed into the ceiling of the top floor or on a rear porch to provide access. Inside the cockloft there is typically a ladder that leads to a scuttle opening onto the roof. This is an easy access to the roof for maintenance purposes. This scuttle opening also can provide a quick ventilation opening into the cockloft area if ladder access can be gained to the roof from the exterior. Remember that there may be several inches to several feet from the top of the building wall to the roof below. It is critical that building preplans indicate the roof construction and features so that, should roof operations become necessary, critical decisions can be made at the ground level. These would include the construction of the roof, the roof covering, and the tools or equipment needed to open the roof.
